**Marion County Courthouse Square
555 Court Street NE, Salem Oregon
Remediation Study Final Report
February 07, 2011**

Volume Two of Six

**MARION COUNTY COURTHOUSE SQUARE & BUS MALL
555 COURT STREET NE
SALEM, OREGON**

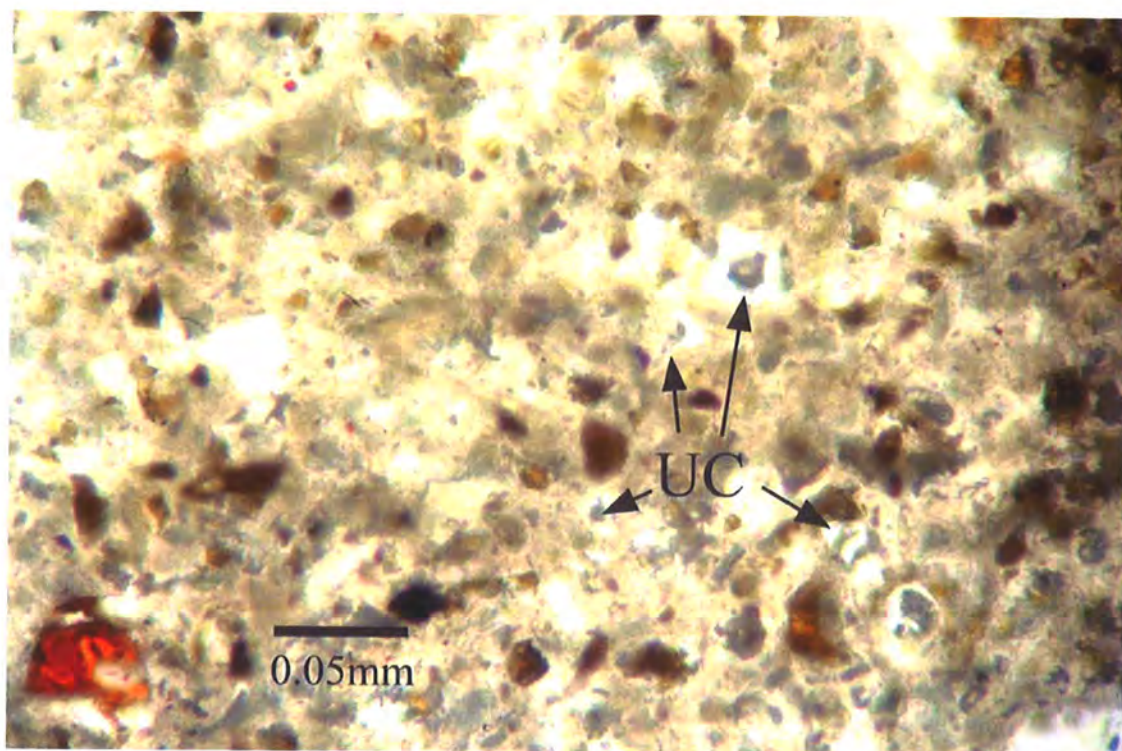
FIGURE 6 Micrograph of 1-P Series thin-section shows typical appearance of aggregate (A) and voids (V) (X40).

FIGURE 7 More highly magnified micrograph of 1-P Series shows typical appearance of hardened paste with some un-hydrated cement particles (UC) (X400).

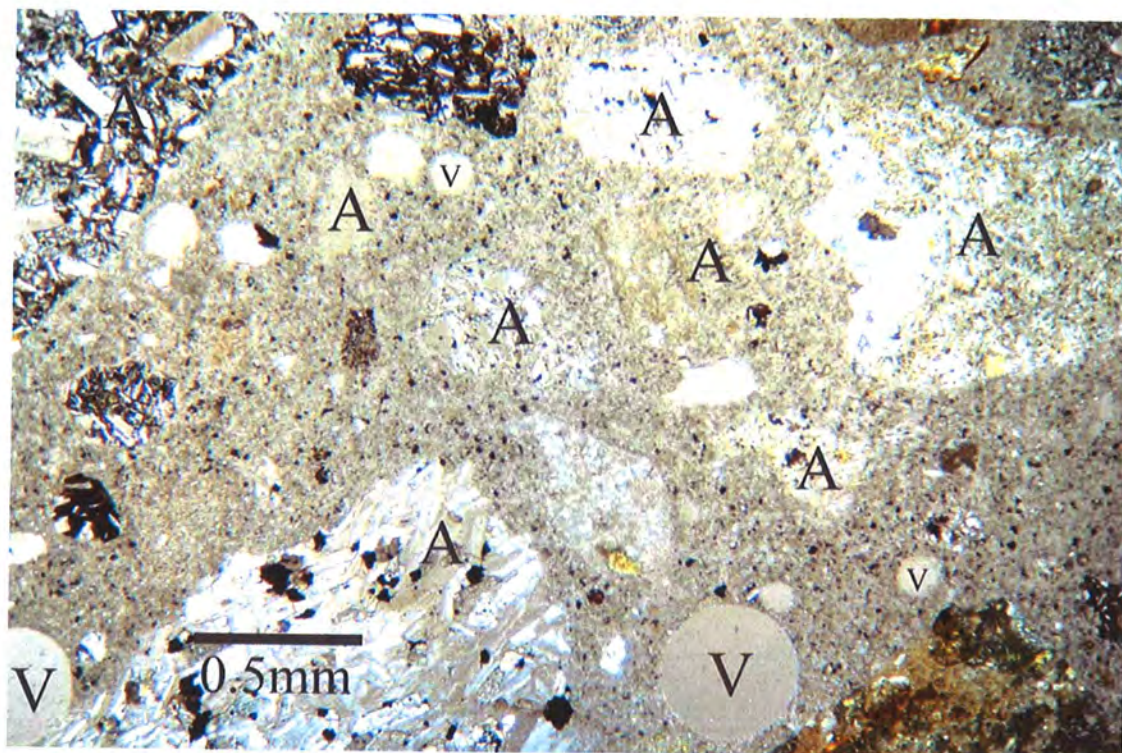
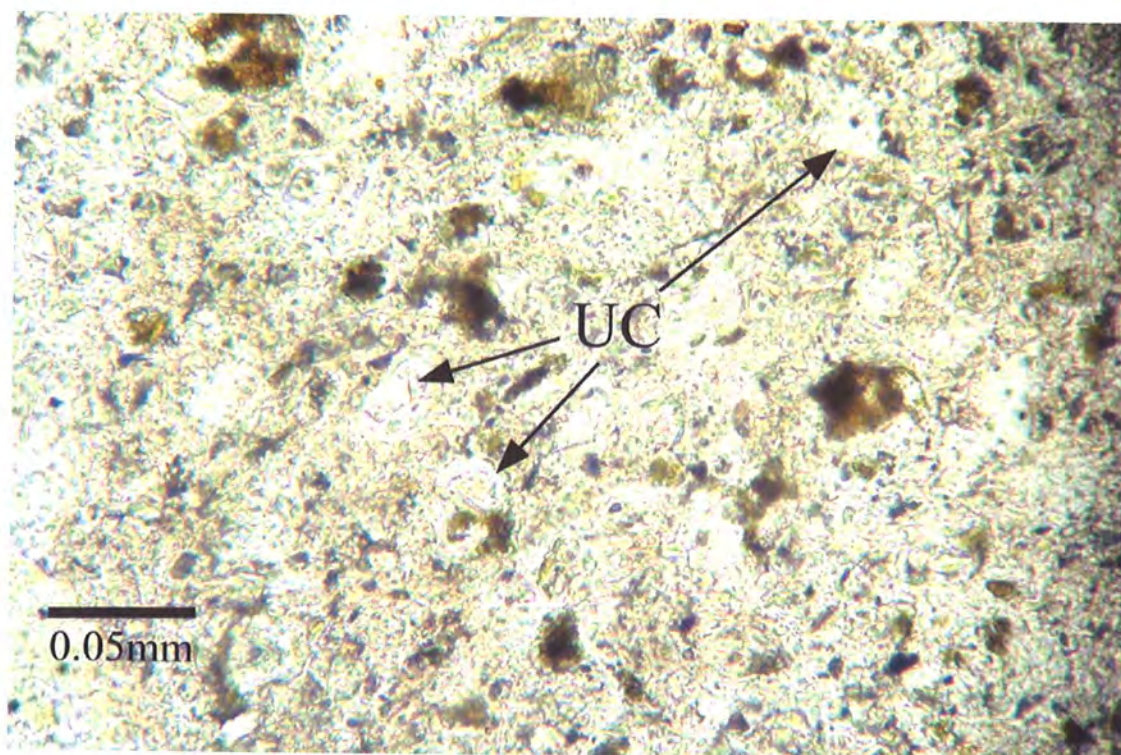
FIGURE 27 Micrograph of 4-P Series thin-section shows typical appearance of aggregate (A) and voids (V) (X40).

FIGURE 28 More highly magnified micrograph of 4-P Series shows typical appearance of hardened paste with some un-hydrated cement particles (UC) (X400).

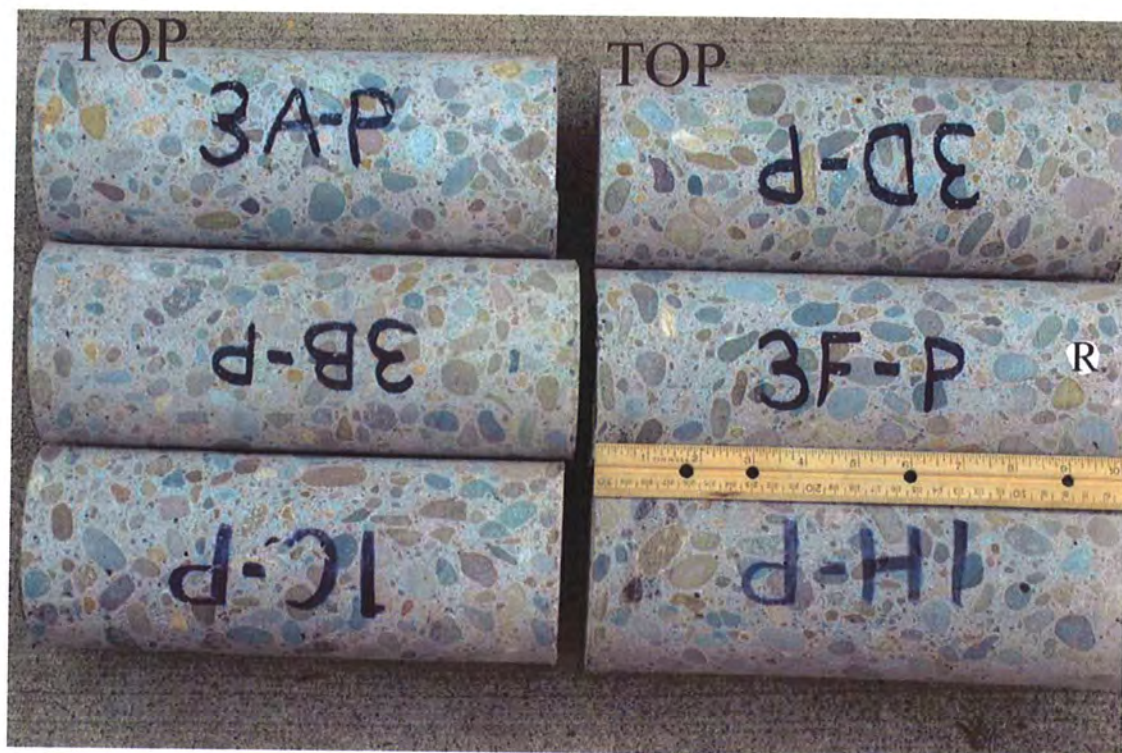
FIGURE 1 Side of cores as received for examination and analysis show aggregate size, shape, and distribution. Intercepted rebar (R) is evident in Core F.

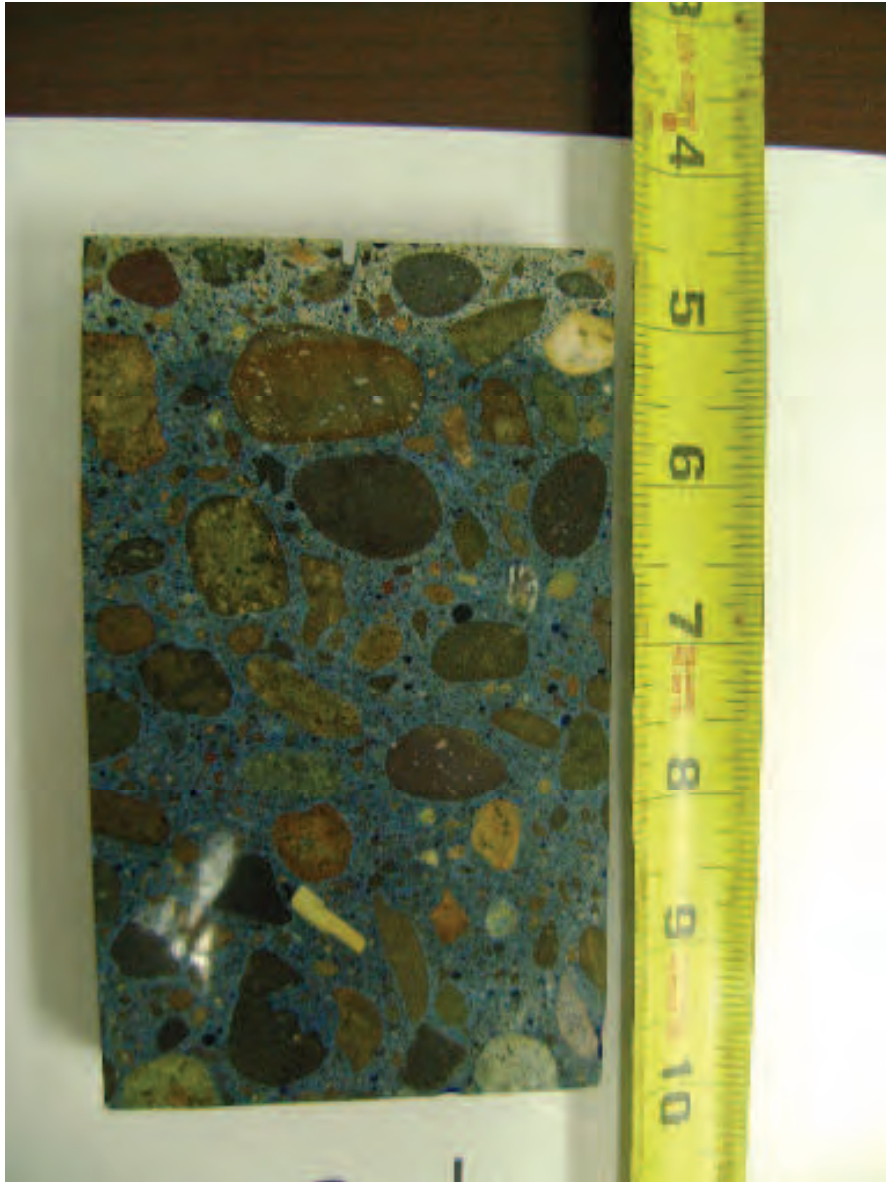
Photograph #1 - Sample 06033-1. Change in paste color can be seen at top surface and lower right corner.

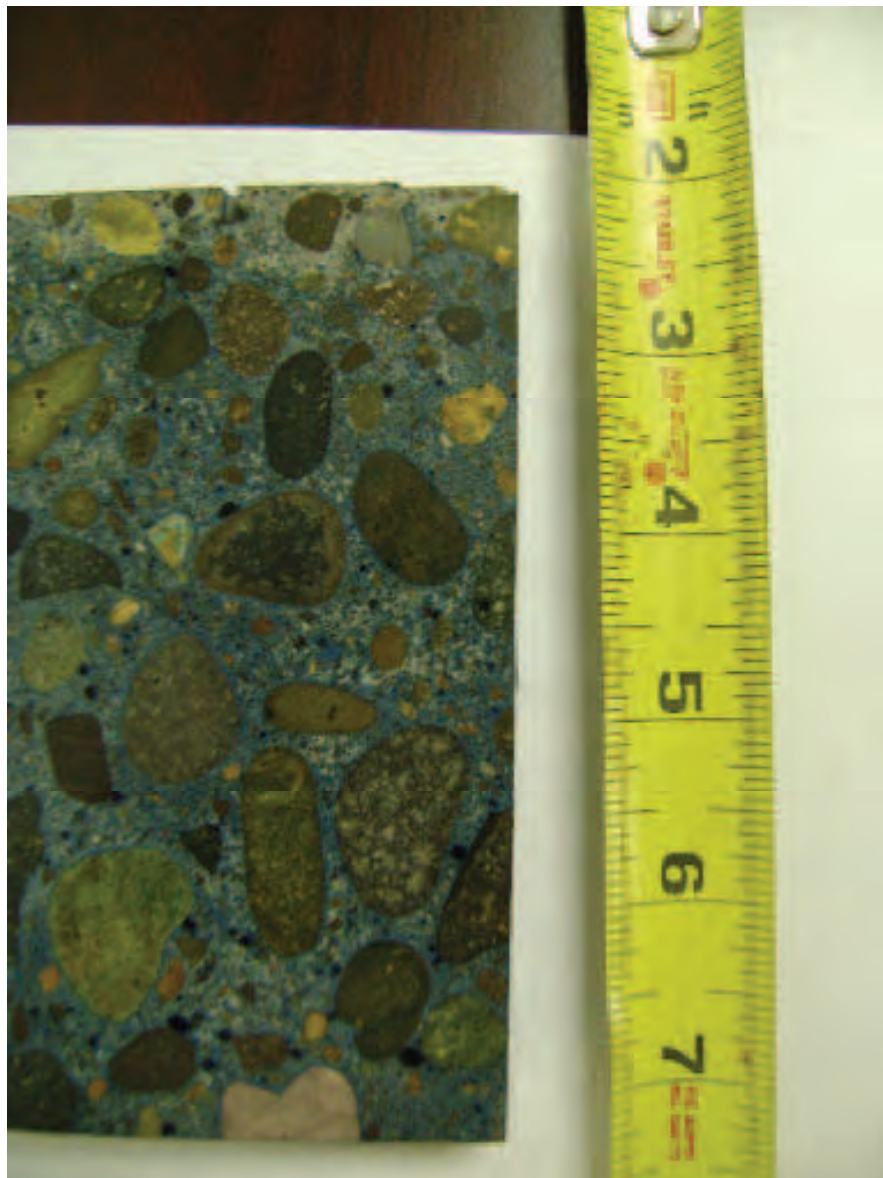
Photograph #2 - Sample 06033-2. Color change can be seen in paste at top surface as well as the bulk paste.

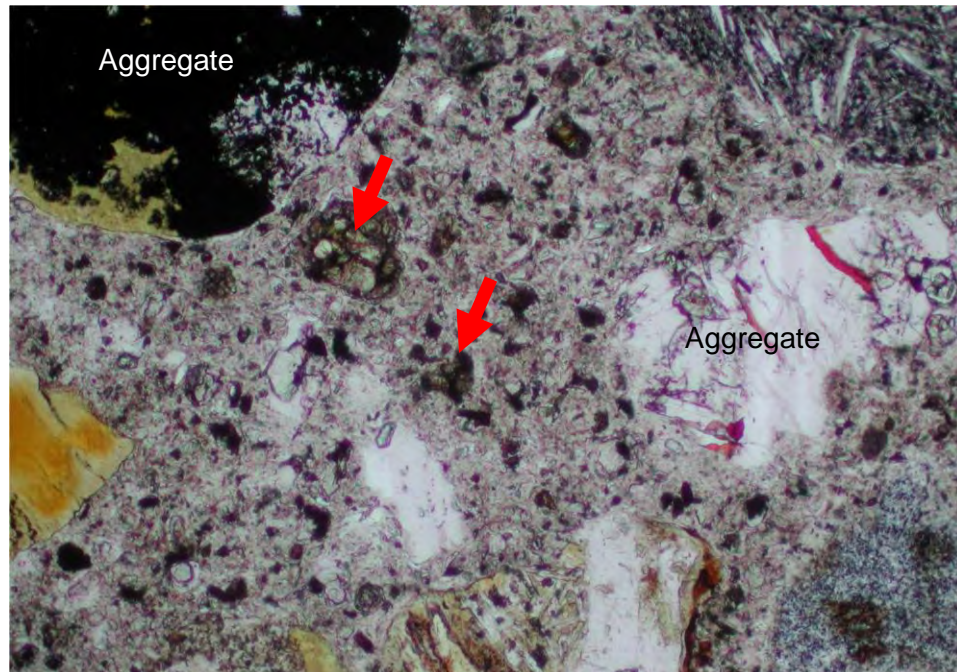
Fig. 5 Thin-section photomicrograph (plane-polarized light) showing a field of hardened paste in Core 2A-2. Arrows designate residual portland cement particles. No supplementary cementitious material such as fly ash is observed in the paste. Field of view is 0.03 in. across.

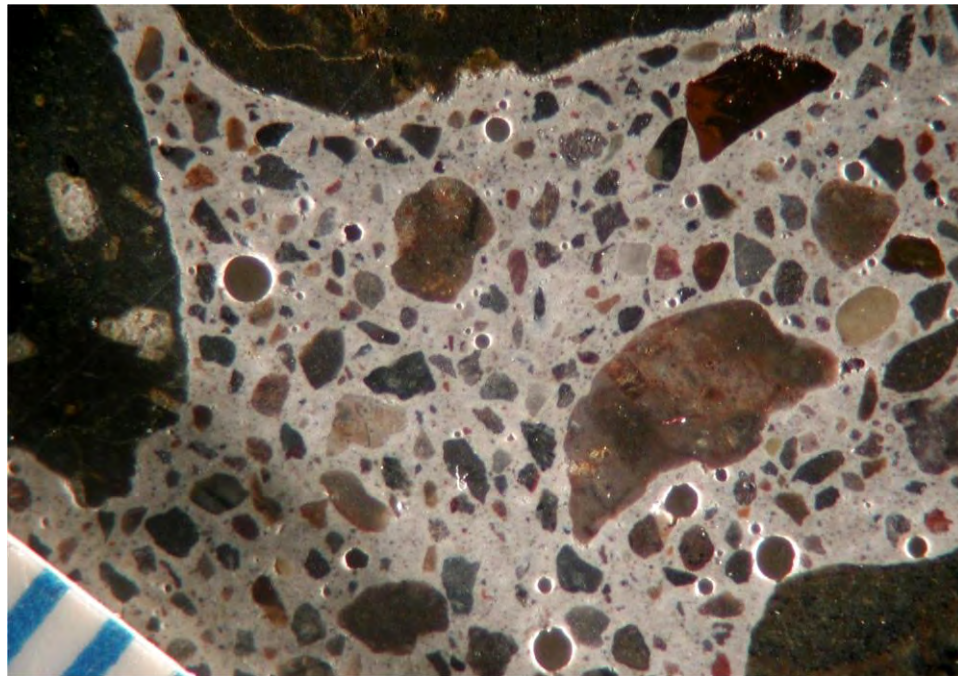
Fig. 6 Stereomicroscope image of a cut and lapped cross-sectional surface of Core 3C-2, showing overall abundance of air voids (estimated at 2 to 4%) in the core. Scale increments are 0.04 in.

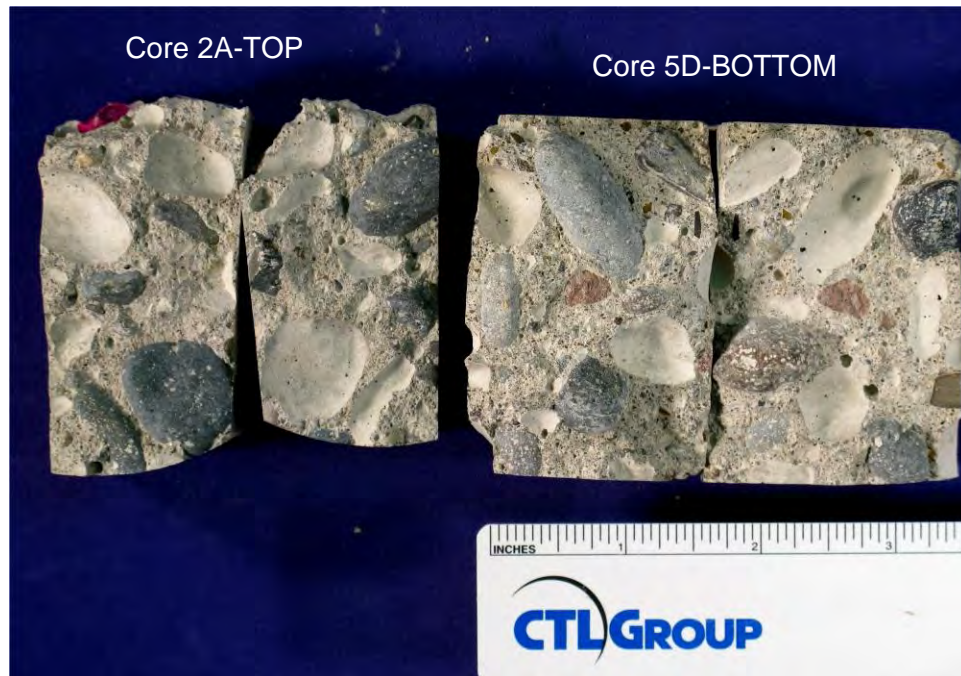
Fig. 7 Image showing freshly fractured surfaces of Cores 2A-TOP and 5D-BOTTOM. The fracture surfaces pass around almost all coarse aggregate particles indicating a weak paste-aggregate bond. Scale is marked in inches.

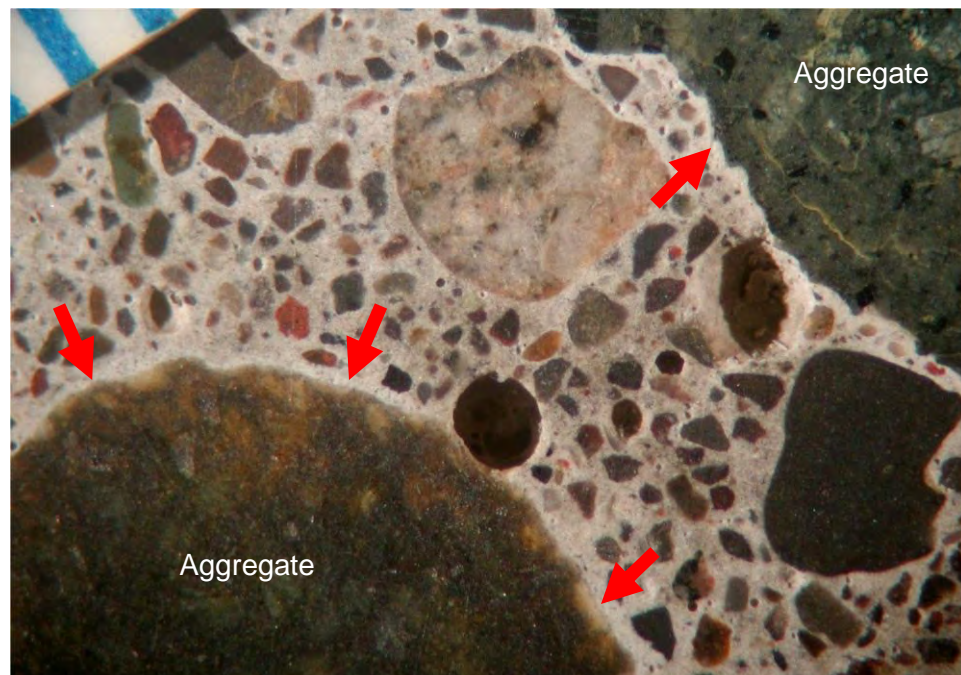
Fig. 8 Stereomicroscope image of a cut and lapped cross-sectional surface of Core 3C-MIDDLE, showing coarse aggregate particles exhibiting lighter paste rims (arrows). Scale increments are 0.04 in.
