**Marion County Courthouse Square
555 Court Street NE, Salem Oregon
Remediation Study Final Report
February 07, 2011**

Volume Three of Six

Miller Consulting Engineers, Inc.
Structural Photographic Documentation

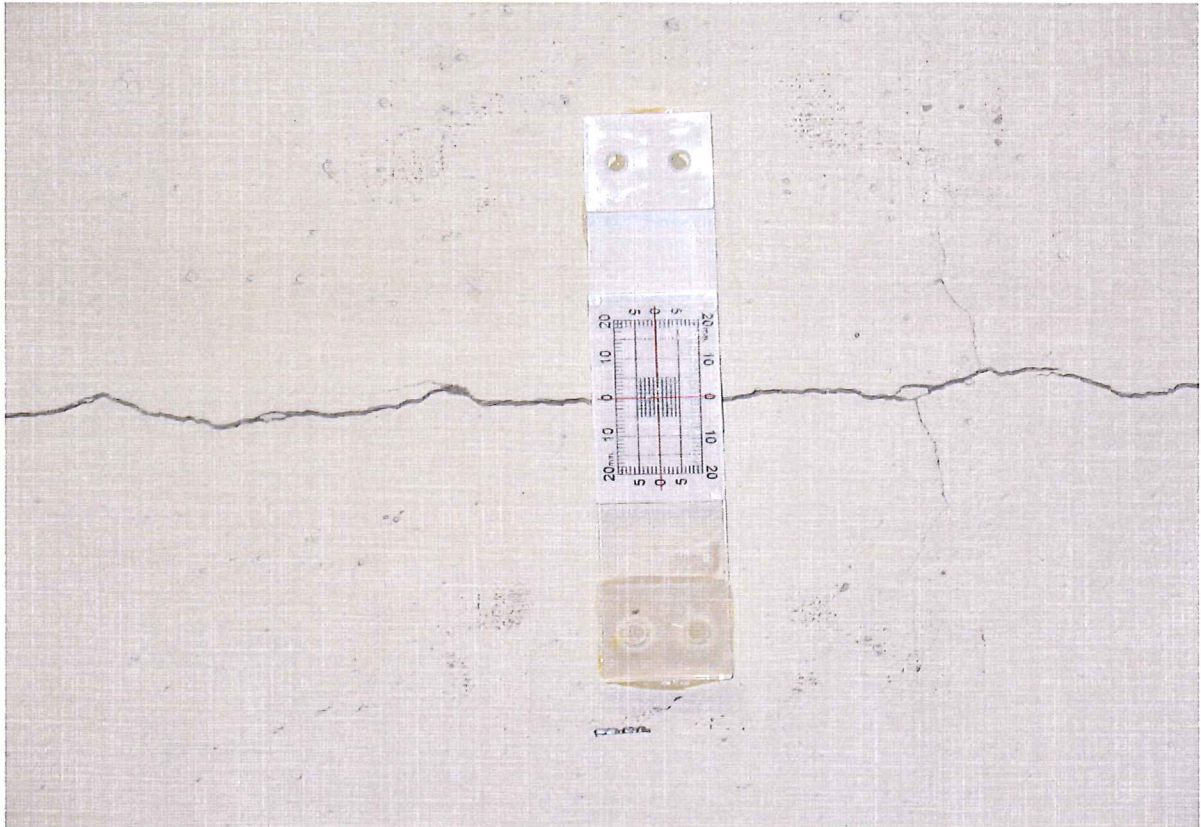
1.1 Building West Stair Tower, Fifth Floor on West Wall

Photograph 1: Movement of Upper Hash toward the South
Date: April 14, 2010

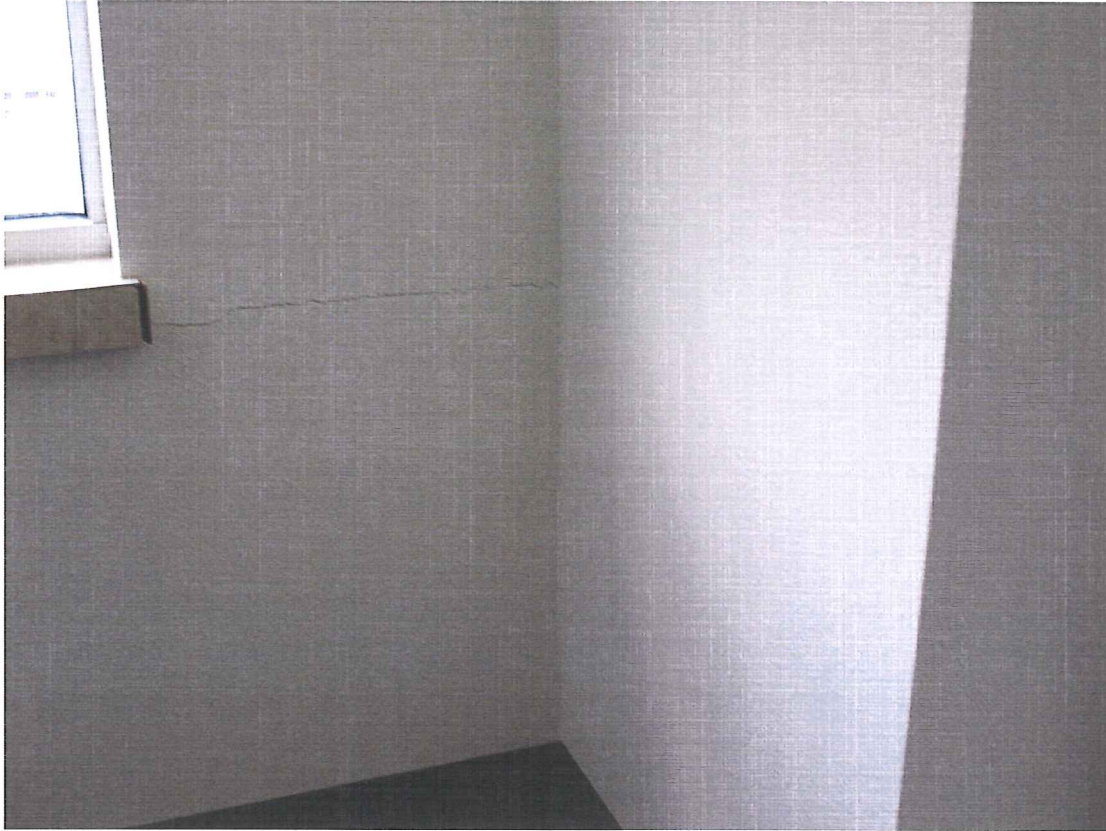
**Horizontal crack at the base of the windows, which was observed on the third, fourth and fifth floors.
Date: April 14, 2010**

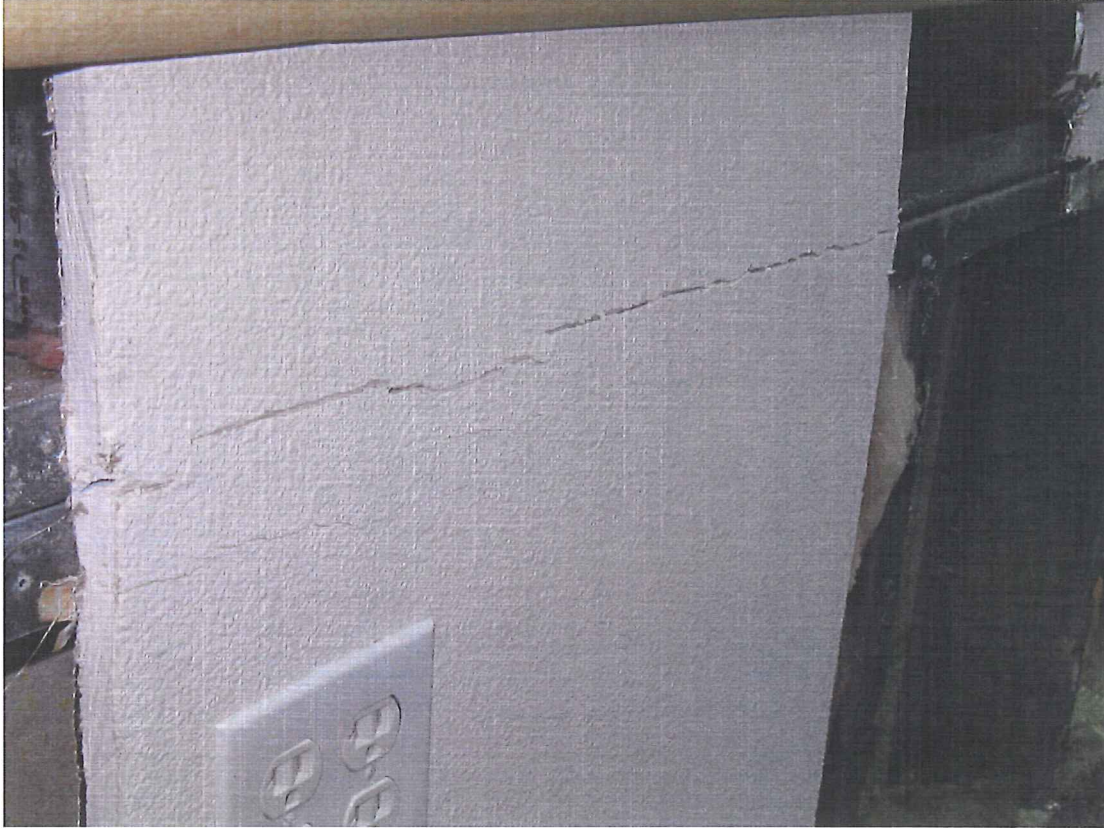
The framing at the horizontal crack is revealed
Date: June 3, 2010

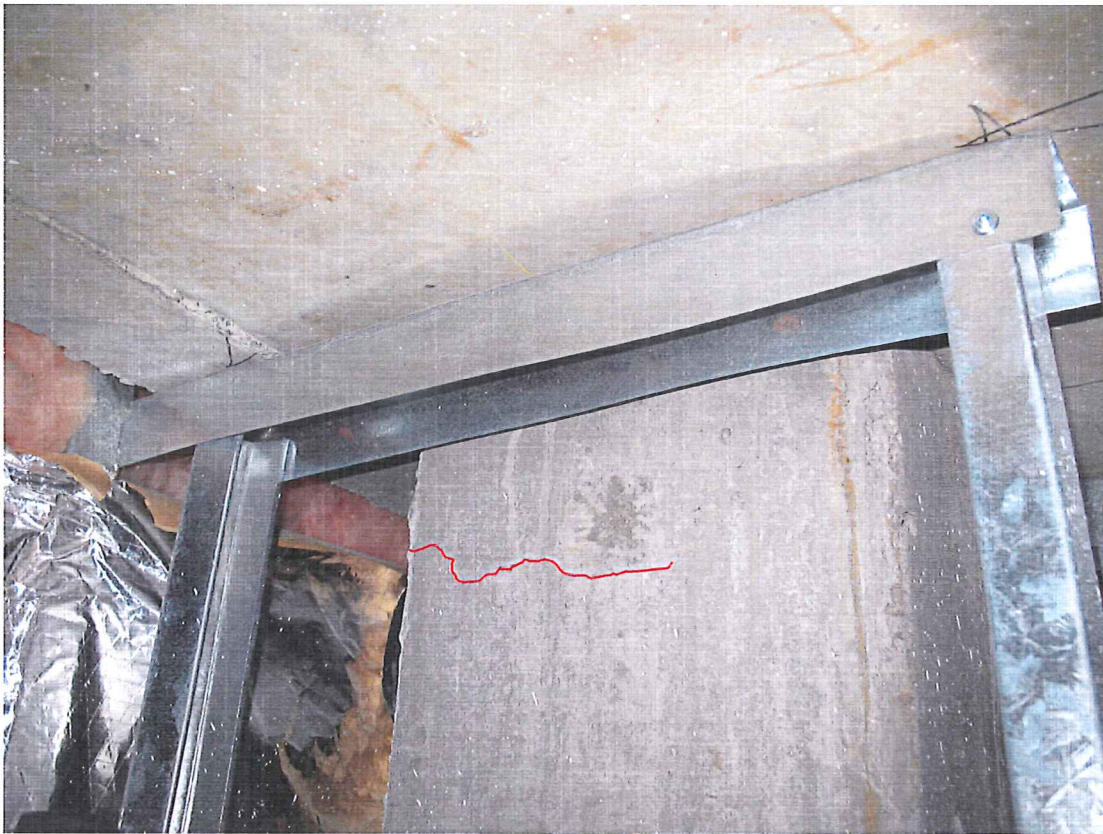
Cracking on outside face of column at the fifth floor
Date: April 14, 2010

1. Cracking was observed at the top of the concrete columns. At the lower floors, the cracking was observed in the inside face. However, at the fifth floor, the cracking was observed on the outside face.
2. At the bottom of the slab, north-south cracking was observed along column gridlines, which is parallel with the banded tendons.

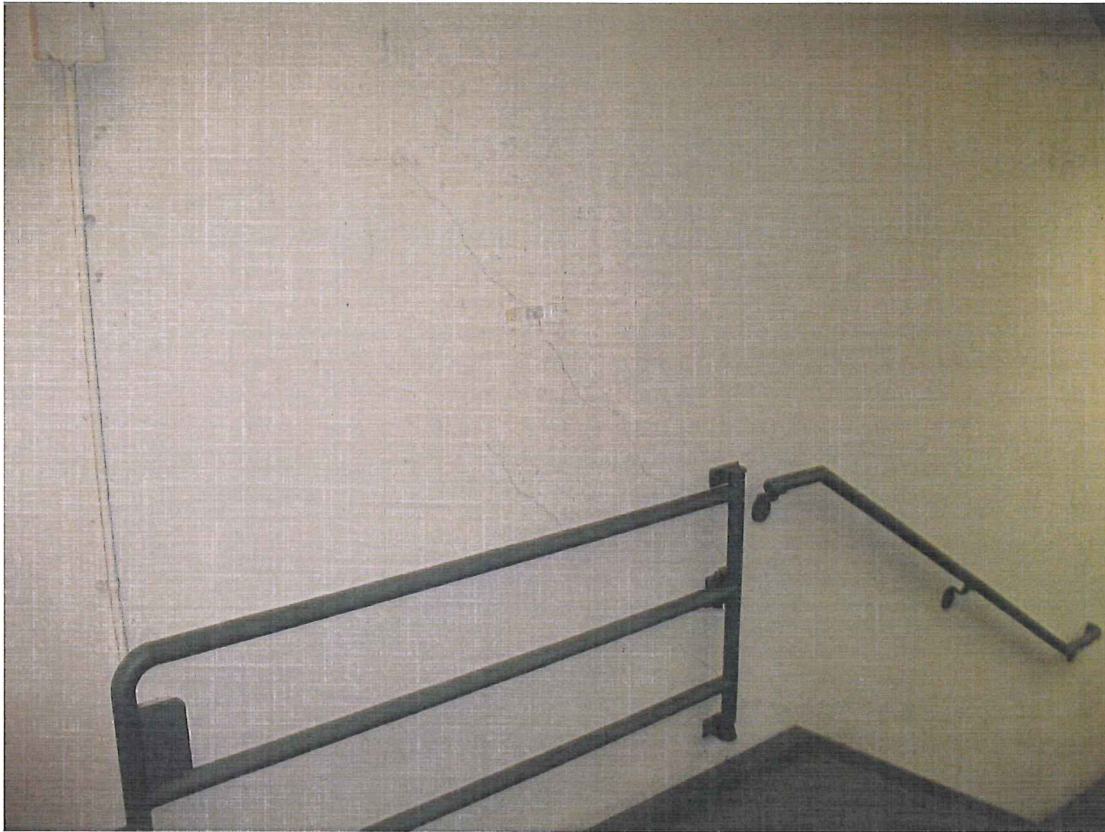
Several diagonal cracks on the ground floor on the north wall of the west stair tower
Date: April 14, 2010

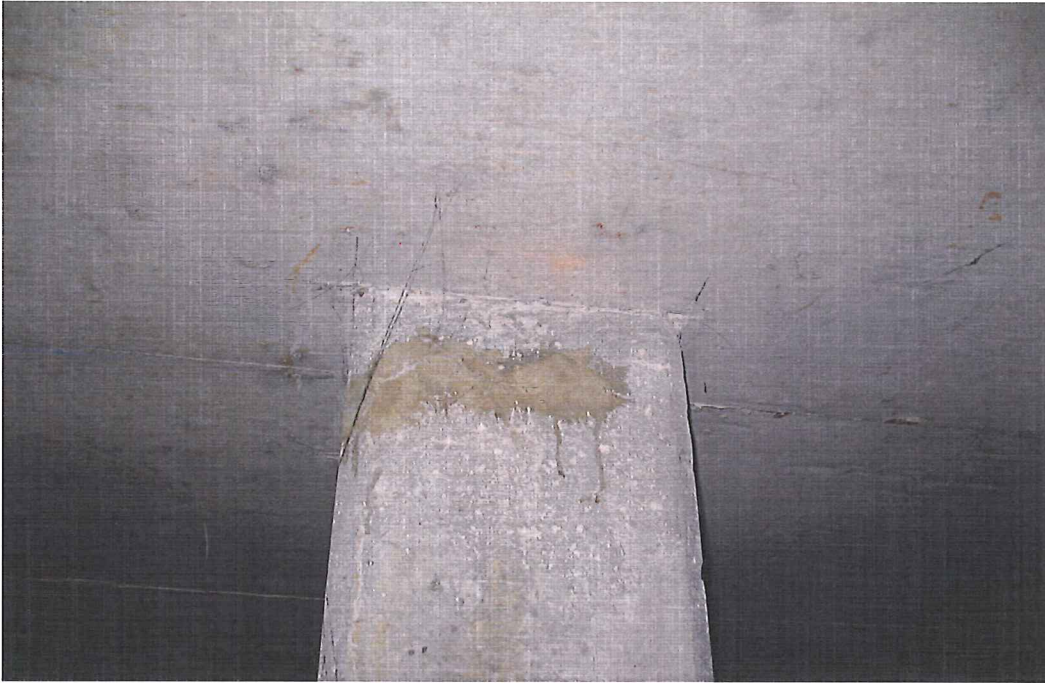
Grid B-9: Visible construction patch with typical cracking (0.20 mm)

Movement to the East

Column not repaired during construction

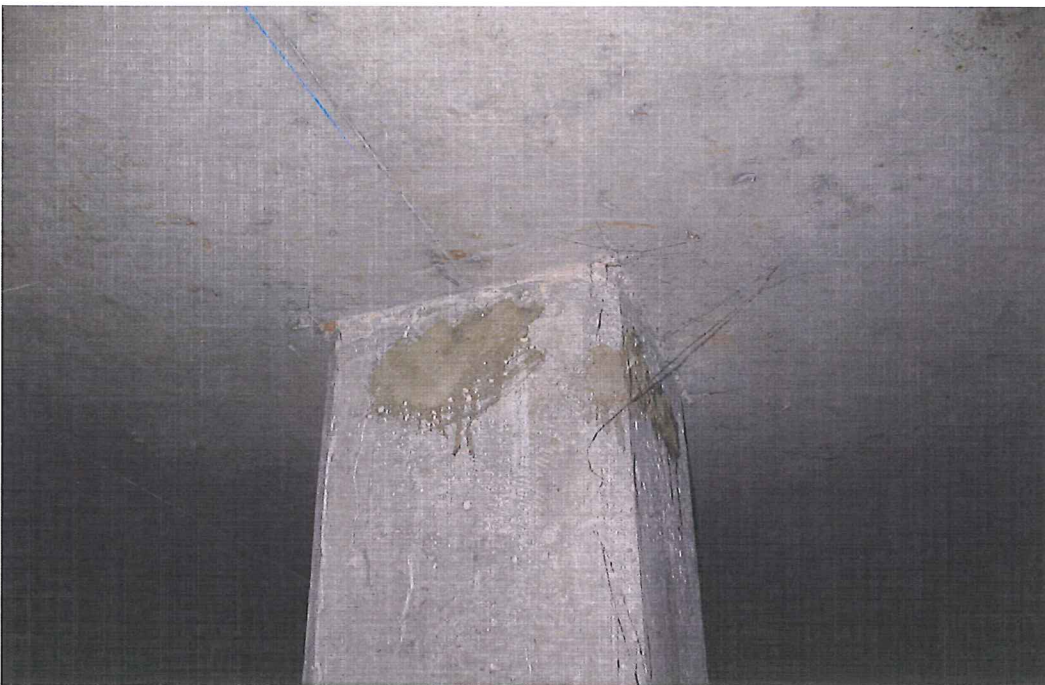
Grid B-9: Visible construction patch with typical cracking (0.20 mm)

Movement to the East

Column not repaired during construction

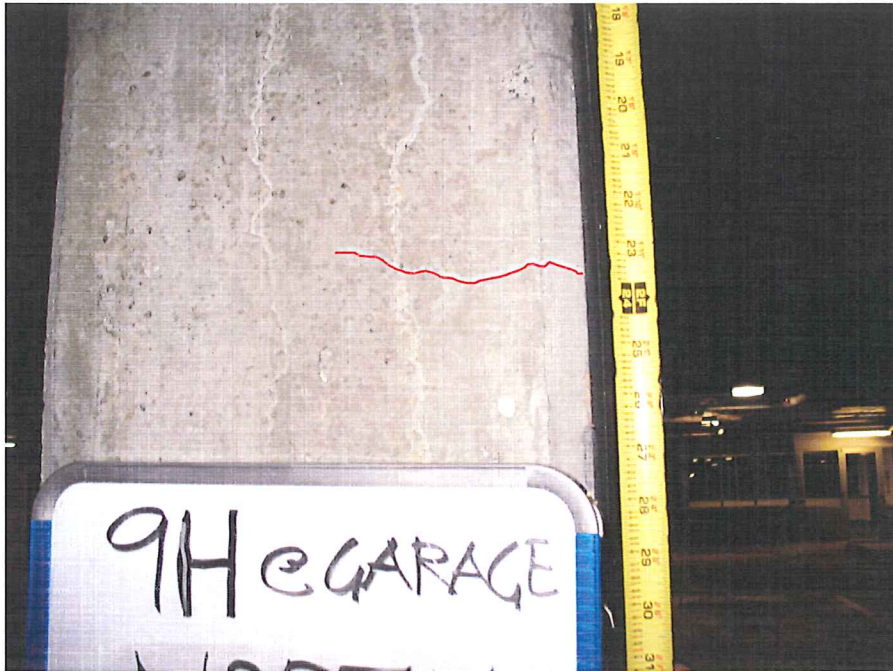
Grid H-9: Visible construction patch with typical cracking (0.30 mm)

Column repaired during construction period.

Movement to the North

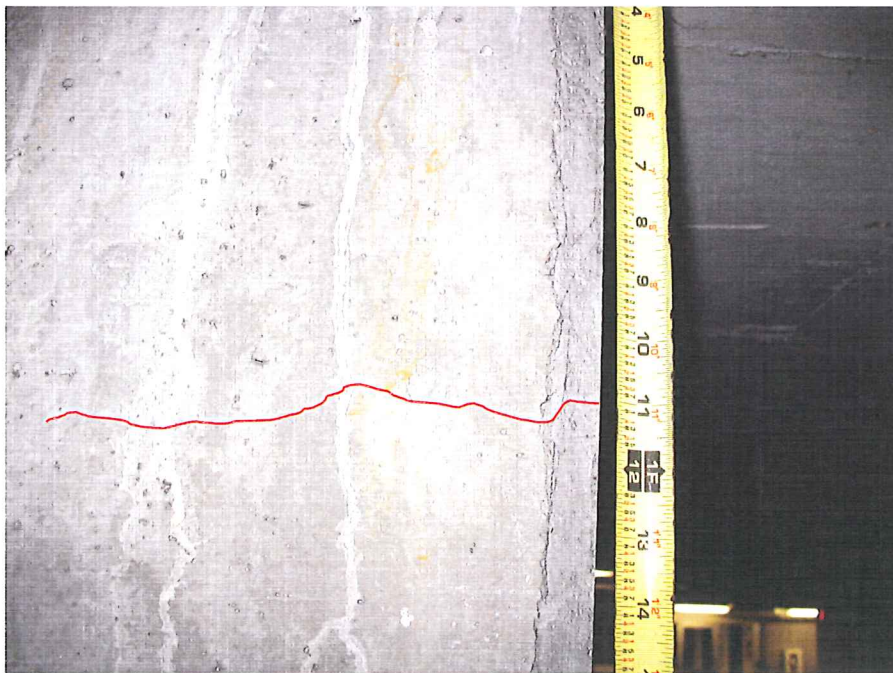
Grid H-9: Visible construction patch with typical cracking (0.30 mm)

Column repaired during construction period.

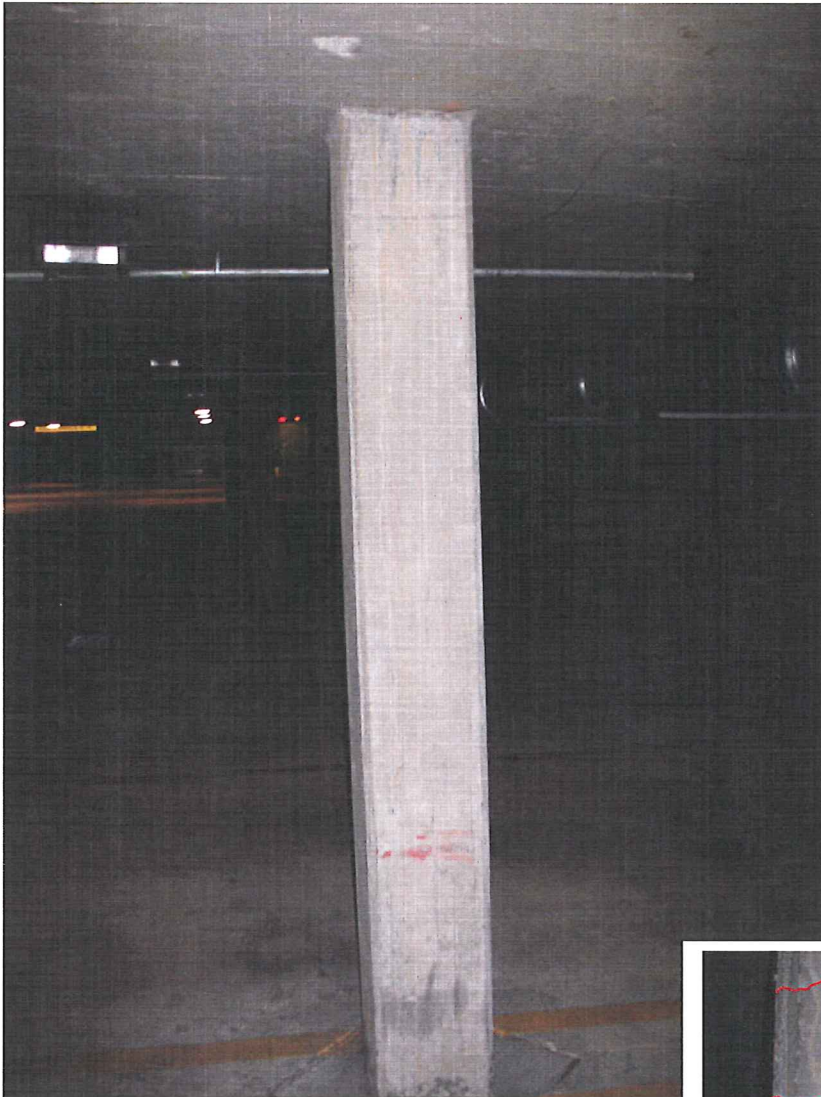
Grid N-9: No visible patch; excessive cracking (0.40 mm)
Movement to the West and North at top of column
Date: December 1, 2010

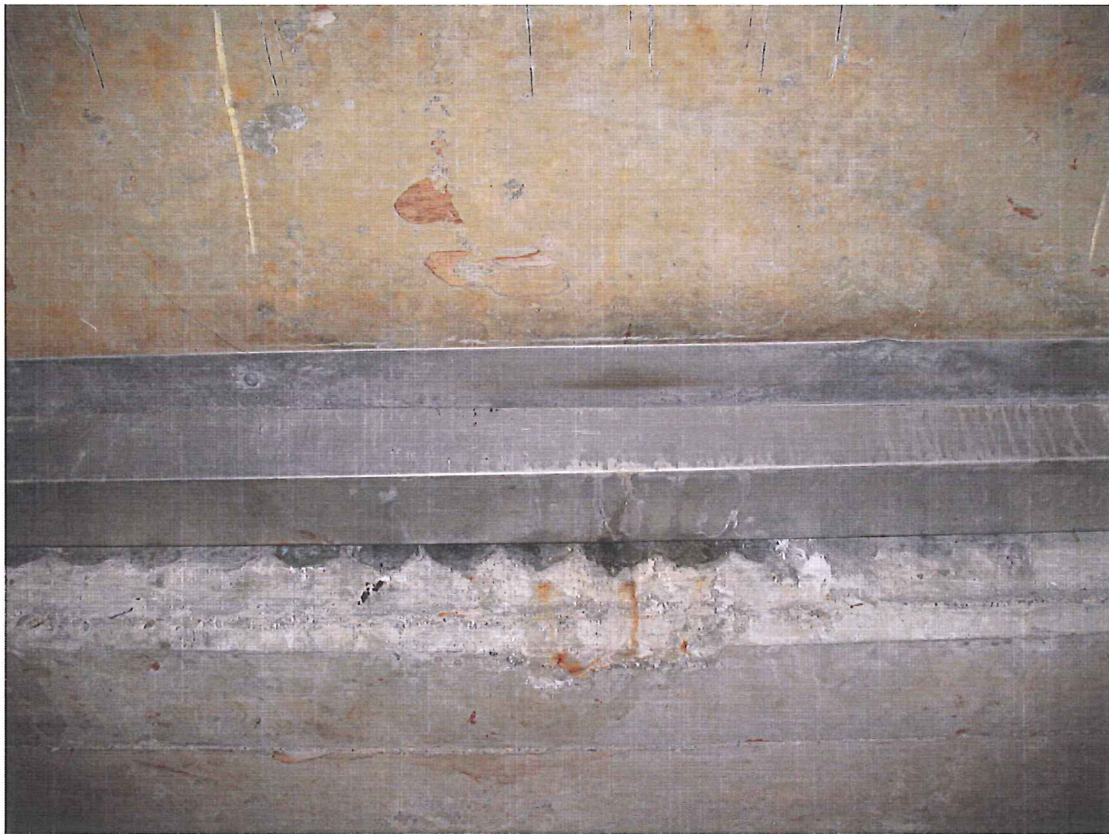
Tendon grout pockets with spalling of the grout pockets visible as a result of moisture penetration
North edge of the bus mall slab
Date: April 14, 2010

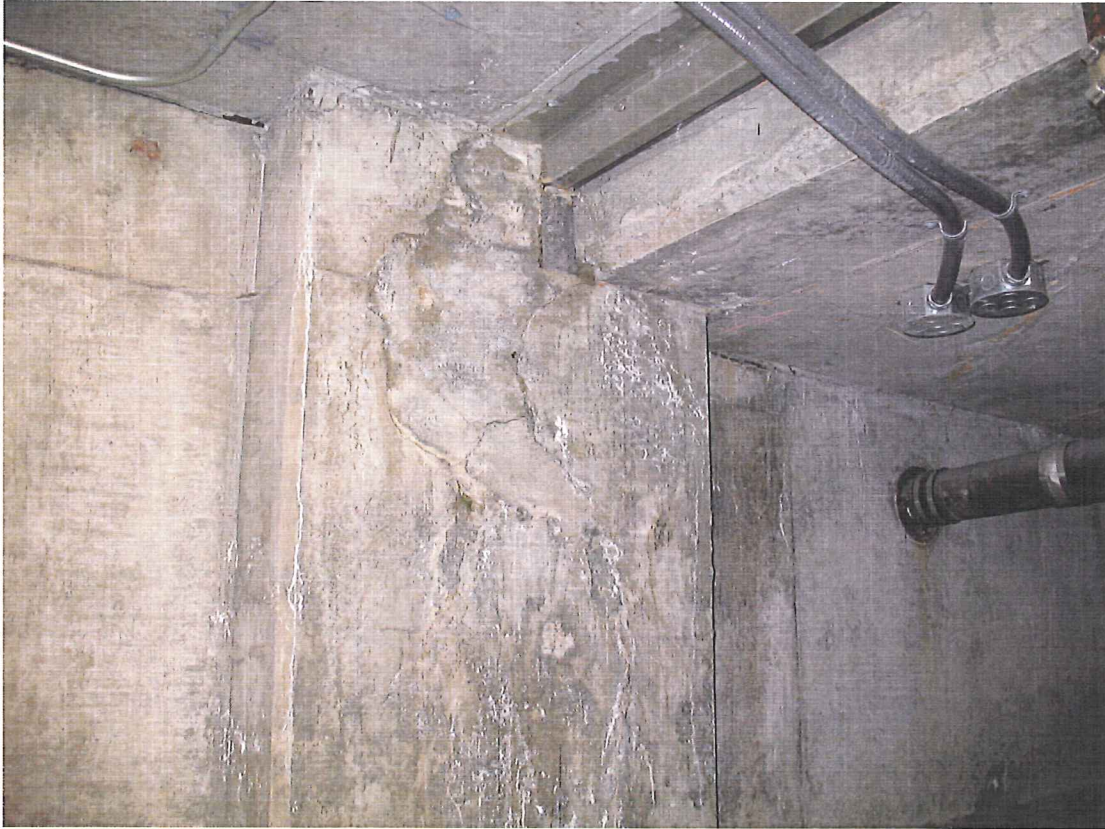
Significant cracking at the expansion joint between Bus Mall and North Block (Grid O-3a)
Date: April 14, 2010

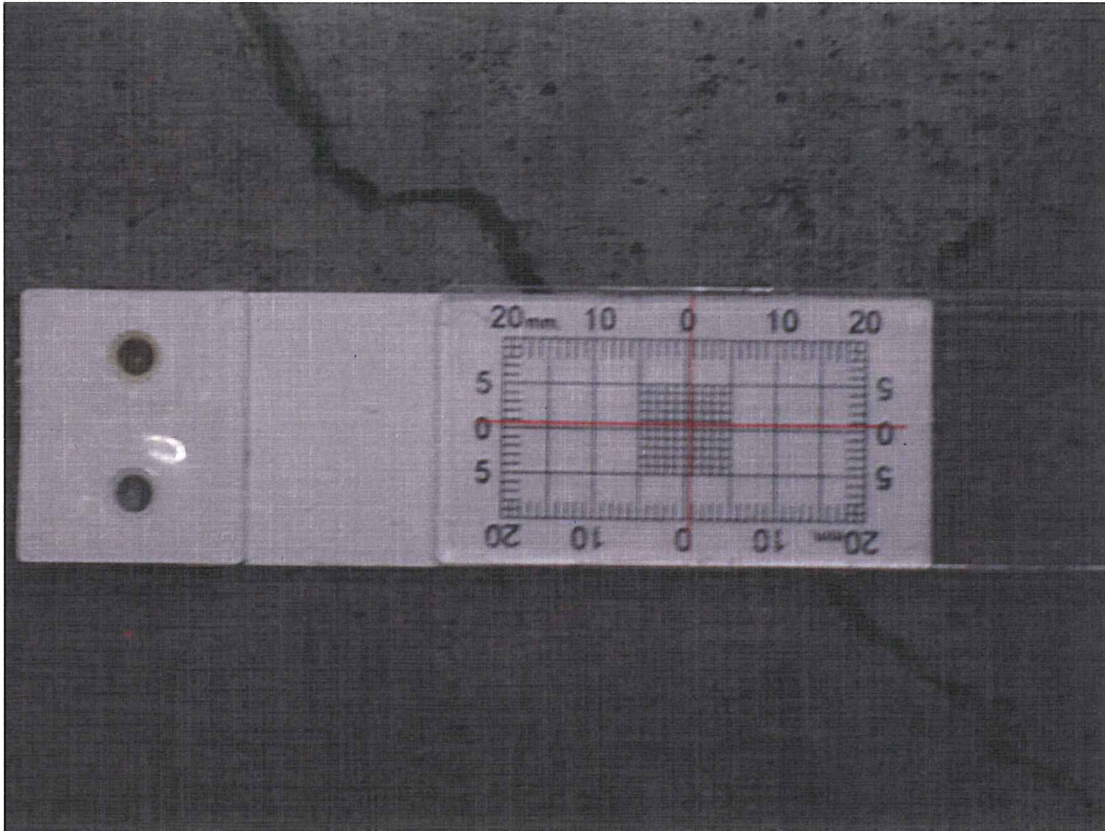
**Crack gauge at the south wall of room 298
Date: December 1, 2010**

**Significant cracking at the expansion joint between the
Bus Mall and the North Block
Date: December 1, 2010**

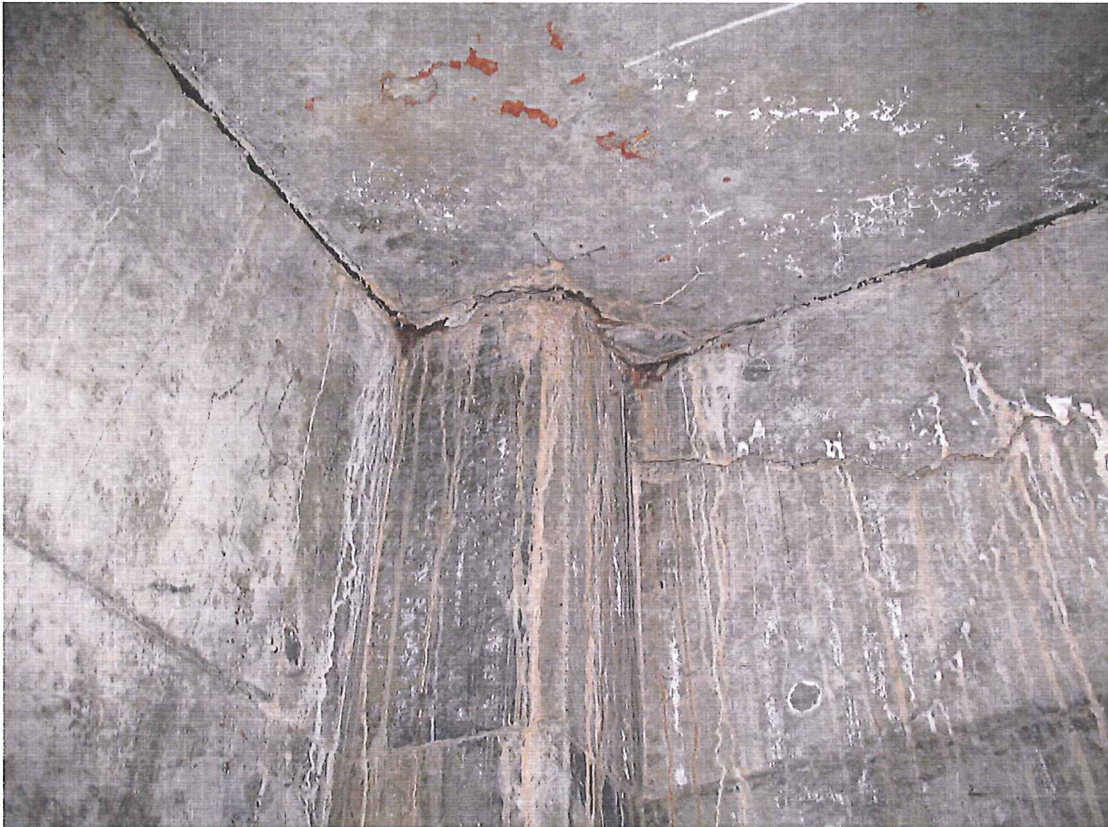
Significant cracking and efflorescence coming through concrete at Northeast corner column (Grid N1-1)
Date: April 14, 2010

1. Cracking was observed at the top of the wall at the northeast and northwest corners
2. Signs of moisture penetrating through the waterproof barrier

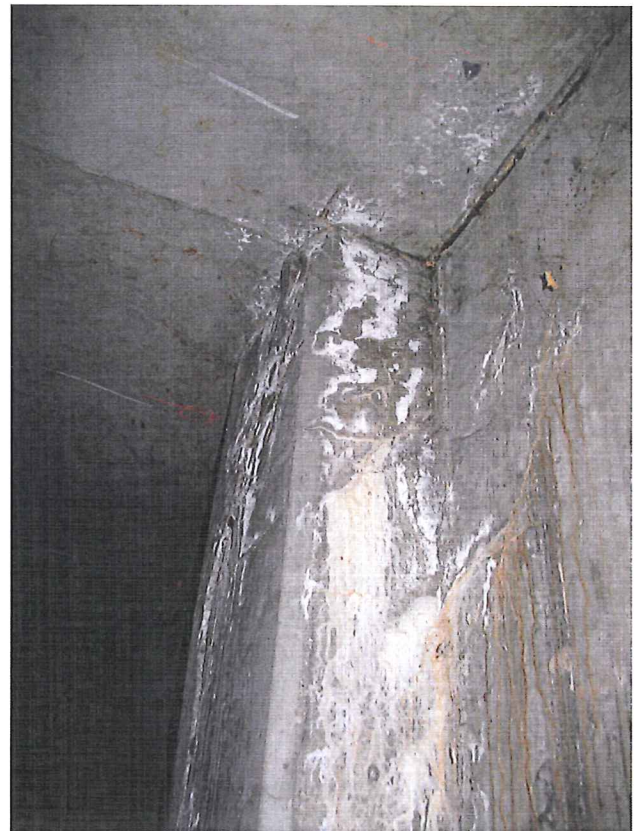
**Significant cracking and efflorescence coming through
Concrete column at Grid M-1**
Date: April 14, 2010

1. This column was the only column in the North Block in this condition.

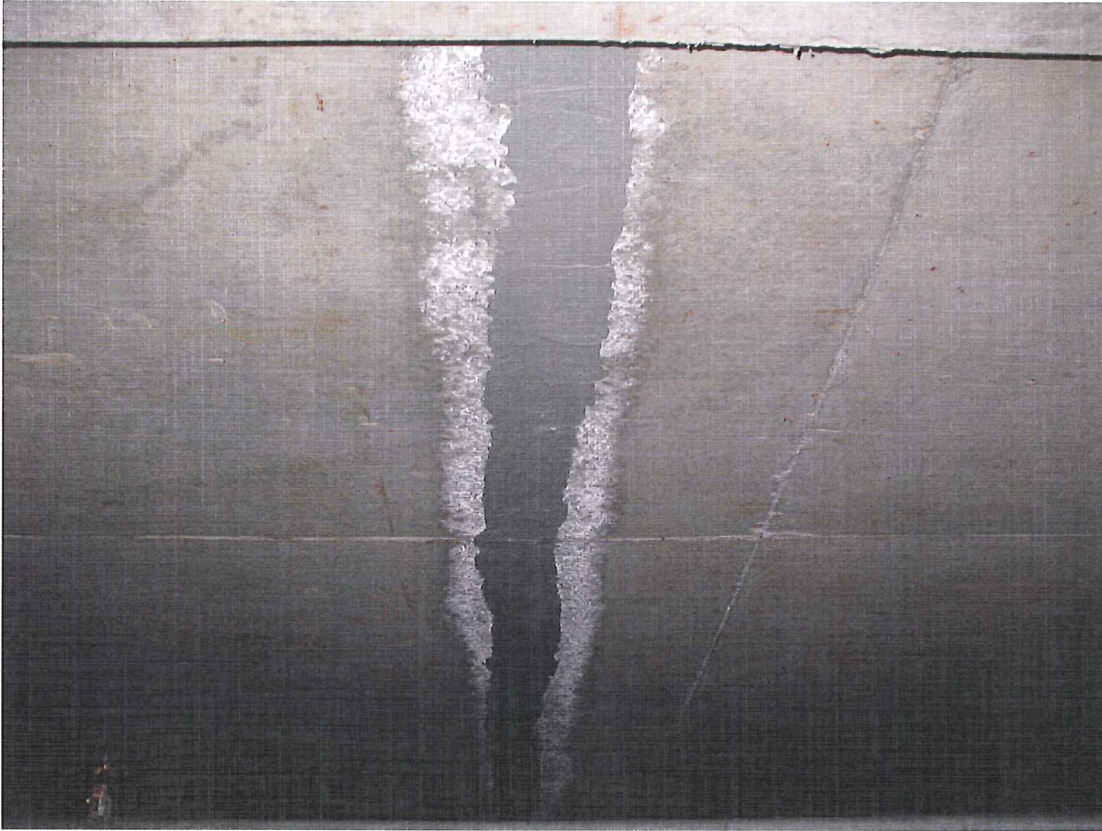
Cracking at midspan between columns as a result of thermal expansion of the exposed PT slab
Date: April 14, 2010

Painted repair of the top of the PT slab
Date: June 1, 2010

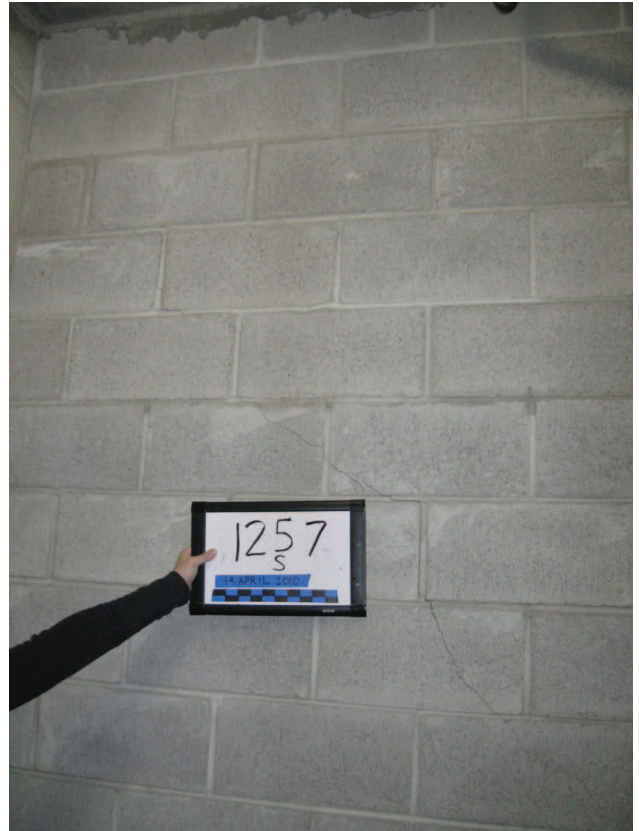
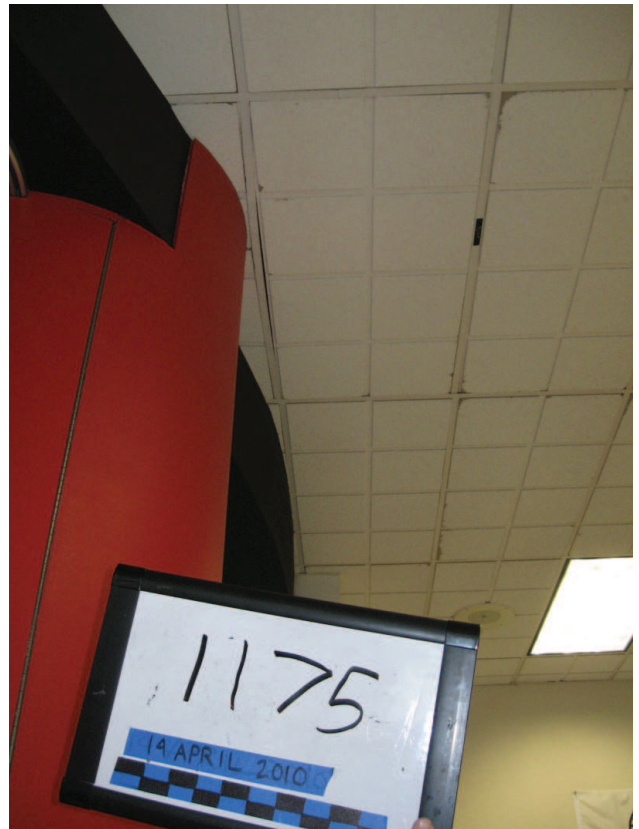
Bottom left: Wall crack can be seen above chair and below sign.

Bottom right: Ceiling grid has shafted and buckled.

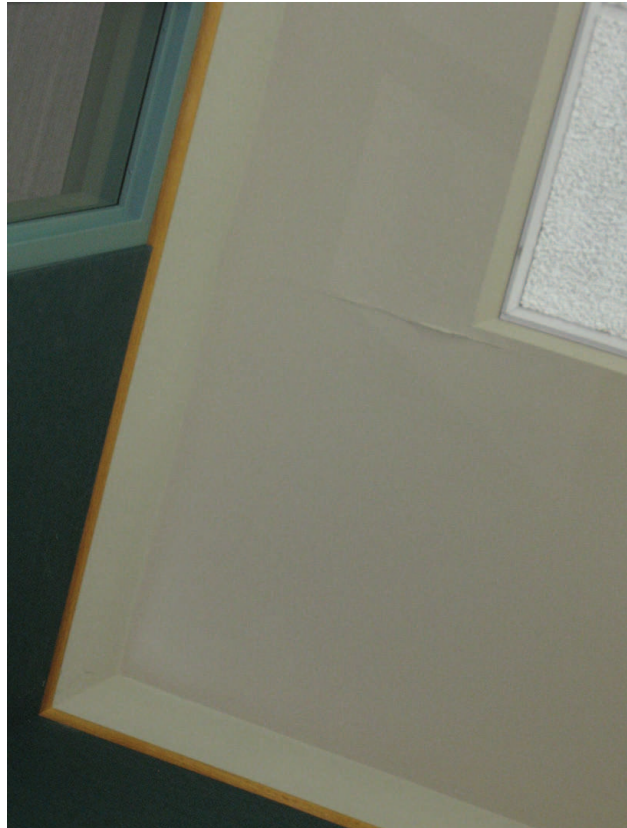
Top left: Ceiling crack in a utility space.

Top right: ceiling crack in the ground floor lobby.

Bottom left: Ceiling grid buckling at window head.

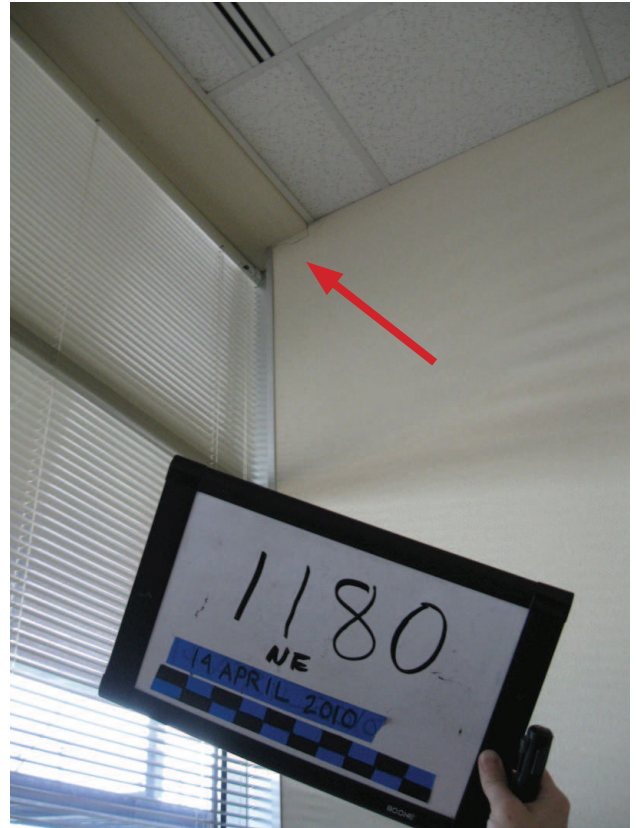
Top left: Racked electrical room door.

Top right: Wall damage at window jamb.

Bottom left: Wall damage at window jamb.

Bottom right: Cracked terrazzo floor at main lobby.

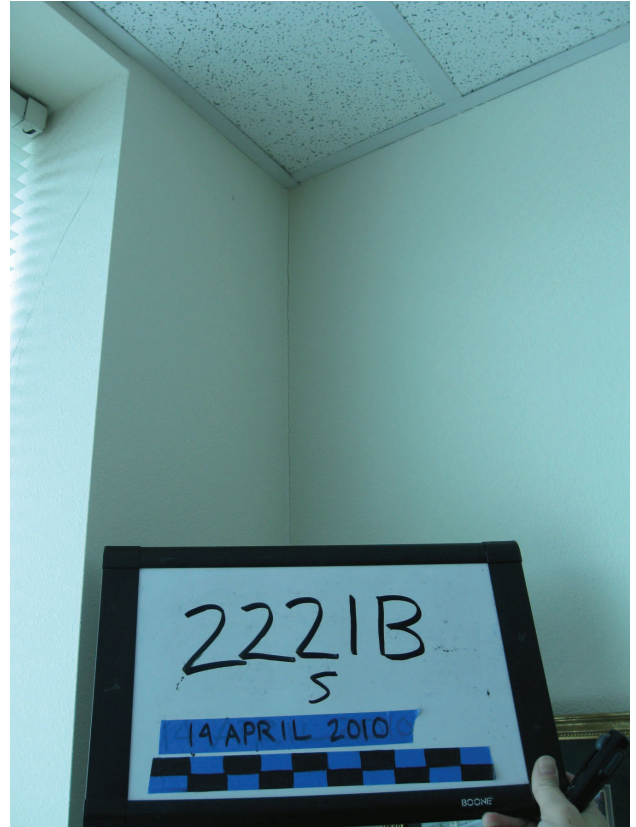
Top left and right: Small cracks are visible at some wall intersections.

Bottom left: Wall crack at exterior wall.

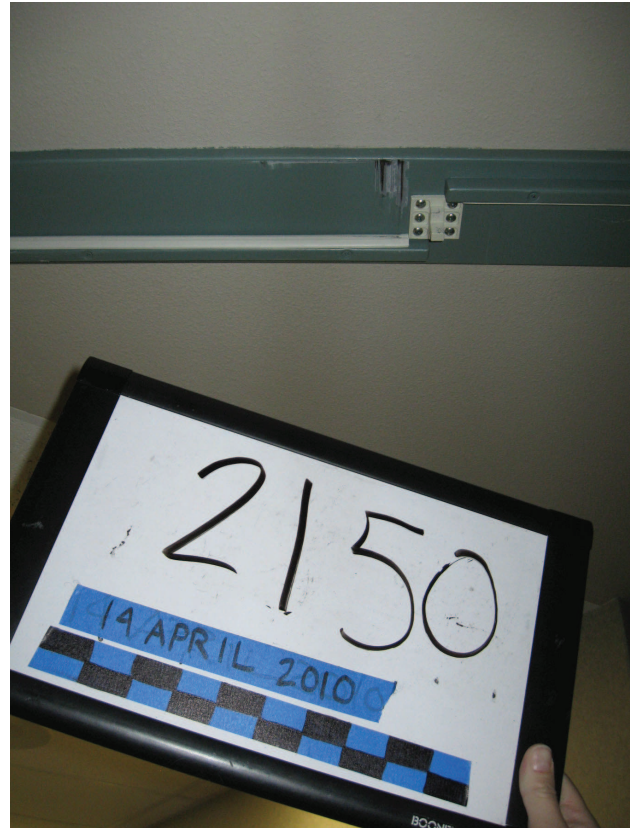
Top left: Racked door frame.

Top right: Racked door frame at elevator lobby fire doors causes them to rub. This may prevent proper function.

Bottom left and right: Building movement is causing some doors to damage floor finishes.

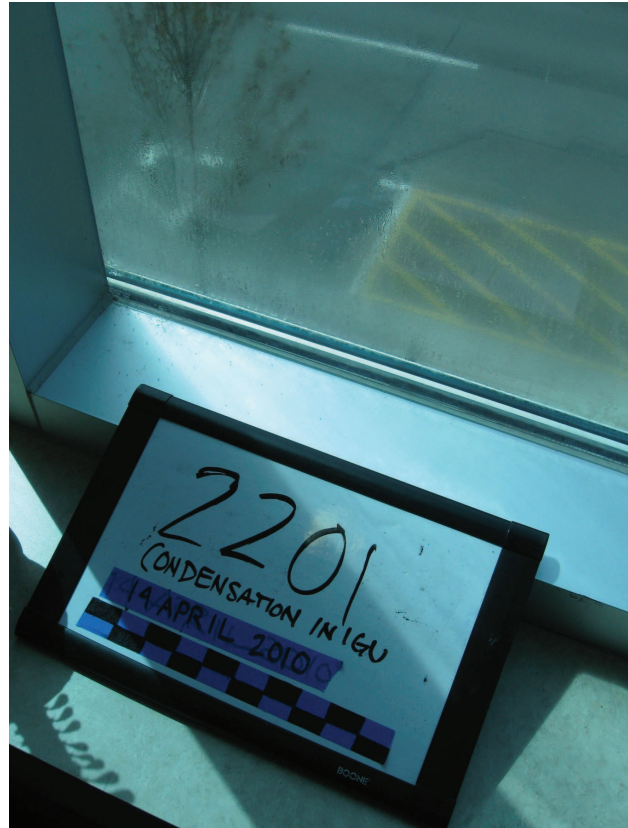
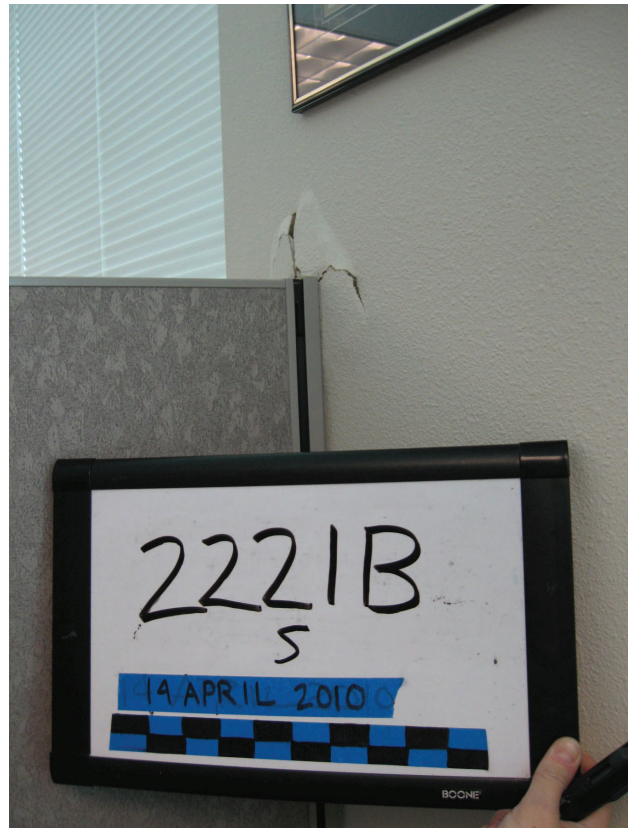
Top left and right: Standing water and condensation in curtain wall window system.

Bottom left and right: Building movement is causing systems furniture to damage walls.

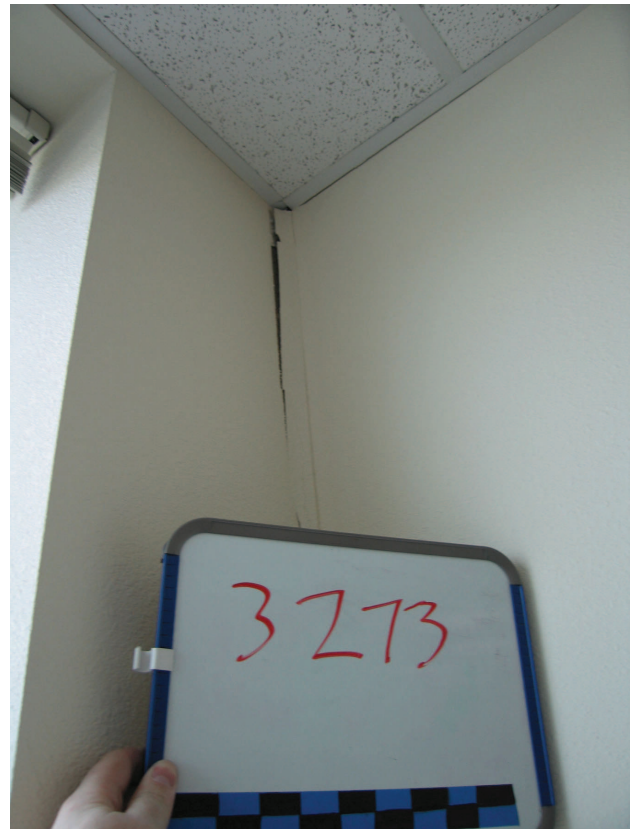
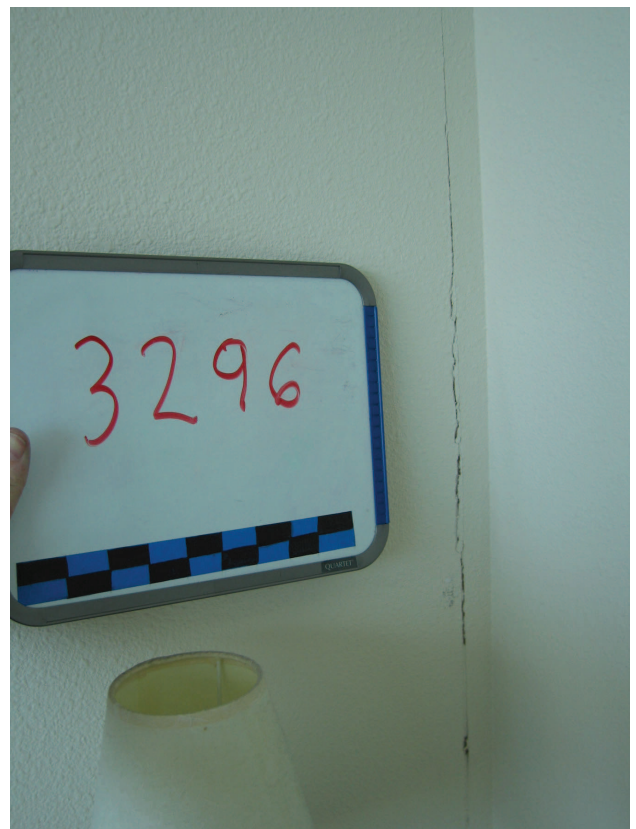
All photos: Cracks at wall intersections is more severe at the Third Floor compared to the Second Floor.

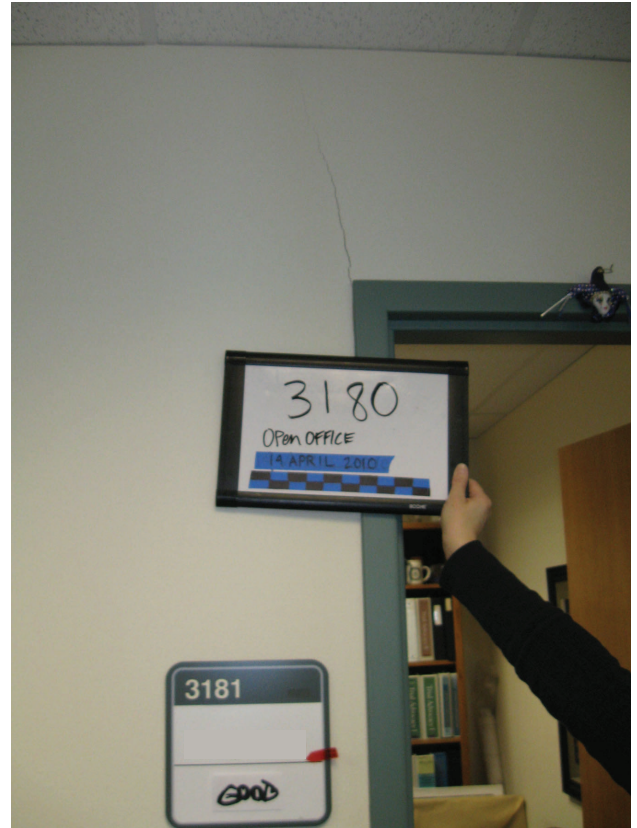
Top left and right: Wall cracks at door frame.

Bottom left: Buckled ceiling grid and ceiling panel damage.

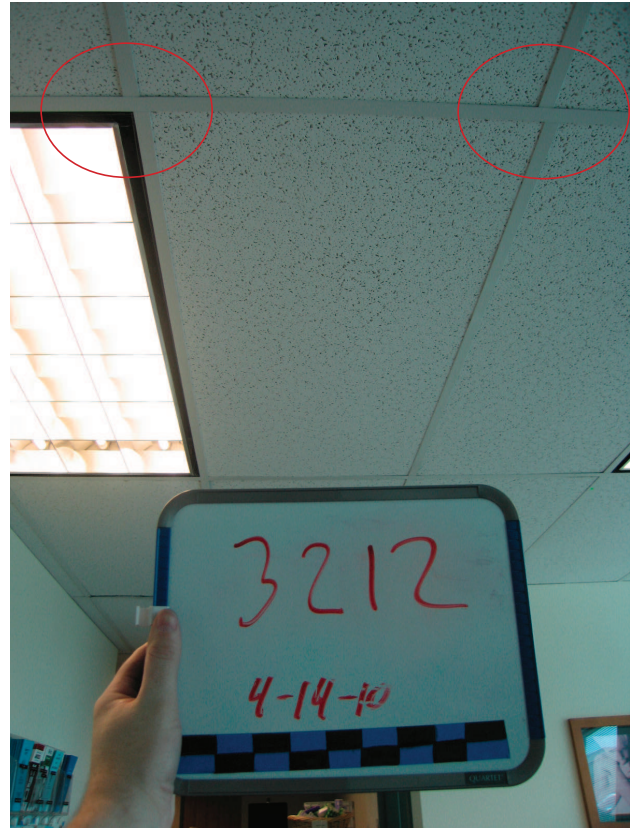
Top left and right: Buckled and shifted ceiling grids.

Bottom left: Damage caused by water infiltration.

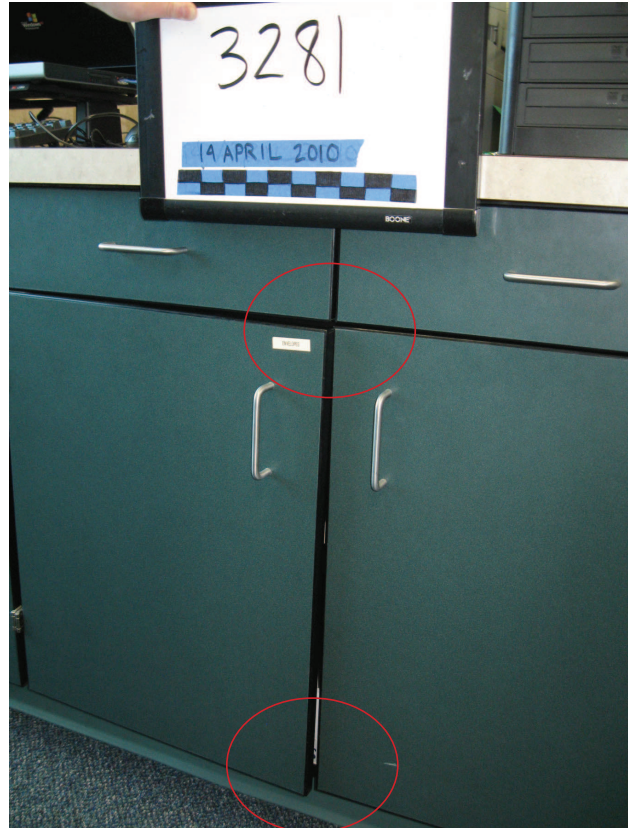
Top left and right: Casework and cabinet functionality to due building movement.

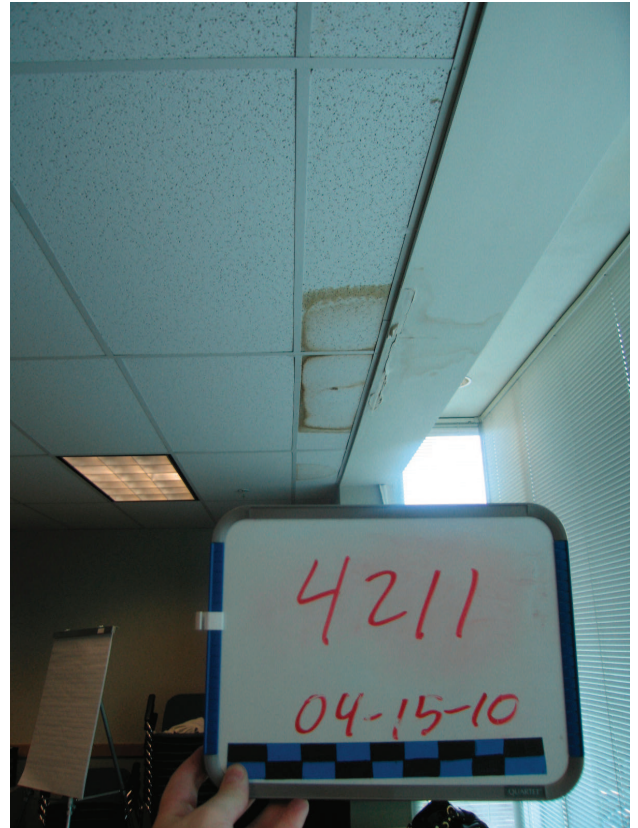
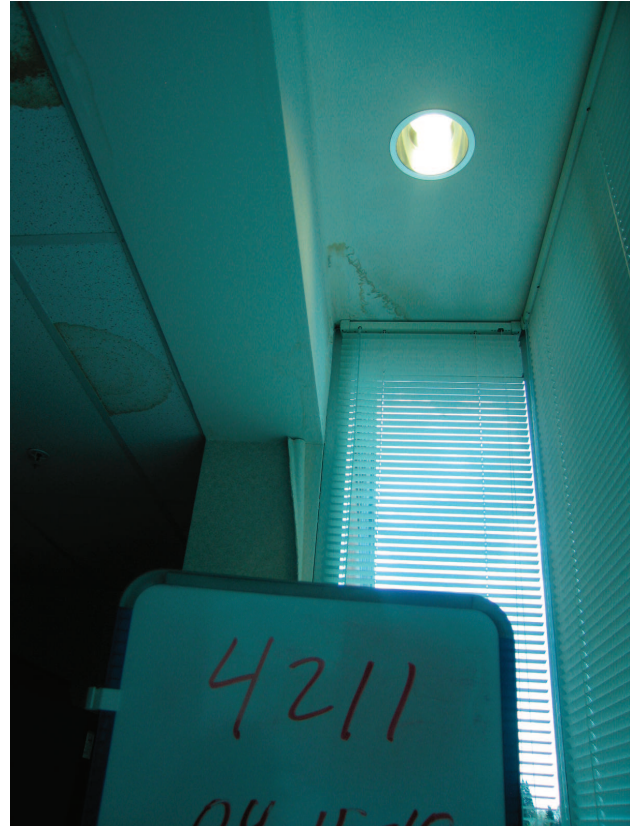
All photos: Damage due to water infiltration is evident at numerous window locations.
