**Marion County Courthouse Square
555 Court Street NE, Salem Oregon
Remediation Study Final Report
February 07, 2011**

Volume Three of Six

Miller Consulting Engineers, Inc.
Structural Photographic Documentation

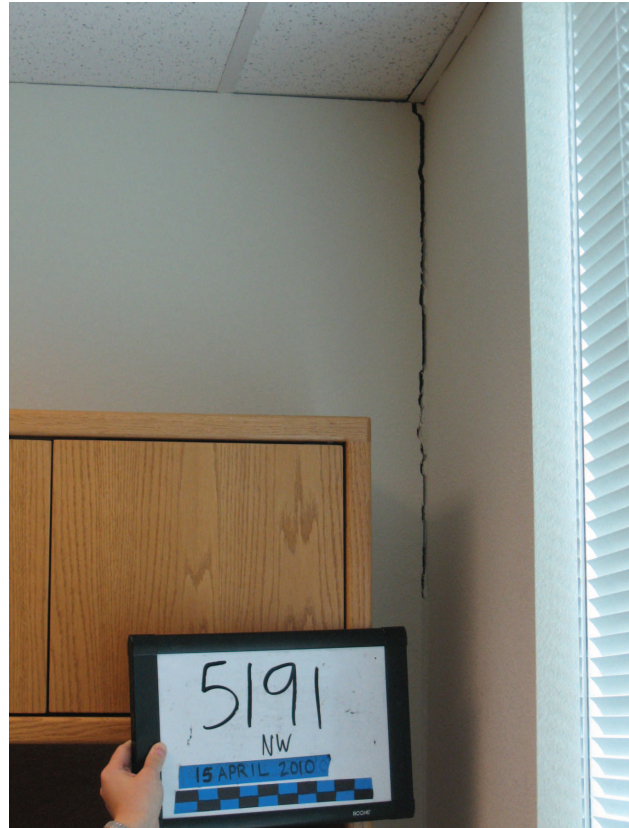
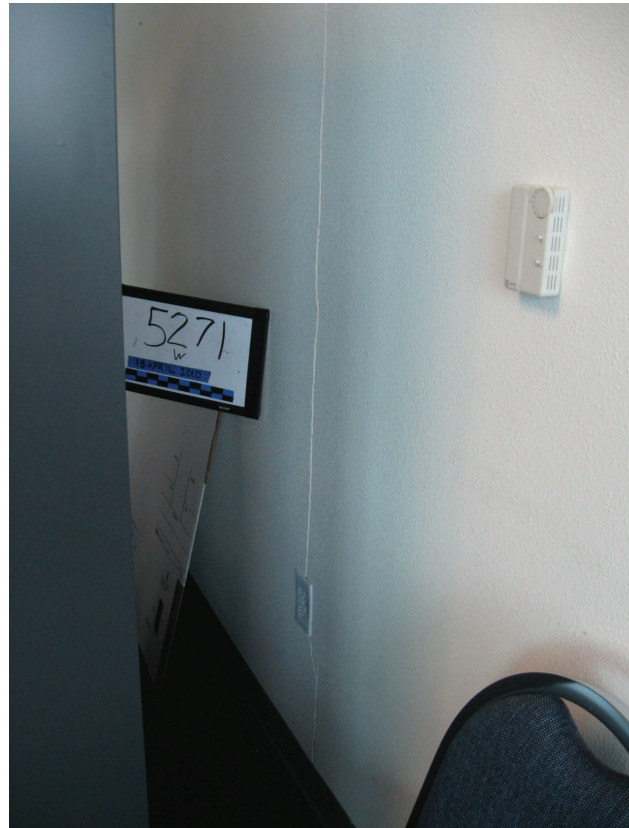
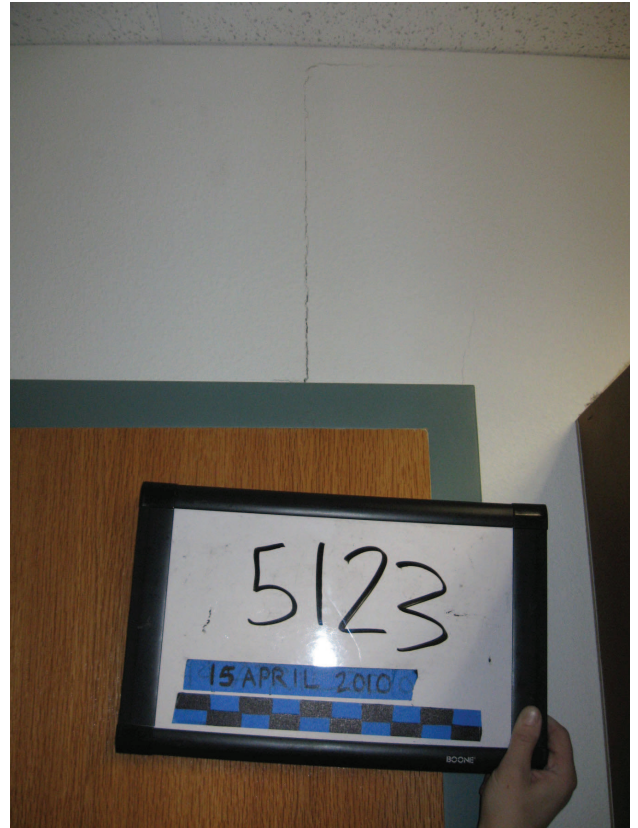
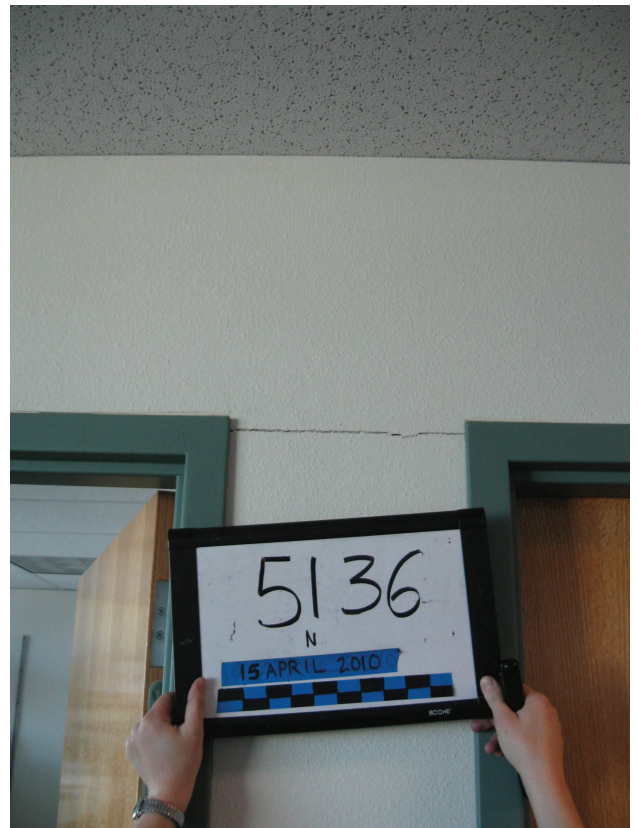
All photos: Wall cracks at door frame.

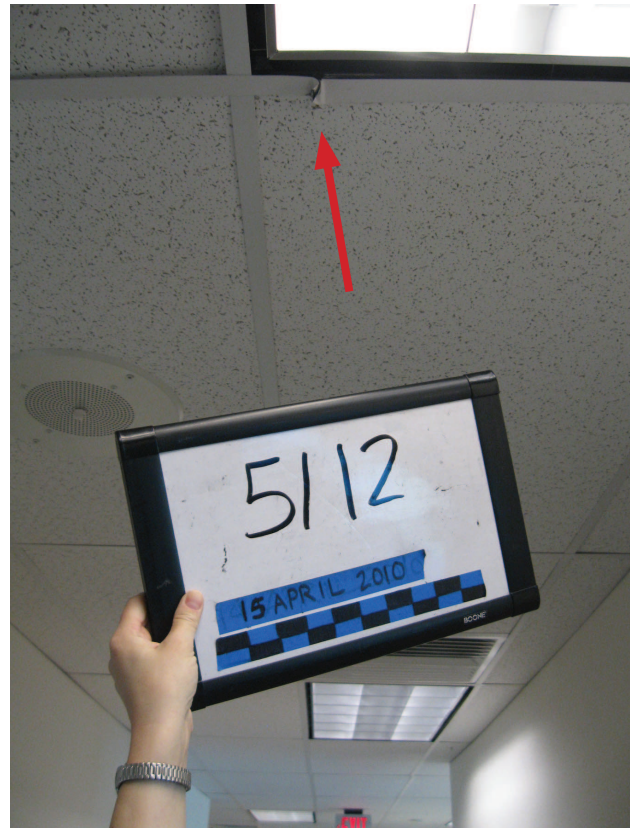
Top left: Building movement resulting in crushed walls.

Top right, bottom left and right: Buckled ceiling grid and panels.

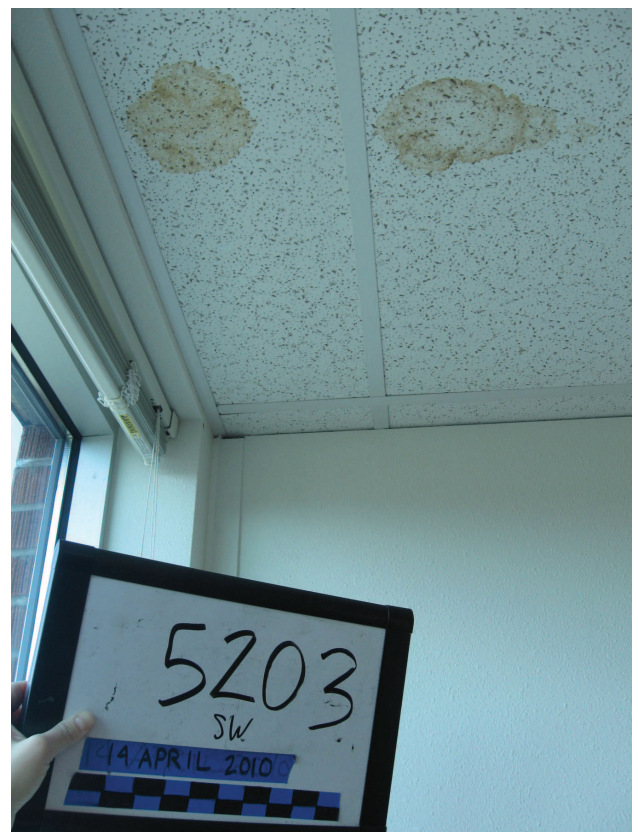
Top left and right: Significant building damage due to building movement.

Bottom left and right: Damage due to water infiltration.

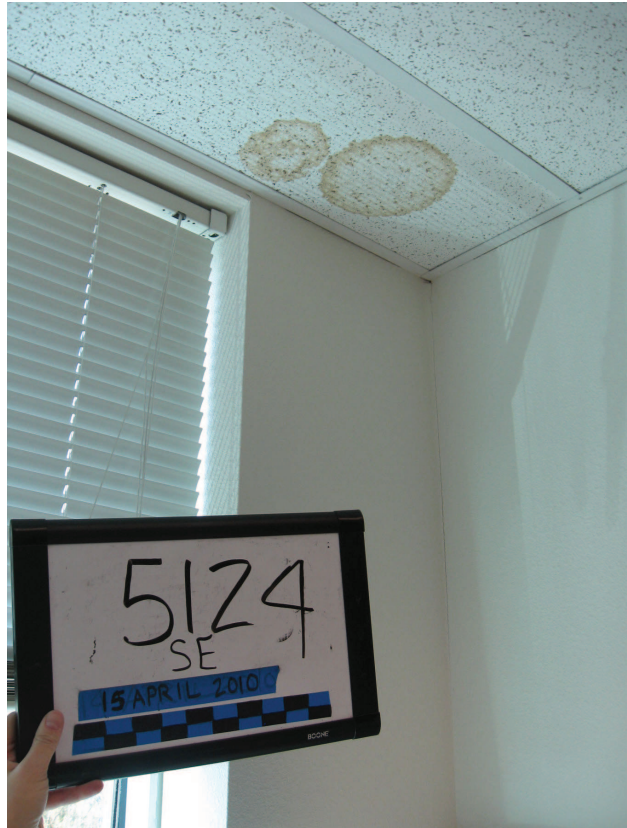
Top left and right: Damage due to water infiltration.

Bottom left and right: Racked door frames causing doors to bind.

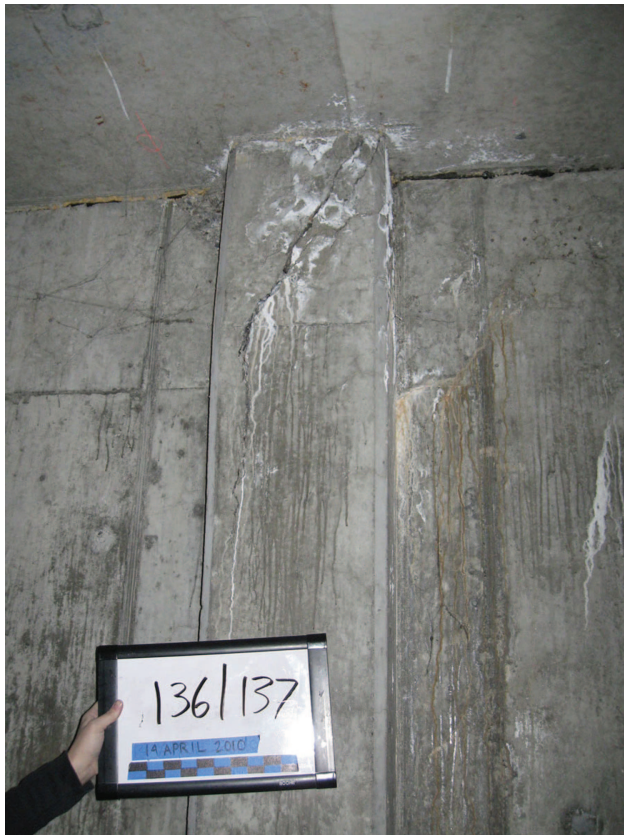
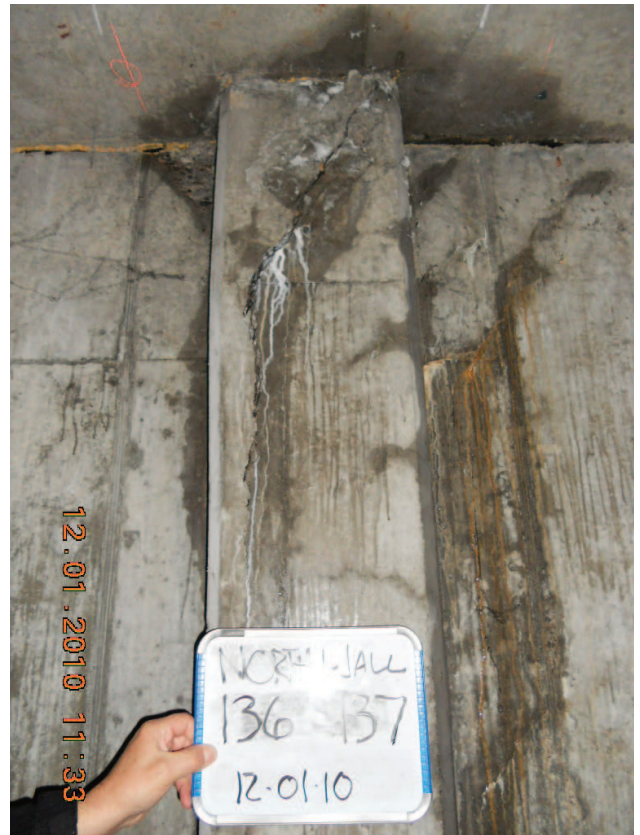
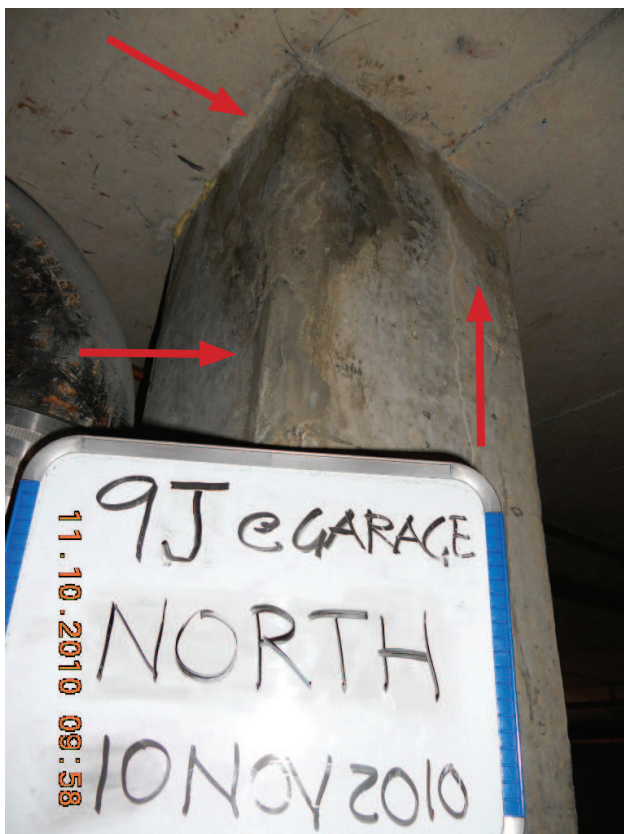
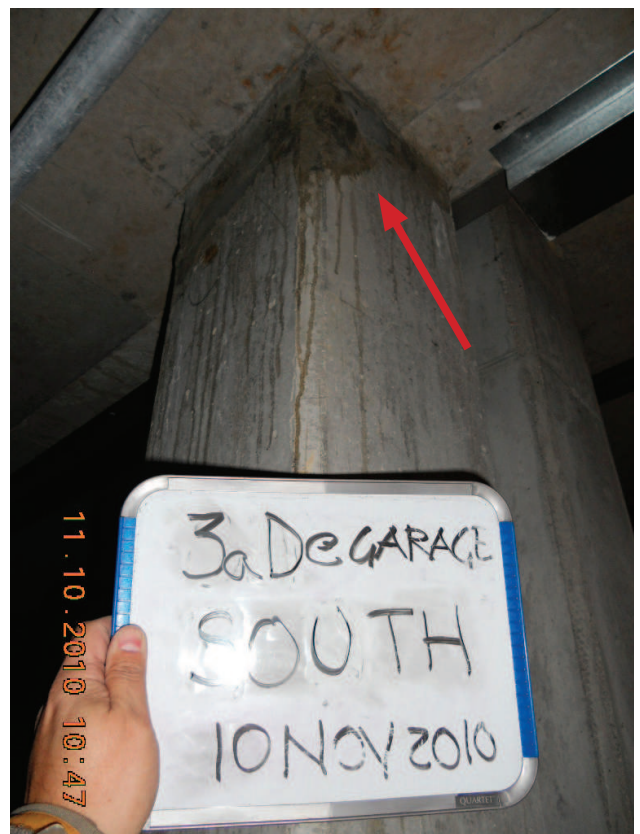
Top left and right: North Block column at grid M-1. Water infiltration is noticeable in the December photo.

Bottom left and right: Columns damaged and repaired during construction.

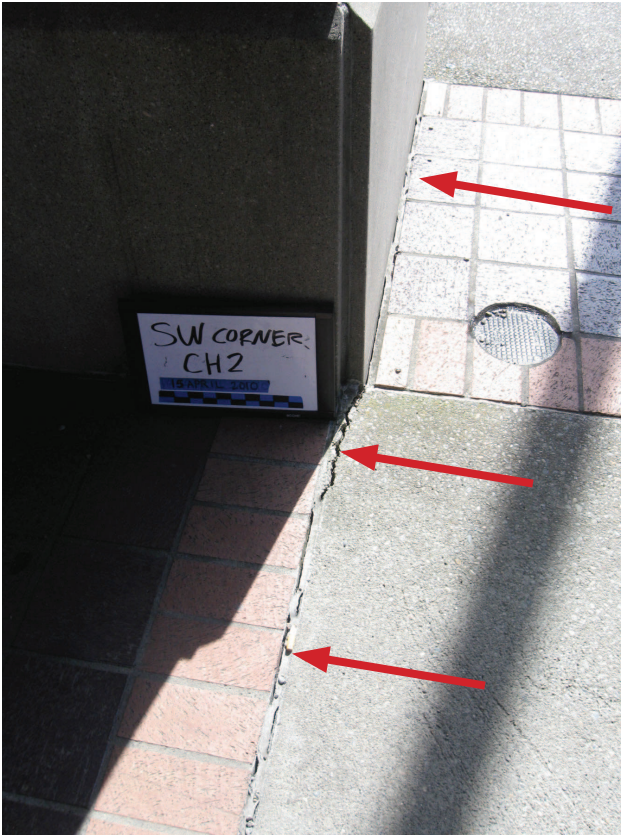
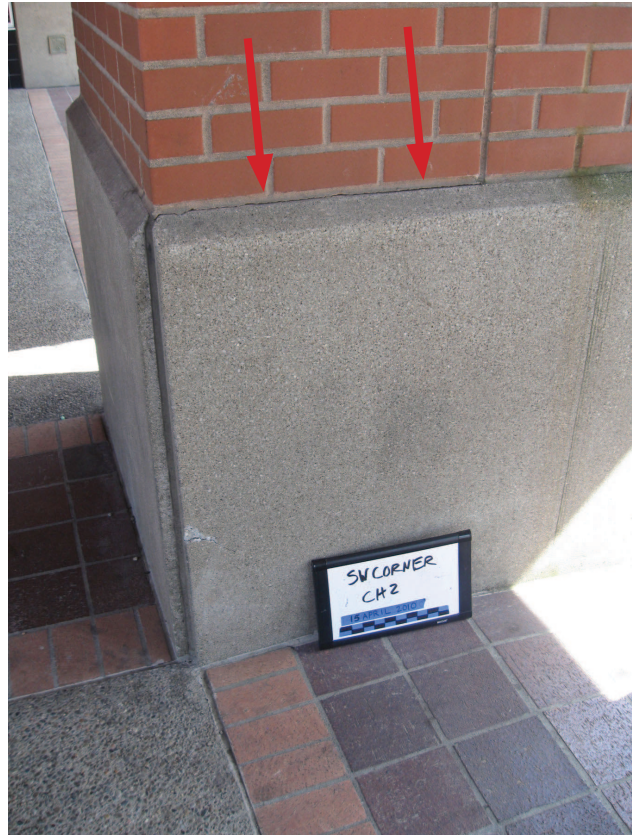
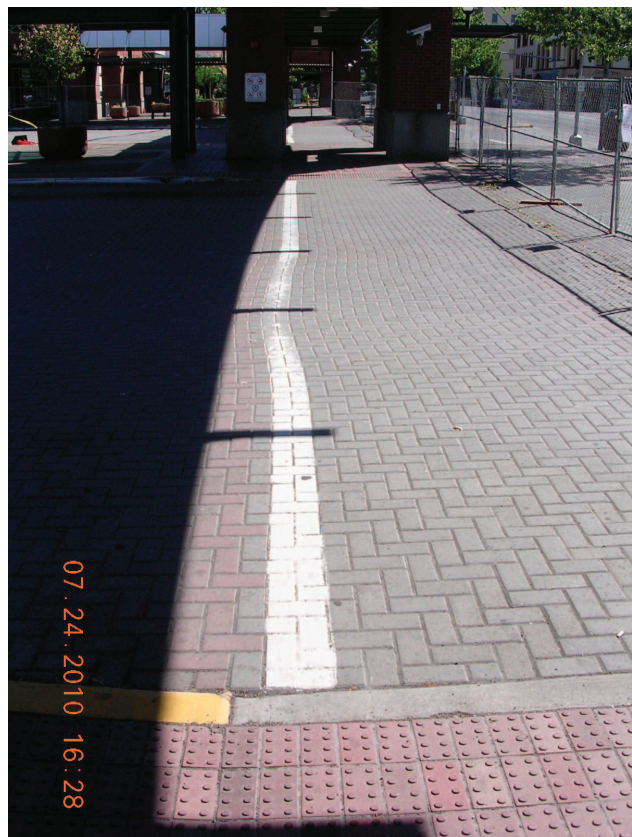
Top left and right: Building movement has caused cracks at joints.

Bottom left: Settlement of the public sidewalk is most severe at the NE corner.

Bottom right: Migration of the Bus Mall paver surface is evident at painted crosswalks.

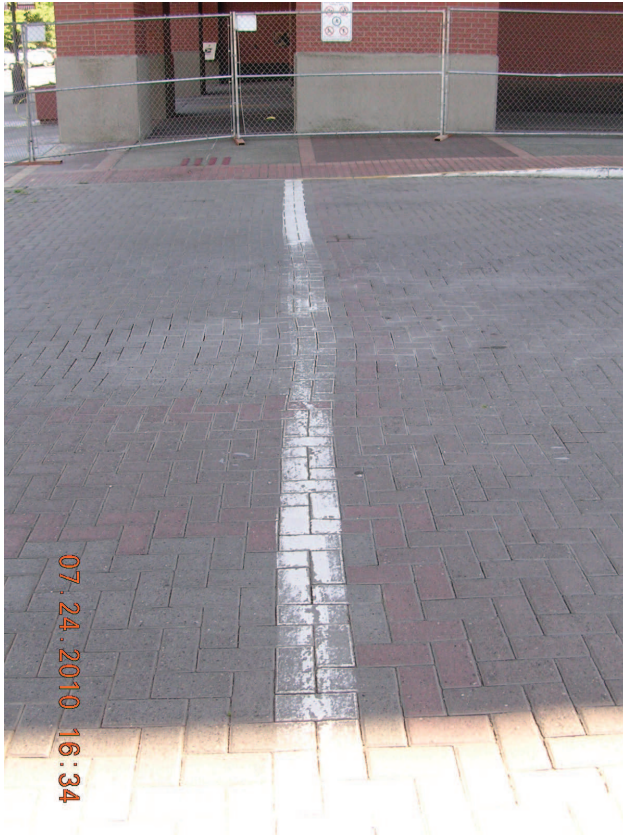
Top left: Migration of the Bus Mall paver surface is evident at painted crosswalks.

Top right, bottom left and right: Subsurface conditions at the Bus Mall are causing pavers to heave and move resulting in damaged pavers.

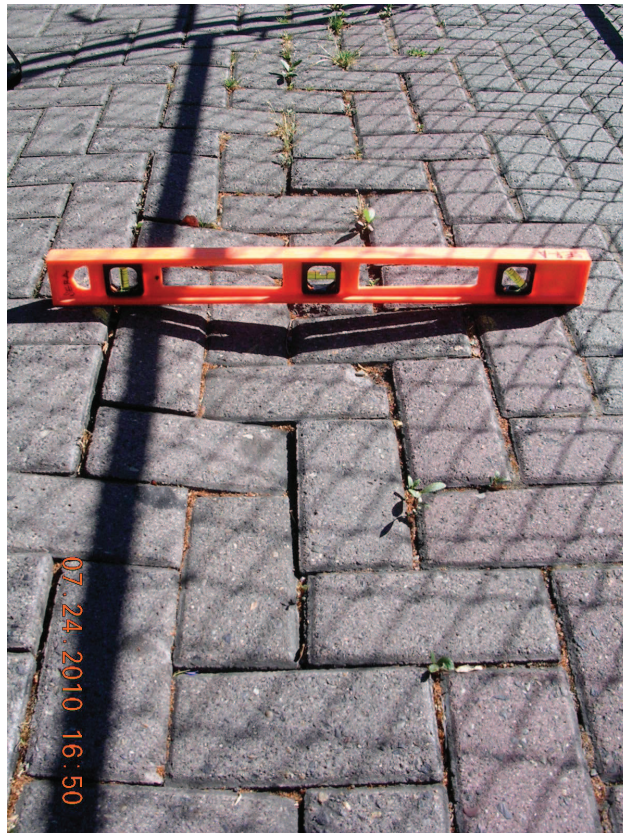
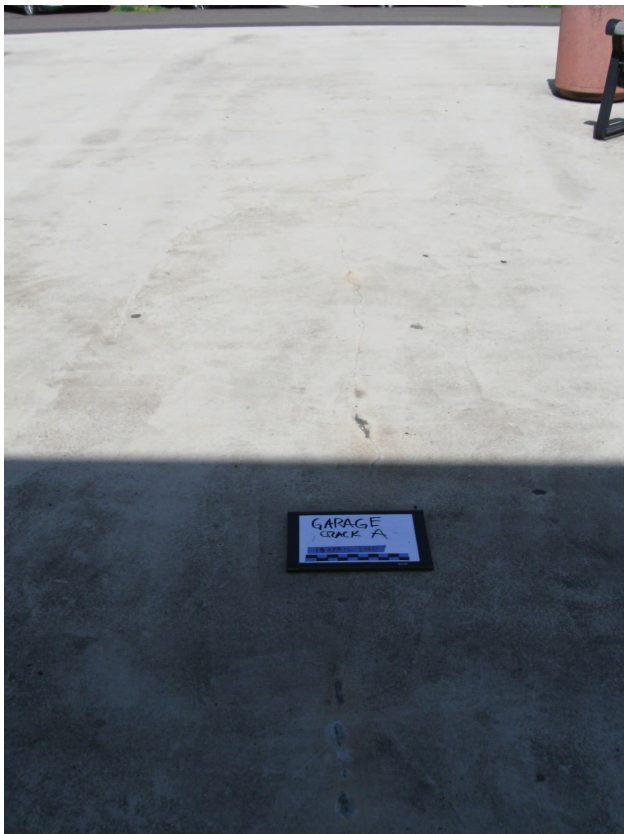
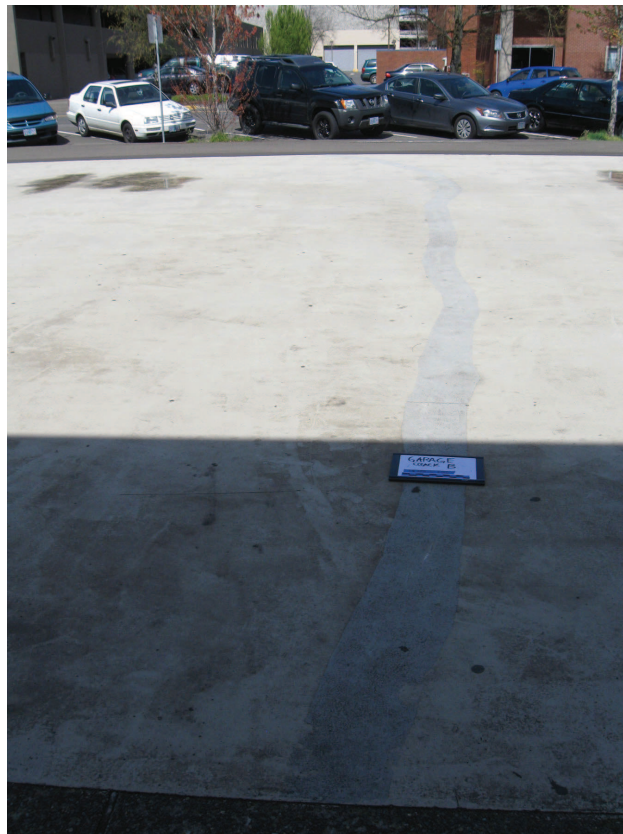
Top right: Settlement at the public sidewalk creates dips at the paver surface.

Bottom left and right: Cracks at the North Block slab span the entire width. Several repairs have been attempted.

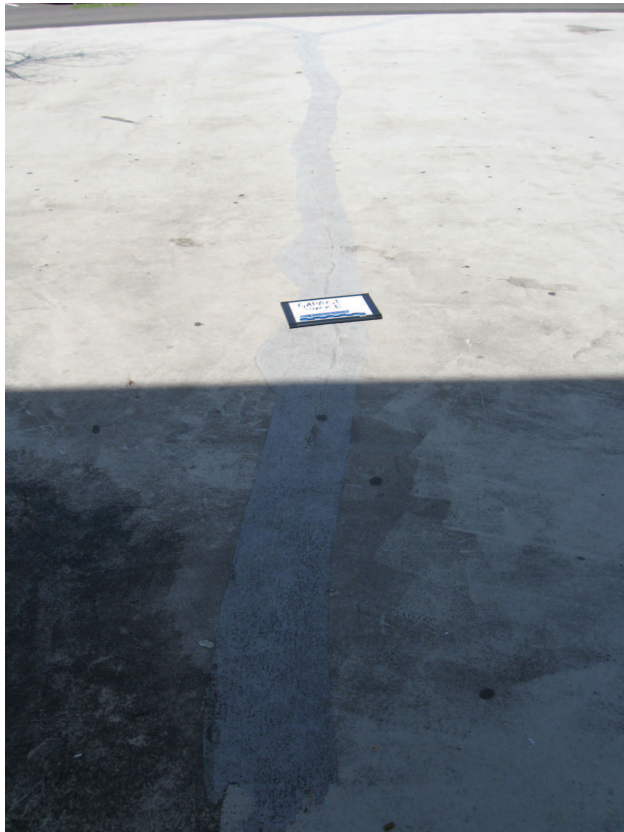
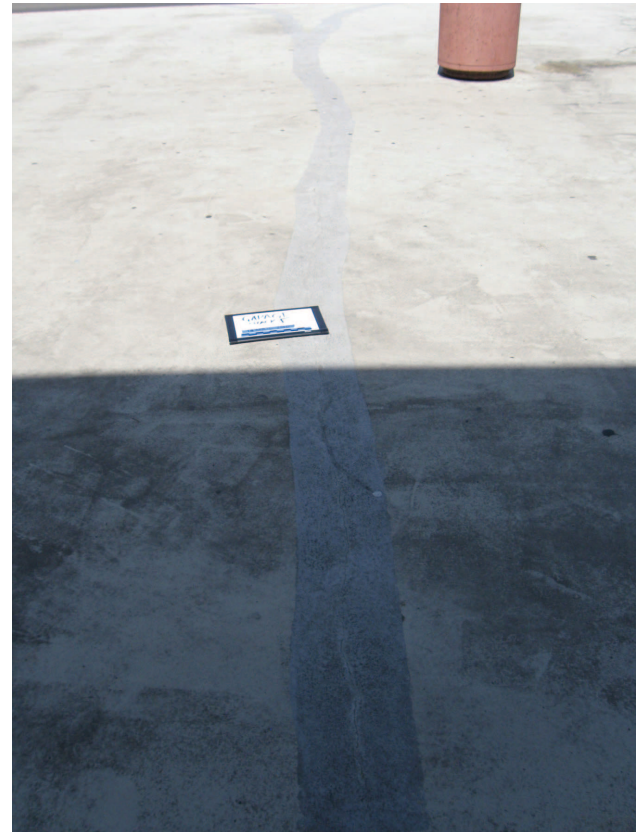
All photos: Cracks at the North Block slab.

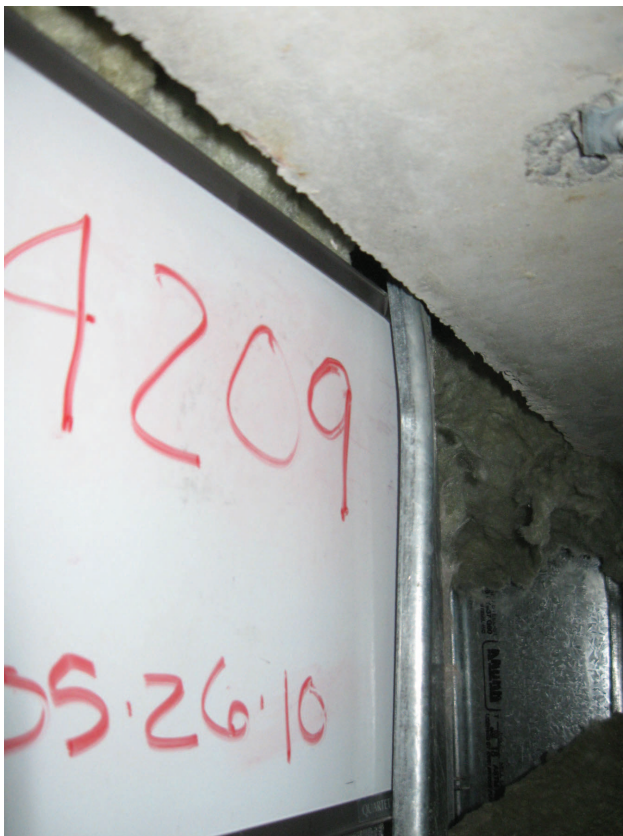
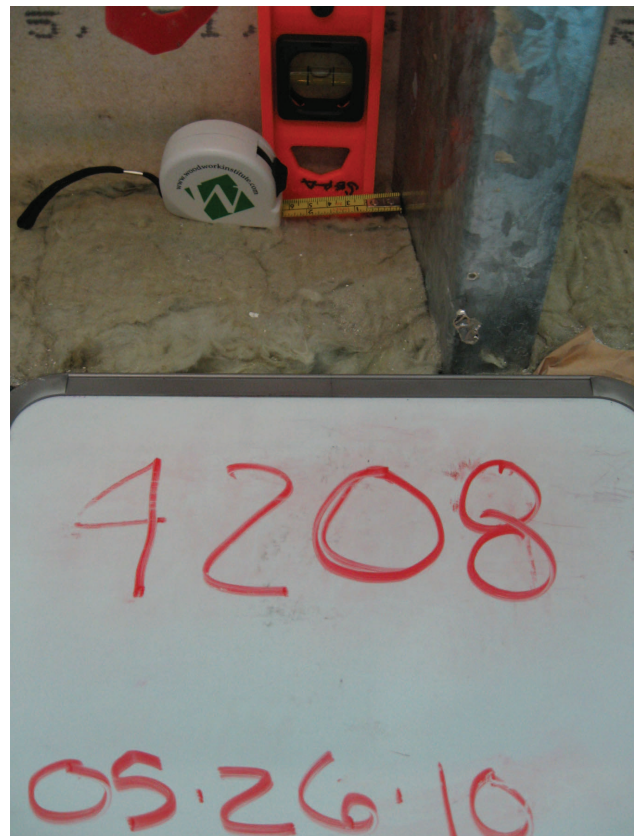
Top left and right, bottom right: Twisting of studs is greatest at the Fifth Floor and at the outer most east and west ends of the north and south walls. Twisting of studs is believed to be caused by floor slab shrinking and shortening.

Bottom left: Some studs have buckled as a result of building movement.

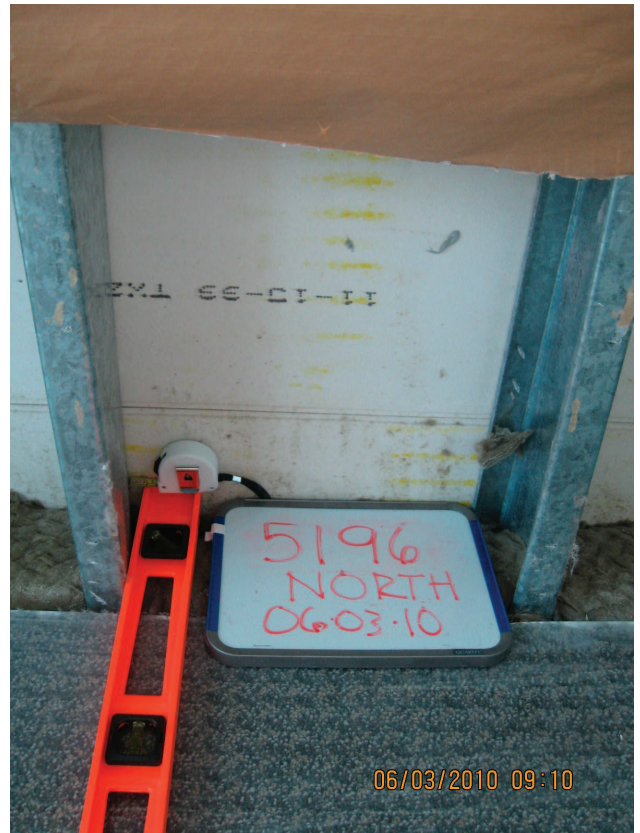
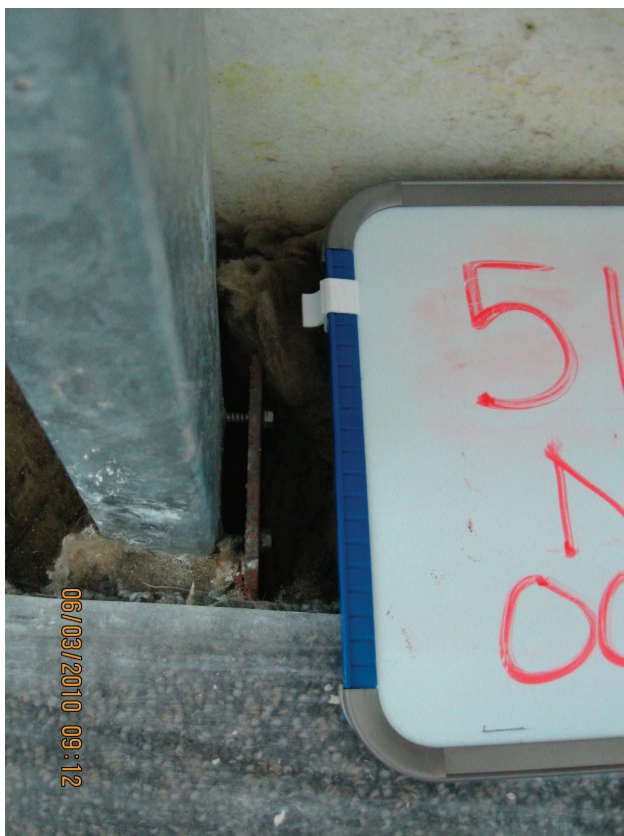
Top left: Twisting of studs is less severe on the east and west walls.

Top right: The most severely twisted studs are approximately 3/4 inches out of plane.

Bottom right: This stud has experienced significant twisting.

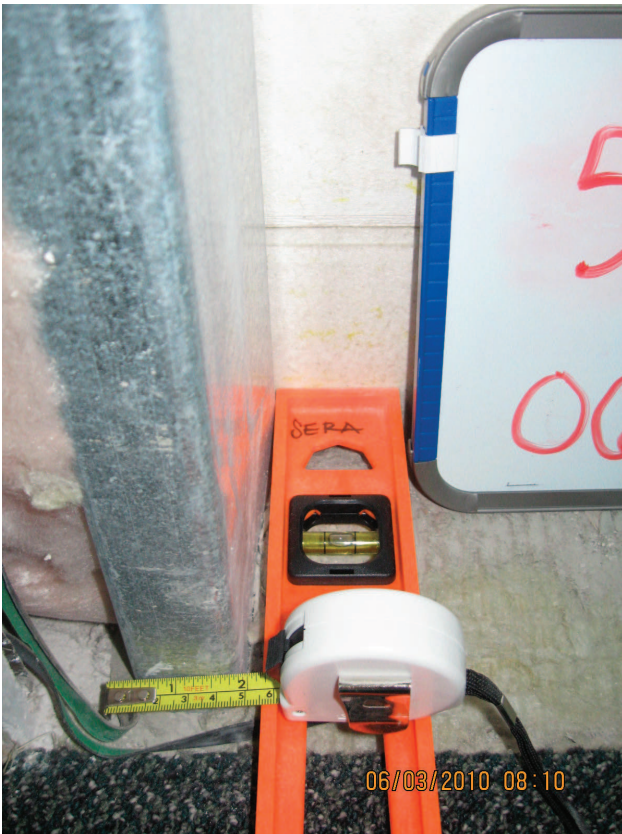
Top left: All observed studs exhibited some degree of twisting. The sign is mislabeled ; it is the north wall of 5299.

Top right: Twisted metal studs. The sign is mislabeled; it is the east wall of 5299.

Bottom left and right: Twisted studs.

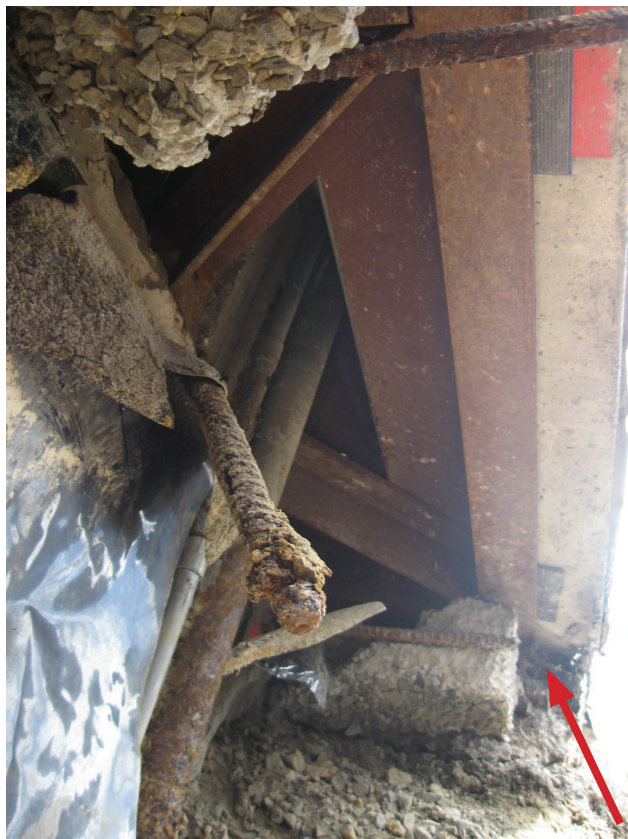
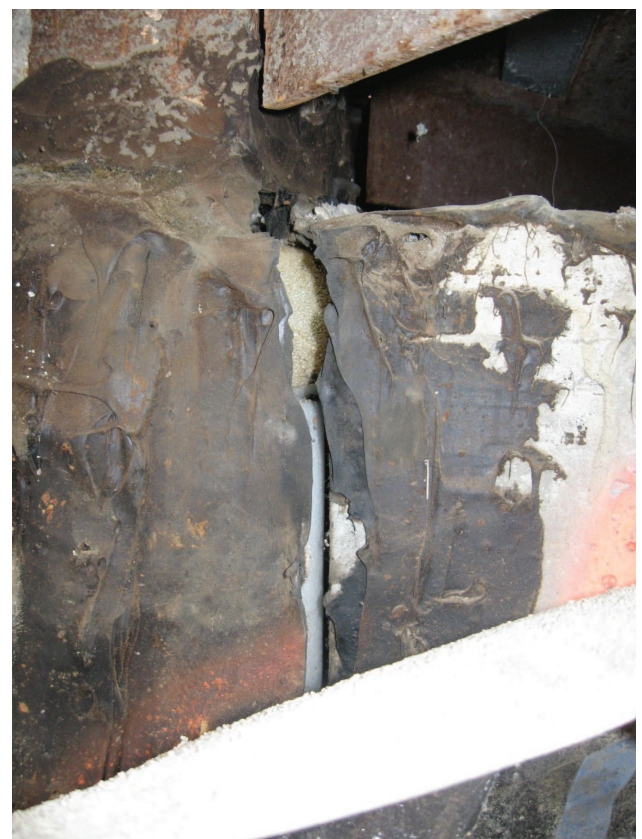
Bottom right: Joint between building and Bus Mall slab. Slab shortening ripped apart installed rubber water proofing.

Bottom left: Installed reinforcing bar bent during construction was not repaired. Bar in background indicated proper installation depth.

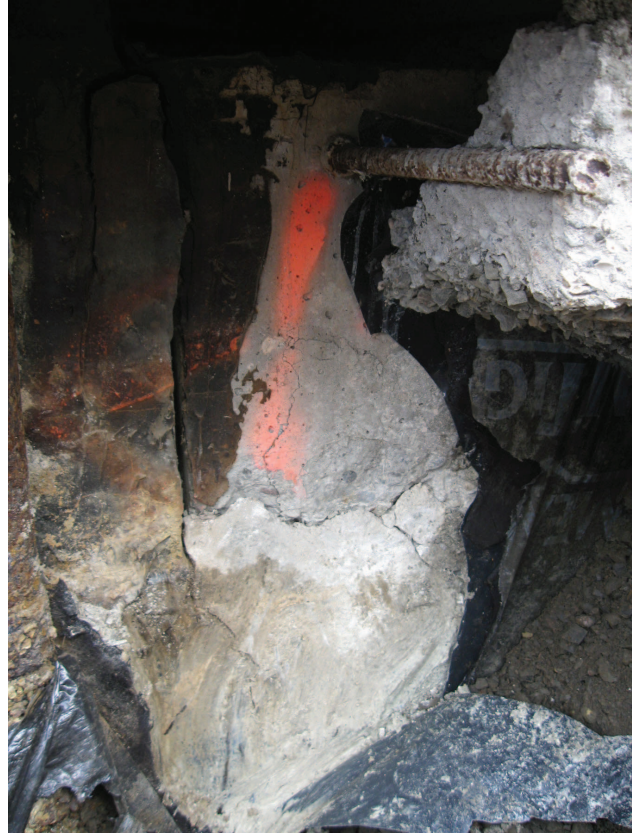
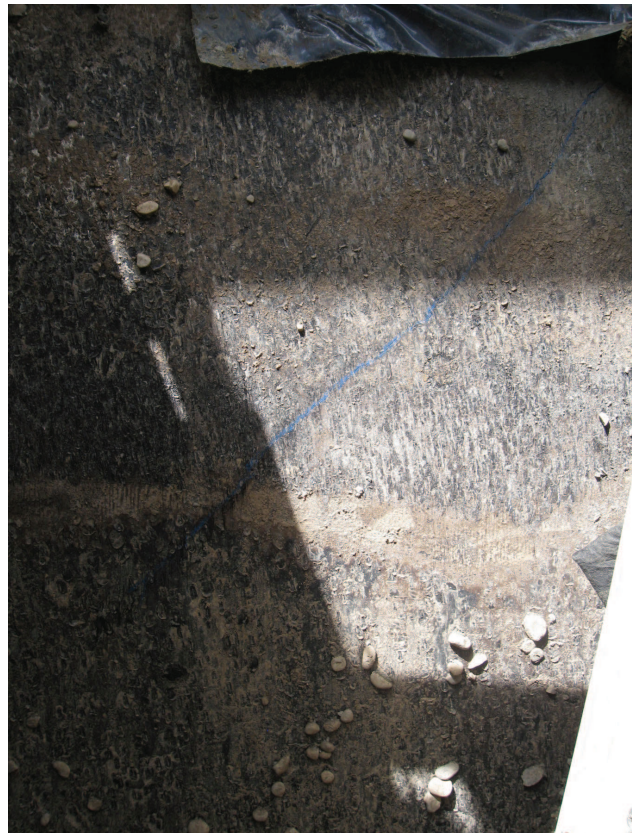
Top left: Joint between building and Bus Mall slab. Slab shortening exacerbated and compounded water infiltration issues from poor design detailing.

Top right, bottom left: Slab shortening and horizontal movement was not properly accounted for and detailed. This is evident by sheared waterproofing and cracks at the foundation wall/slab interface. The column at this location on the interior is significantly damaged.

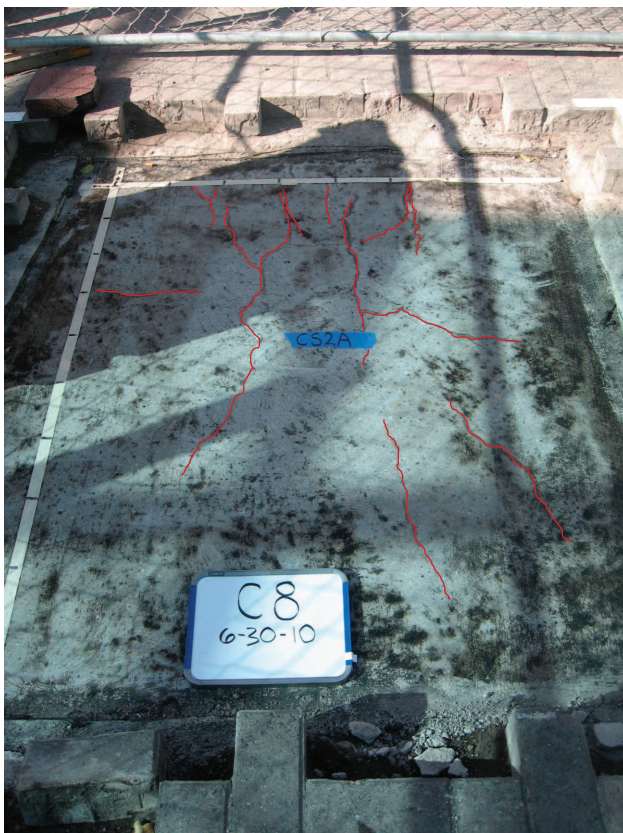
All photos: Evidence of punching shear failure was found at all investigated locations of the Bus Mall slab. Note: Cracks have been traced for ease of viewing.

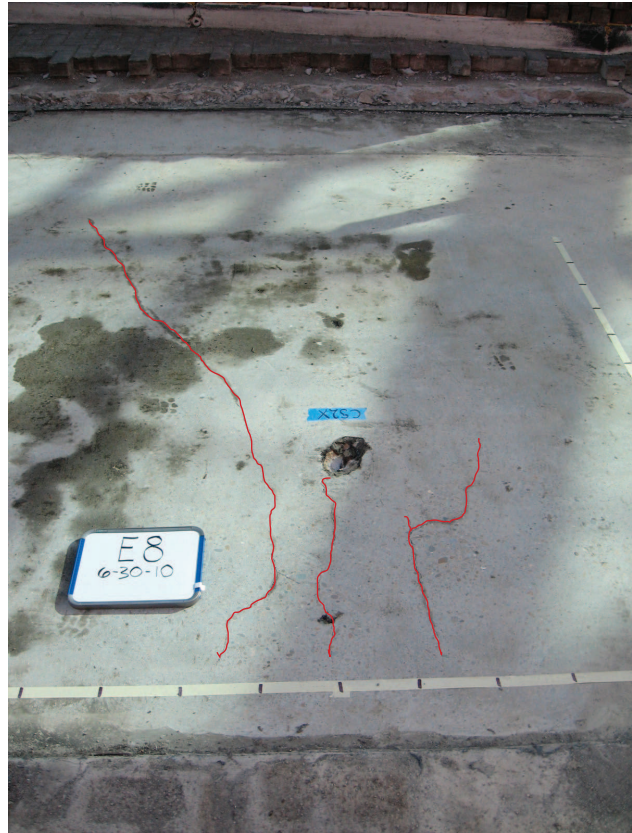
Top left: An improperly installed reinforcing bar can be seen exposed at the top of the Bus Mall slab.

Top right, bottom left and right: Evidence of punching shear failure at gridline E-8. Unrepaired damage from construction was found at this location. Note: Cracks have been traced for ease of viewing.

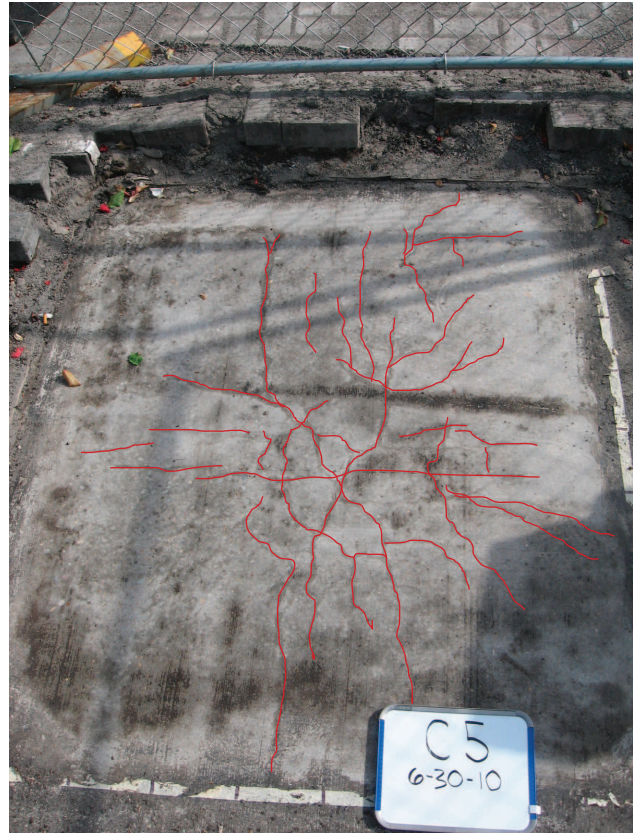
Top left: Location E-8 has a perceptible crown, sloping down and away from the unrepaired hole at a rate of 1/4 inch per foot.

Top right, bottom left and right: Evidence of punching shear failure at gridlines C-5. Note: Cracks have been traced for ease of viewing.

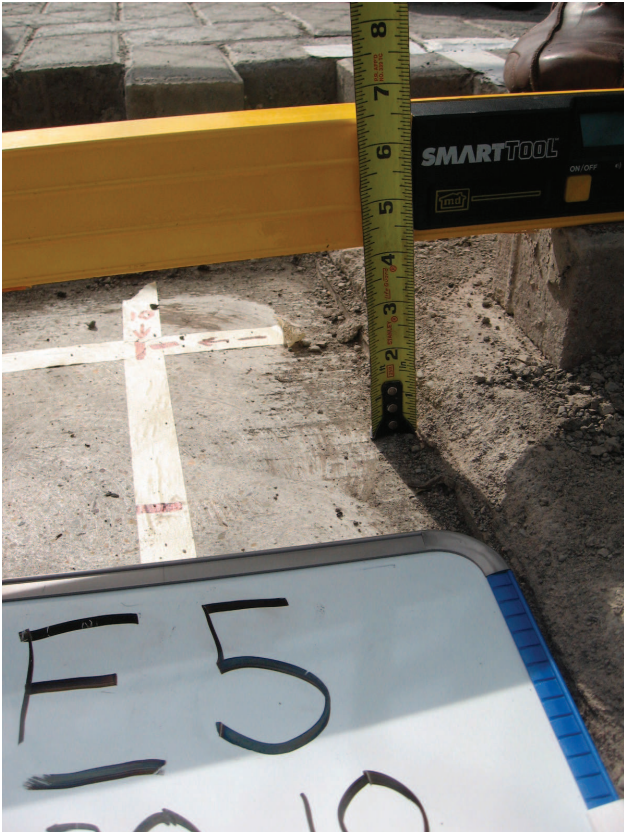
Top left and right: Evidence of punching shear failure at gridline E-5.

Bottom left and right: Thickness of the waterproof/ paver assembly varies from approximately 4-7 inches. Note: Cracks have been traced for ease of viewing.

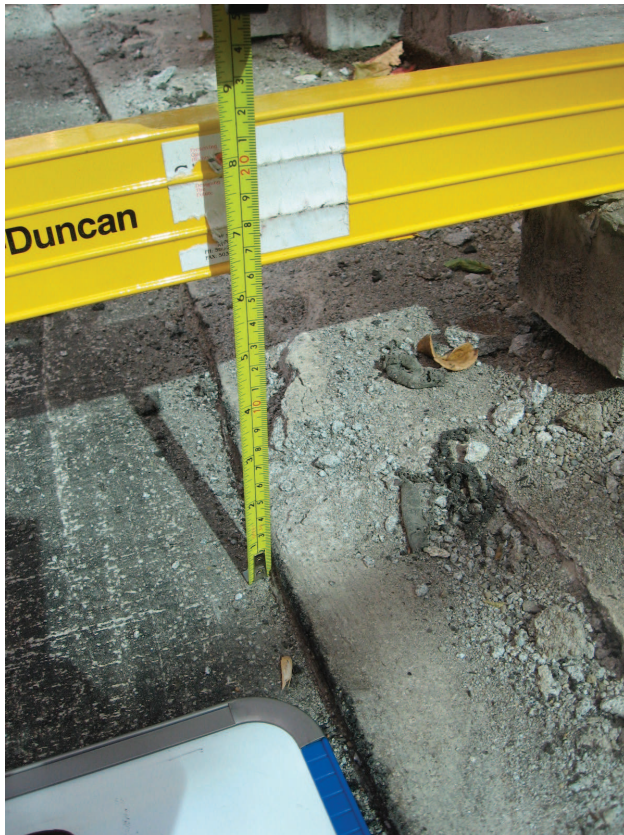
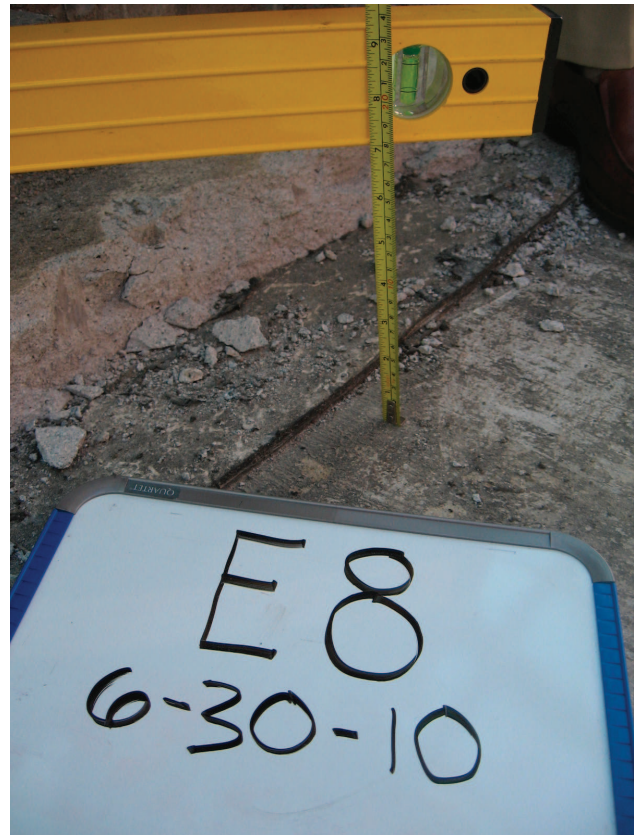
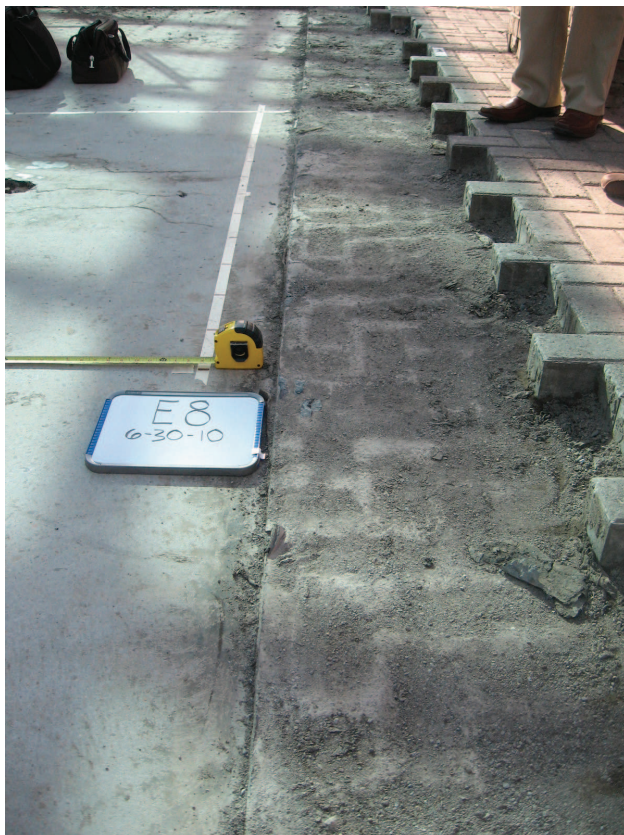
All photos: Original design record drawings indicate the Bus Mall slab undulated to provide positive drainage for storm water runoff. Actual installation discovered found a uniformly sloping Bus Mall slab with a light weight concrete installed to provide slope to the paver surface.
