**Marion County Courthouse Square  
555 Court Street NE, Salem Oregon  
Remediation Study Final Report  
February 07, 2011**

**Volume Four of Six**

Marion County  
Courthouse Square Structural Remediation  
Project Summary  
June 09, 2010

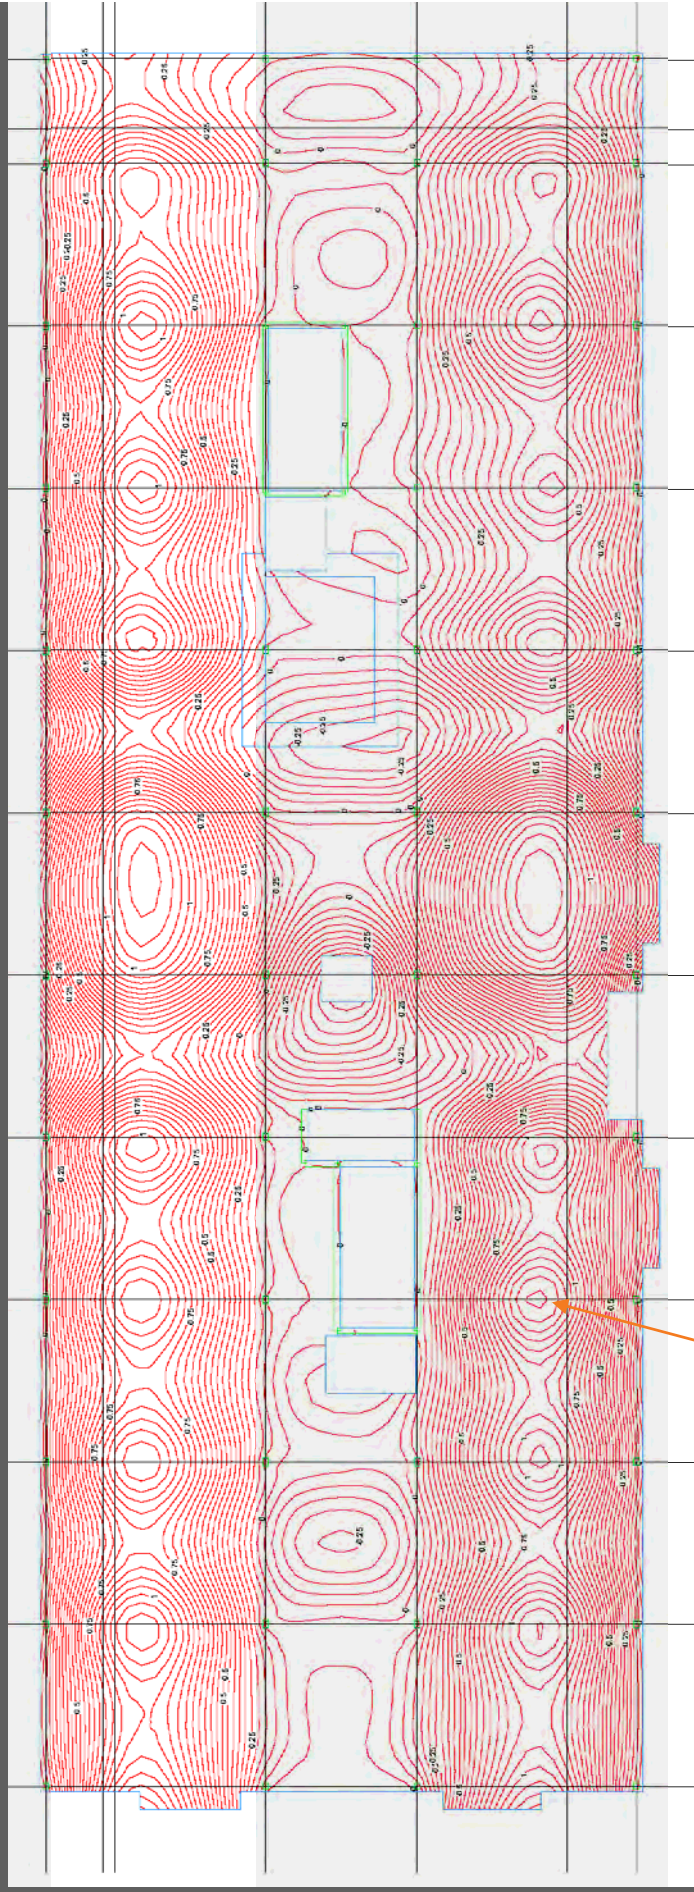
# CONSTRUCTION LOADING: STD DEFLECTION PLAN (INITIAL 30 DAYS)

- High amount of precompression stress
  - Many areas over the industrial standard recommend 300 PSI
  - Some areas around 450 PSI
- High amount of load balancing in east-west spans
  - Up to 200% DL – Typically stay within 80% range
- Calculated deflections at  $\approx$  50% of the field survey deflections

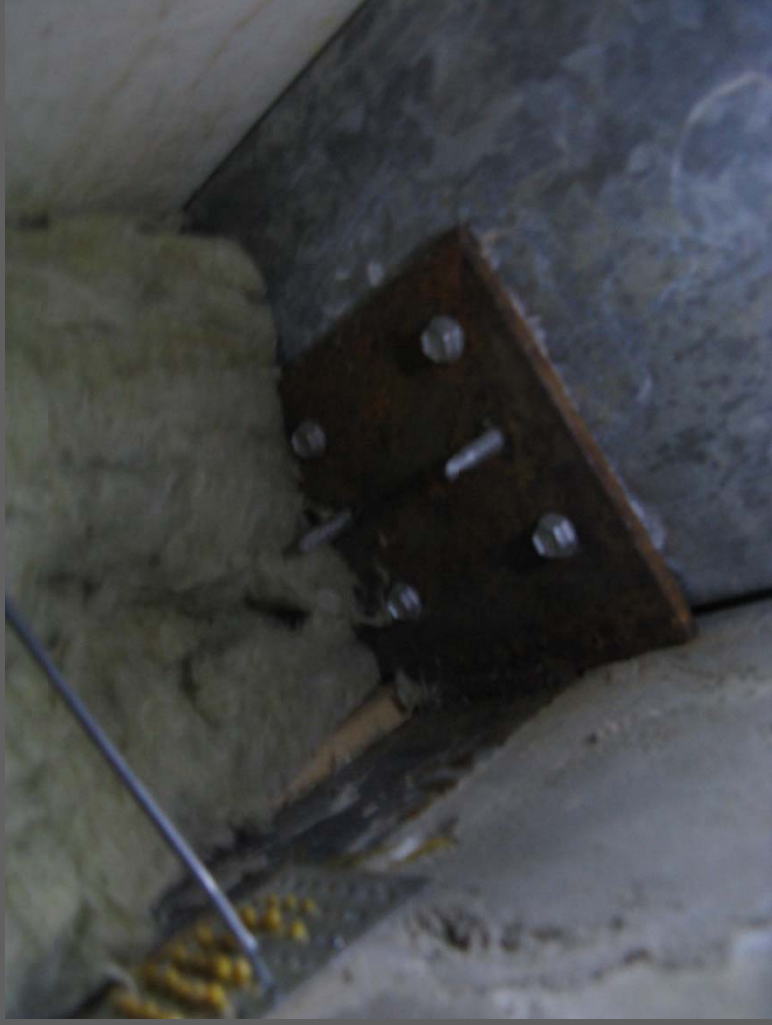
## FASCIA CONNECTION AND GROUT POCKET

Surface corrosion of the fascia connection as discussed during the meeting. It appears to be an insignificant issue, but does call out the lack of a rust-inhibiting primer coat being applied to the structural connection. In addition, there is a grout pocket to the lower left that appears to be in very good condition with no visual signs of moisture penetration or corrosion of the PT connection.

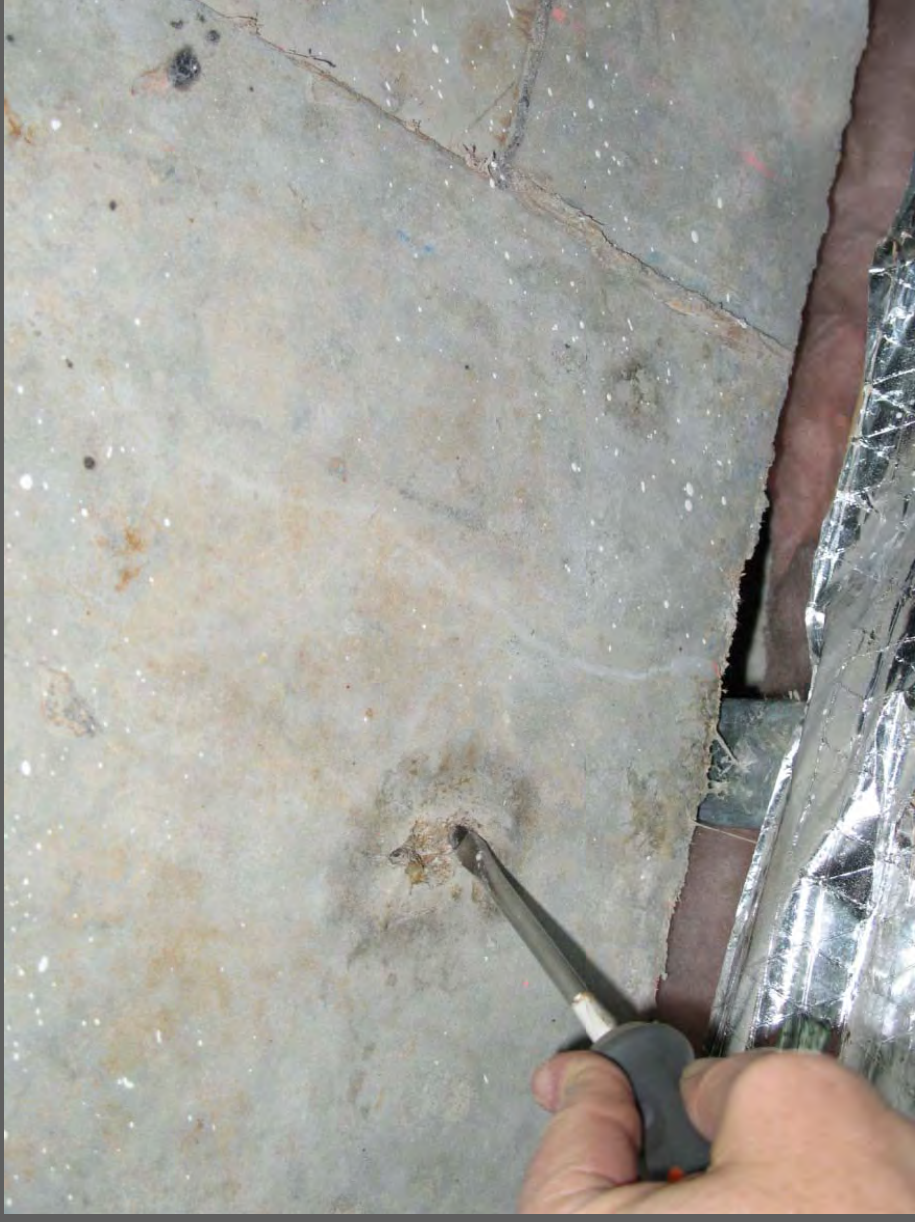
## WOOD CHIPS CAST INTO CONCRETE SLAB

Another indication that poor construction methods were used during the construction of the slab; another pocket of wood debris was cast into the concrete slab approximately at Grid L-10 near the slab edge. The wood debris pocket appears to be approximately 3" in diameter and 1" deep.

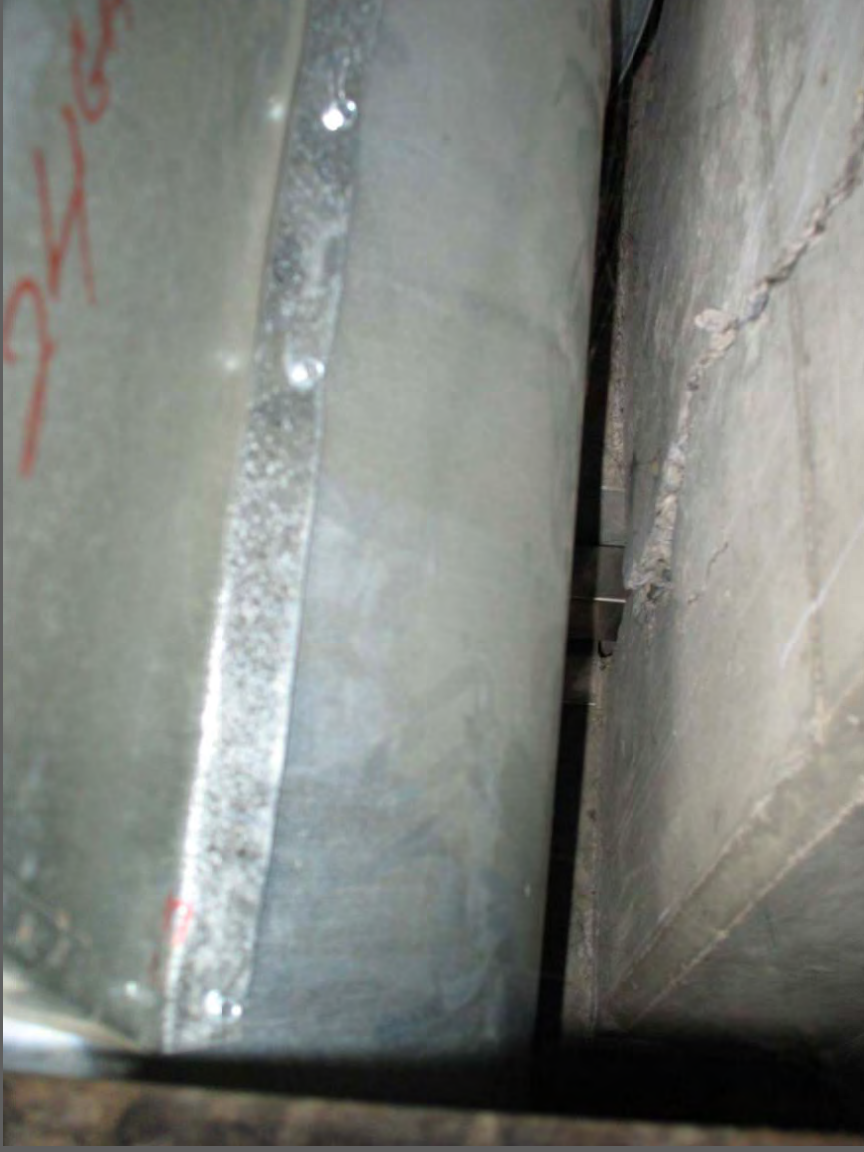
## SIGNIFICANT CRACKING IN CONCRETE COLUMN AT GRID A-10

Crack w/spall removed  
at Grid O-10

Cracking that has occurred at each of the concrete columns at the joint between the building and the bus mall (Grids A-10 and O-10). The spall at Grid O-10 was easily removed exposing the reinforcing steel and corrosion on the reinforcing steel due to water penetration.

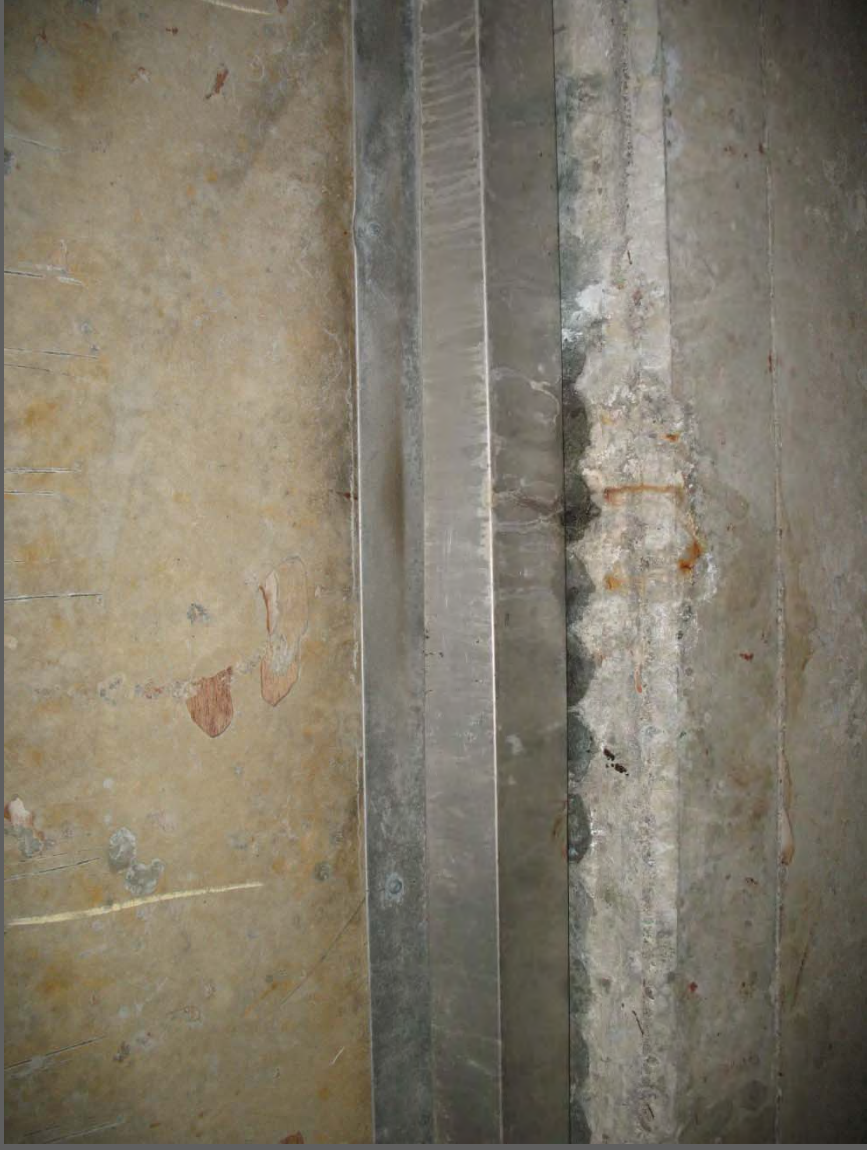
## GROUT POCKETS ALONG THE BUS MALL SLAB EDGE NEAR GRID F-3

Along the north edge of the bus mall at the expansion joint between the Bus Mall and North Block.

Shows that moisture is flowing through the expansion joint, around the gutter fix and wetting the slab edge, which is causing damage to several of the grout pockets. The grout pocket at the center has spalled and signs of corrosion are visible on the slab edge.

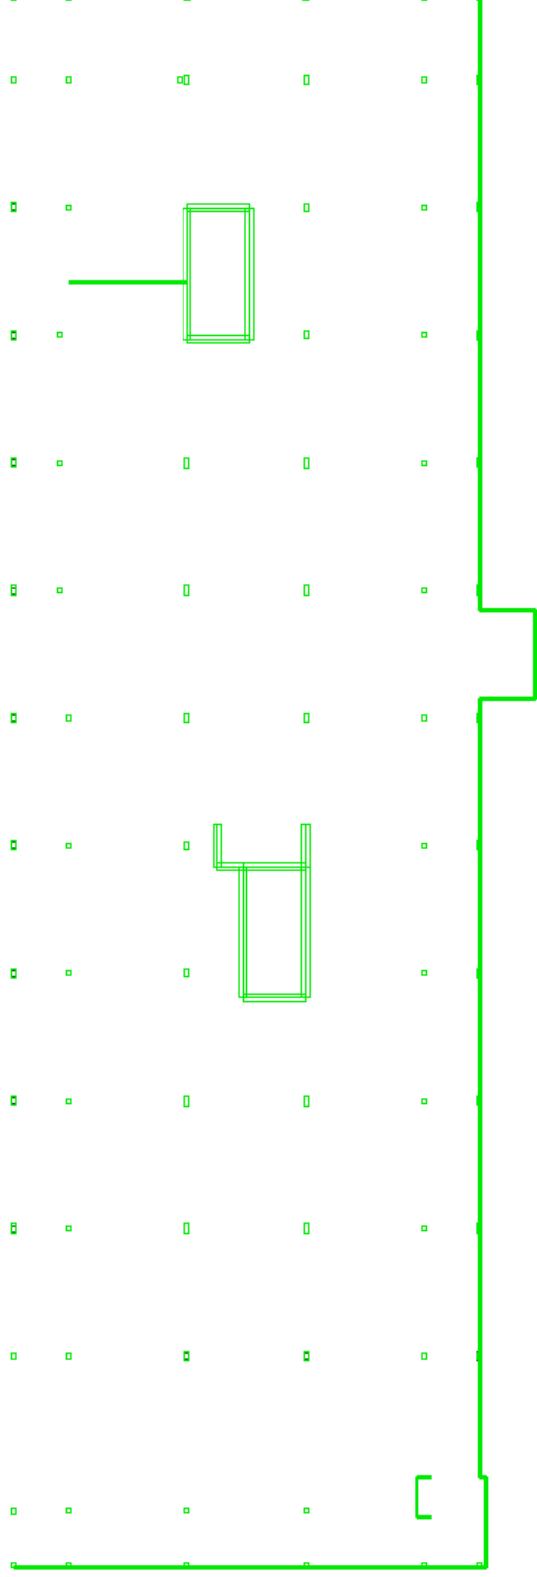
# First Floor Shear Wall Deficiencies

Shear Strength Deficiency

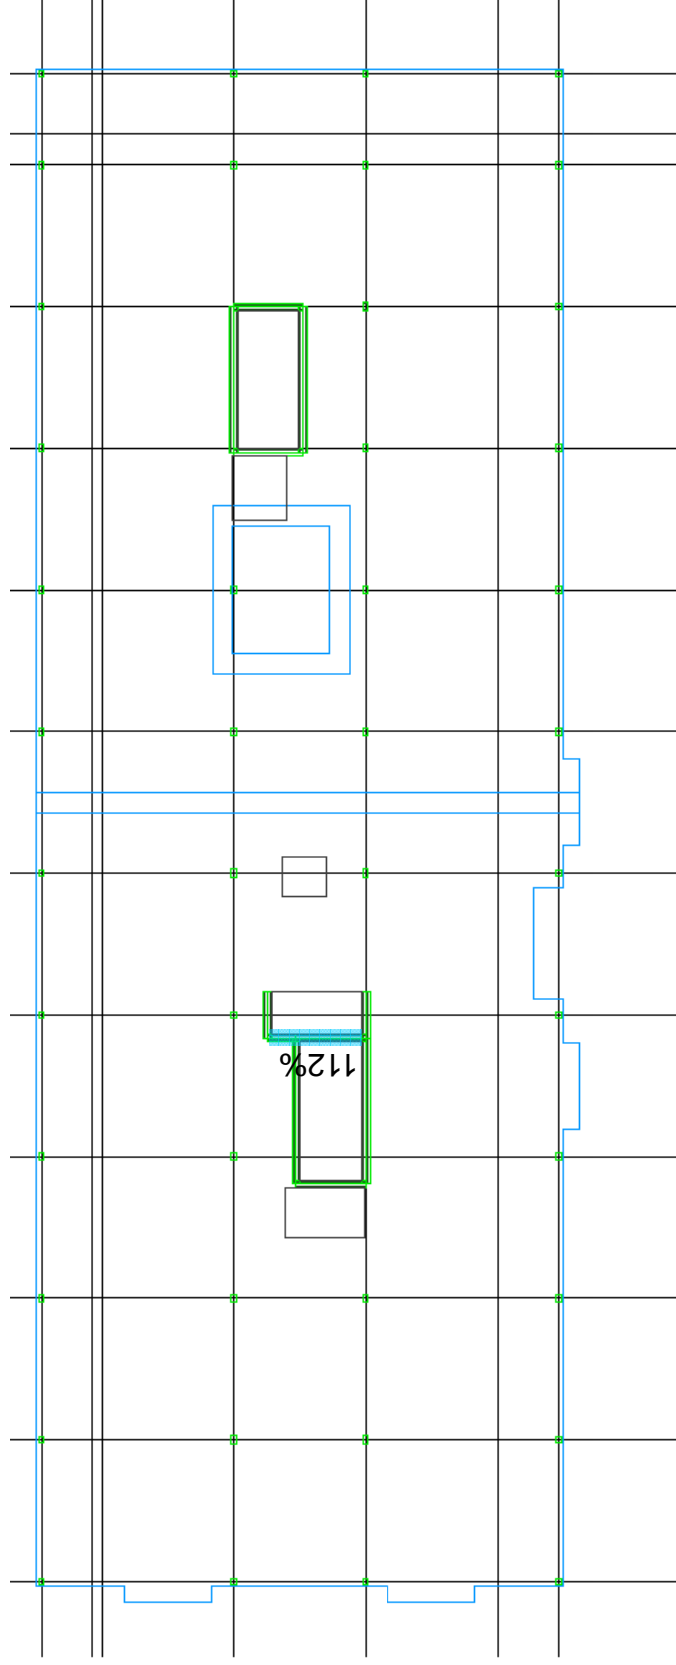
# Third Floor Shear Wall Deficiencies

Shear Strength Deficiency

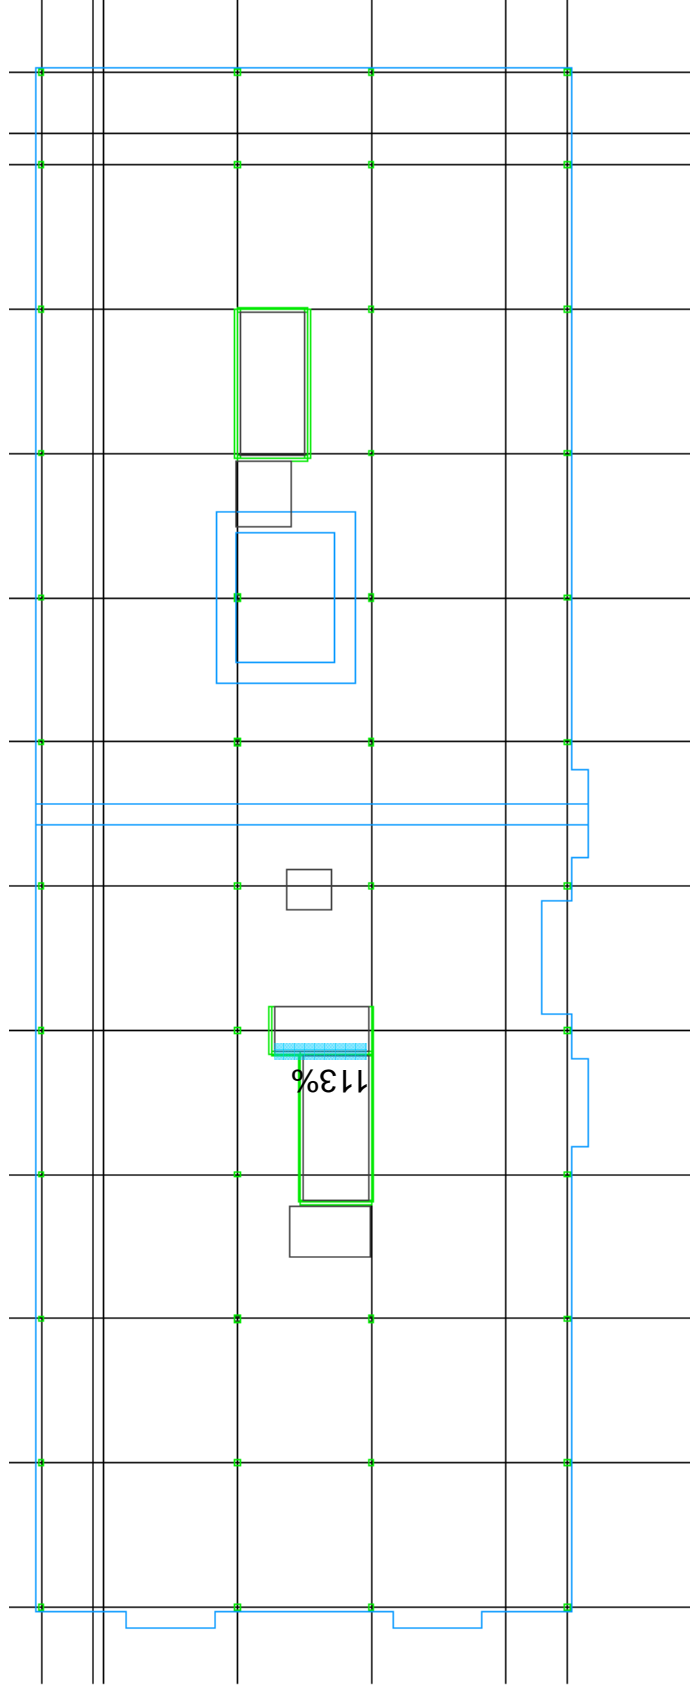
# Fifth Floor Shear Wall Deficiencies

Shear Strength Deficiency

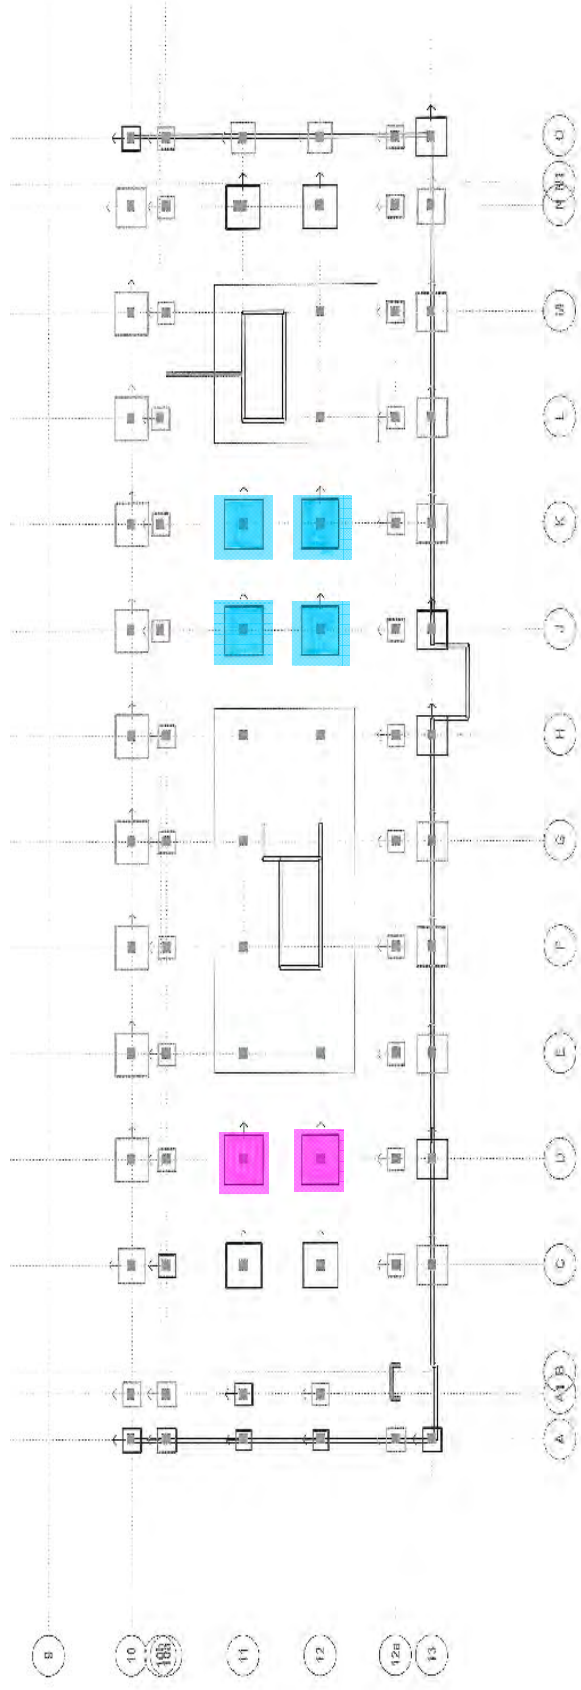
# Building Footing Deficiencies

Punching Shear Stress More Than 1/3 Greater Than Code Allowance

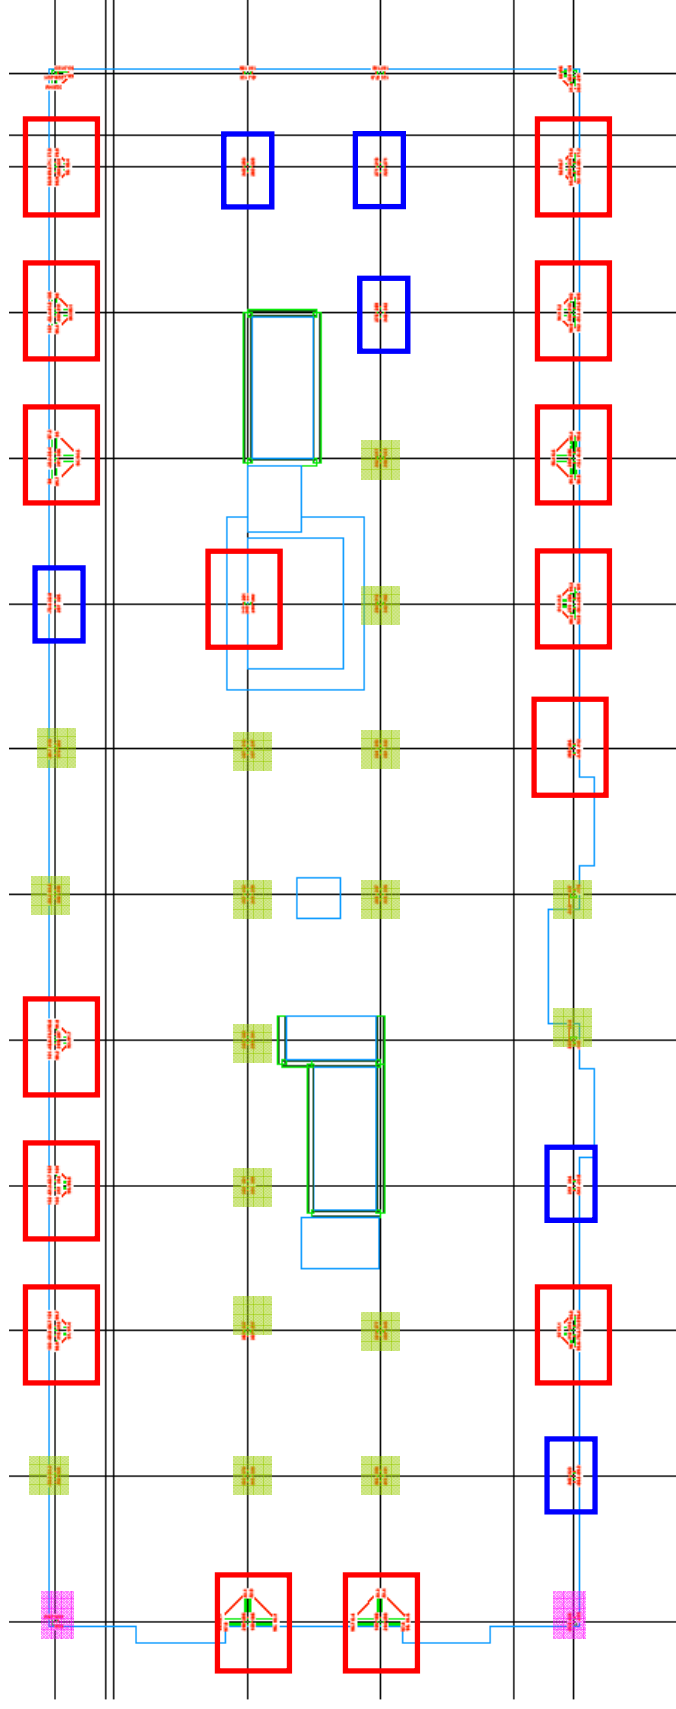
# Third Floor: Punching Shear Stress Plan

- Exceeds Code Stress Limits w/5,000 psi Concrete Design Strength
- Exceeds Stress Limits using Actual Code Strengths
- Stress More than 1/3 Greater than Code Allowable Based on Actual Core Strengths ("Dangerous" Condition)
- Stress more than 1/3 Greater than Code Allowance Based on Original Design Strength (5,000 psi) and Actual Core Strengths ("Dangerous" Condition)

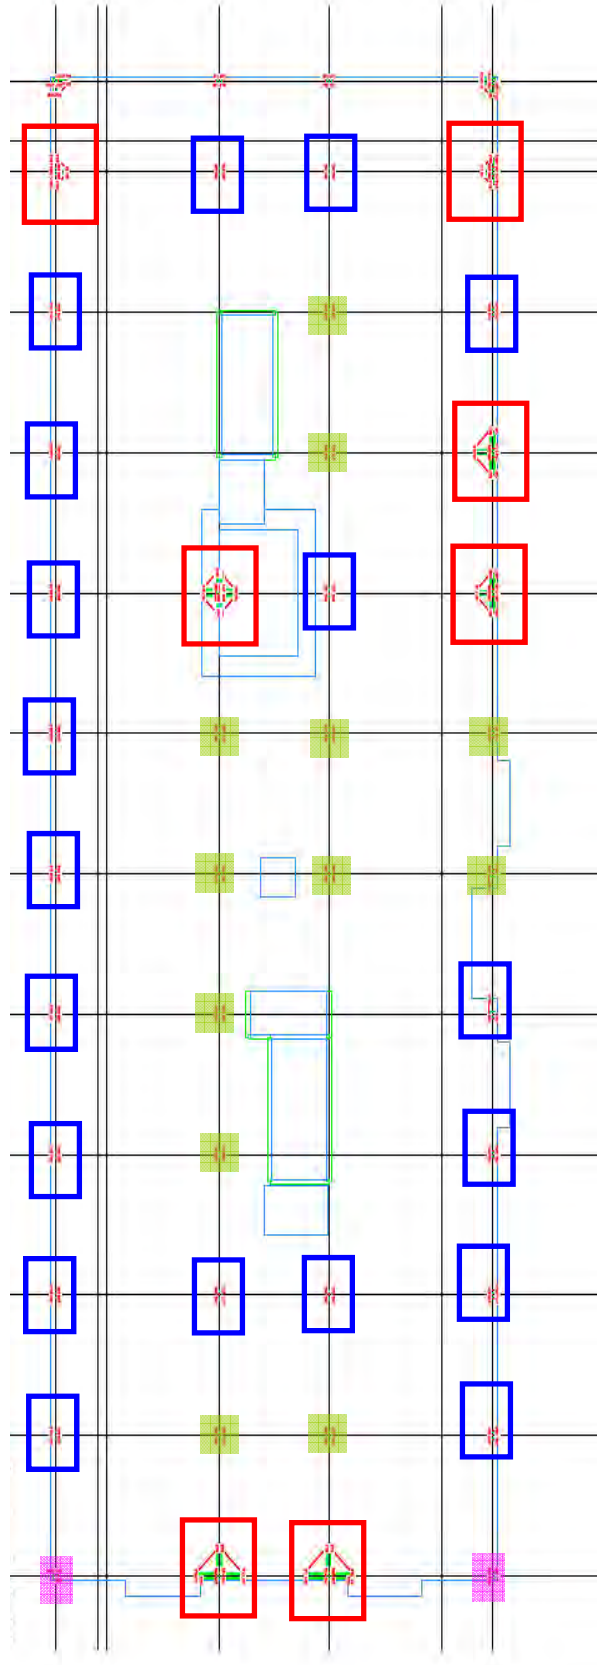
# Fifth Floor: Punching Shear Stress Plan

- Exceeds Code Stress Limits w/5,000 psi Concrete Design Strength
- Exceeds Stress Limits using Actual Code Strengths
- Stress More than 1/3 Greater than Code Allowable Based on Actual Core Strengths ("Dangerous" Condition)
- Stress more than 1/3 Greater than Code Allowance Based on Original Design Strength (5,000 psi) and Actual Core Strengths ("Dangerous" Condition)

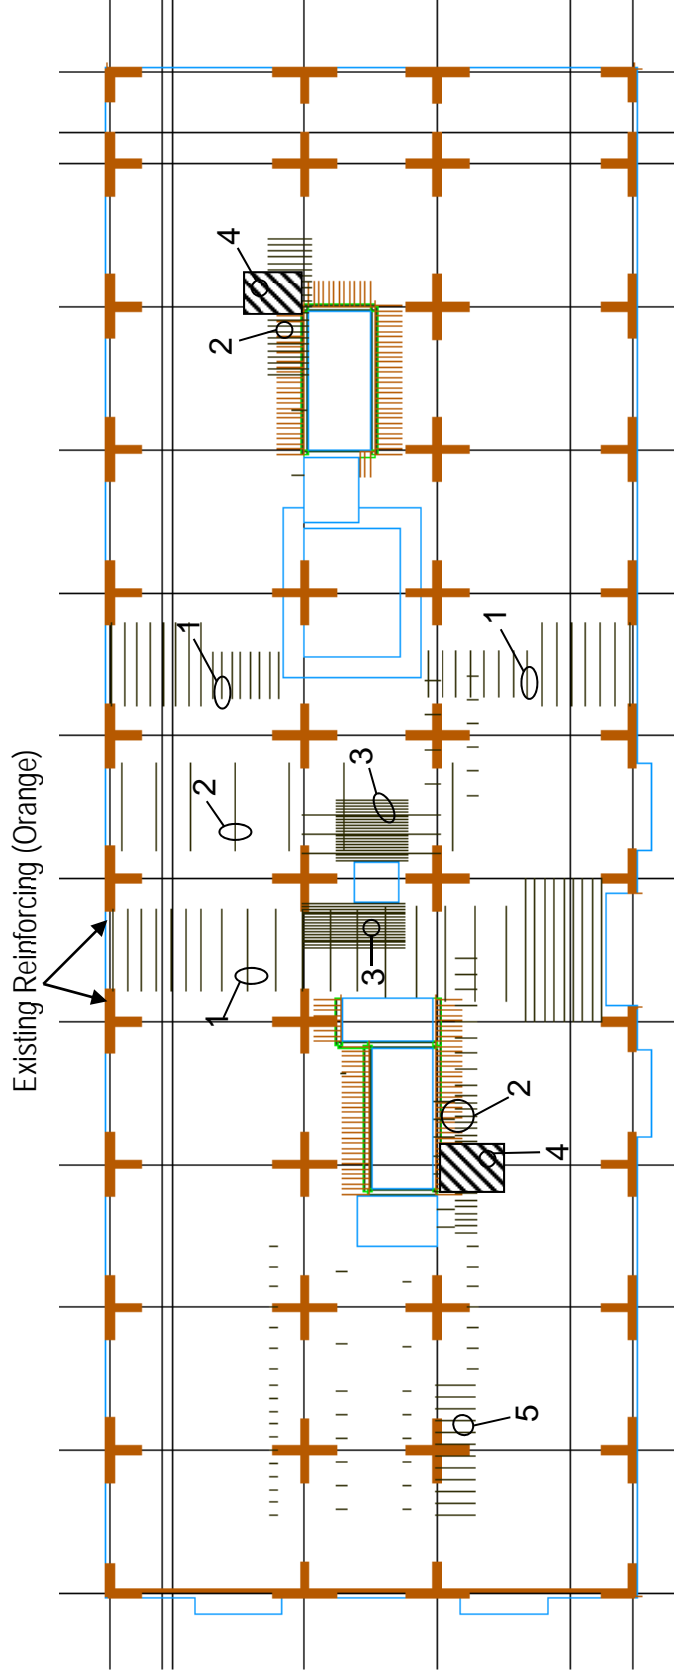
# Typical Slab Top Reinforcing Steel 83

1. Insufficient Top Reinforcing under Service Loads
2. Insufficient Top Reinforcing for Flexural Strength
3. Insufficient Top Reinforcing for Service and Strength
4. Column strip top Stress Exceeded
5. Insufficient Top Reinforcing Steel at 3<sup>rd</sup>, 4<sup>th</sup> Floors

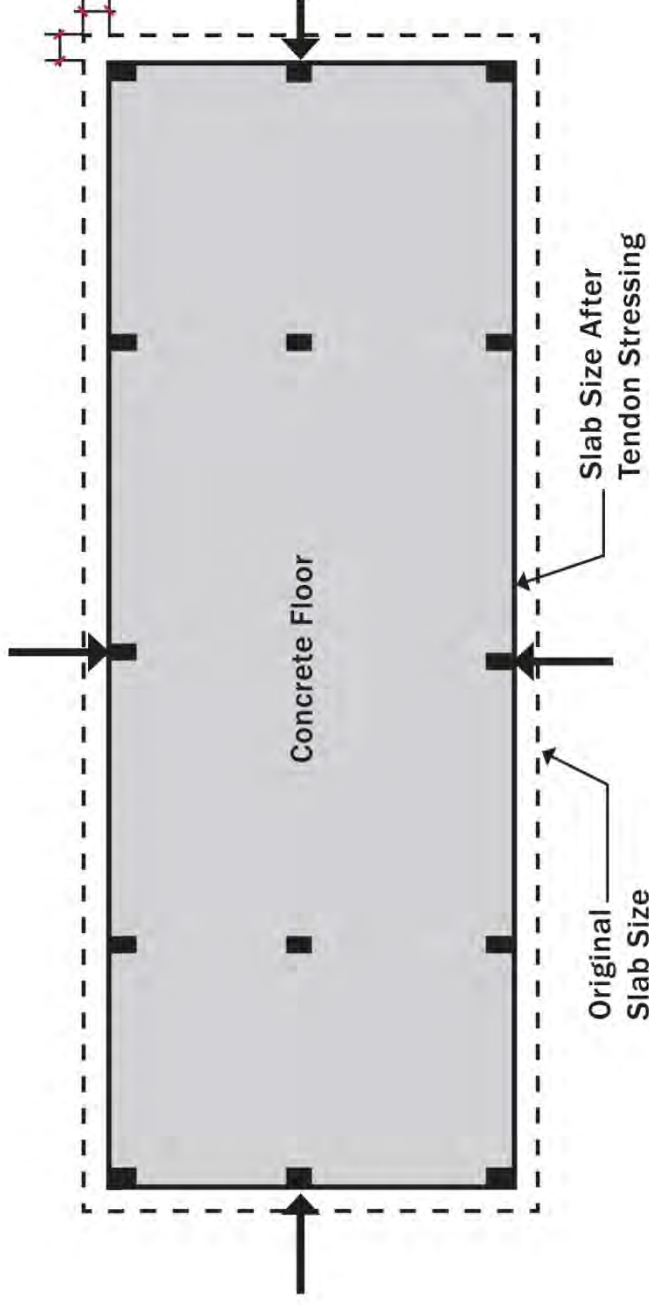
# FLOOR DESIGN ACTUAL CONDITIONS: SHRINKAGE AND SHORTENING

- Shortening due to high pre-compressive stress and dead load balancing
- Shrinkage due to material challenges

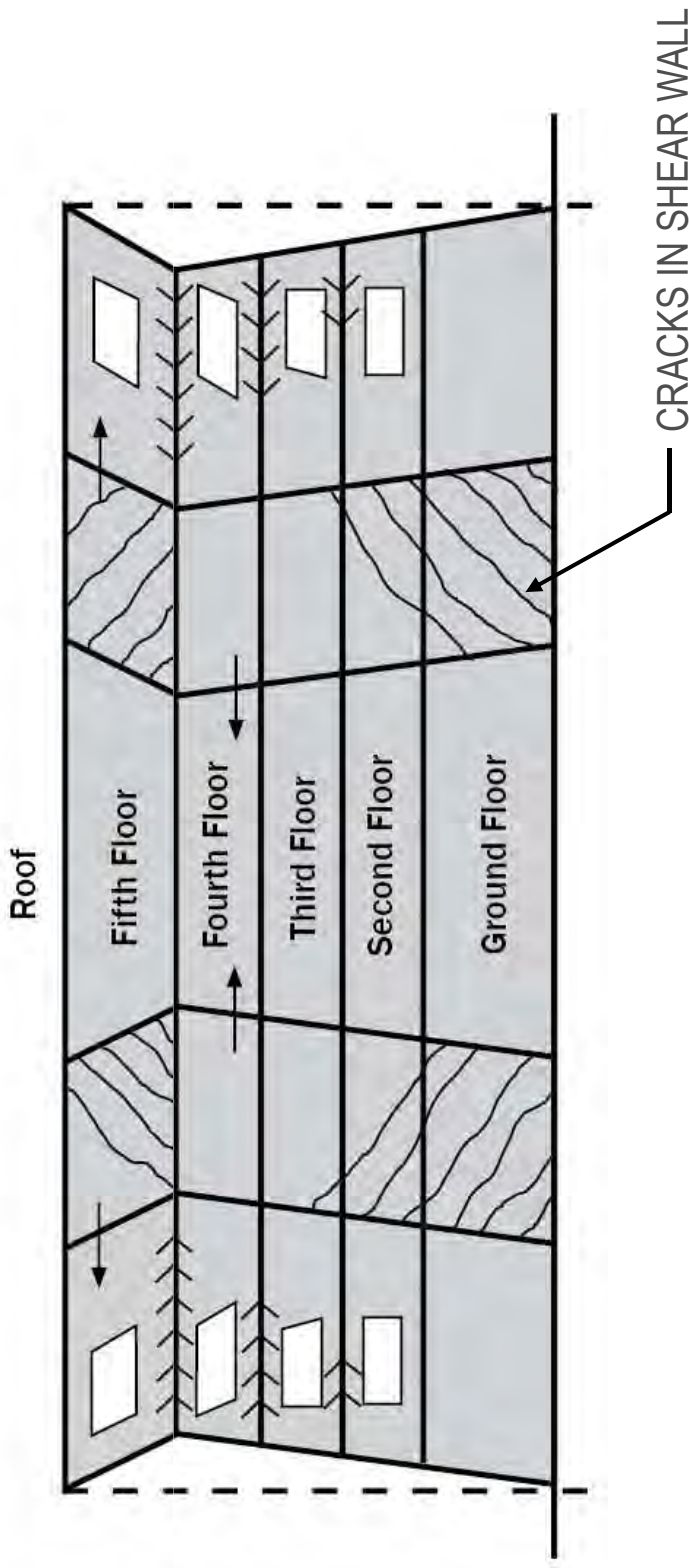
# FLOOR DESIGN ACTUAL CONDITIONS: SECTION DIAGRAM

- Observed column crack patterns are consistent in building and bus mall

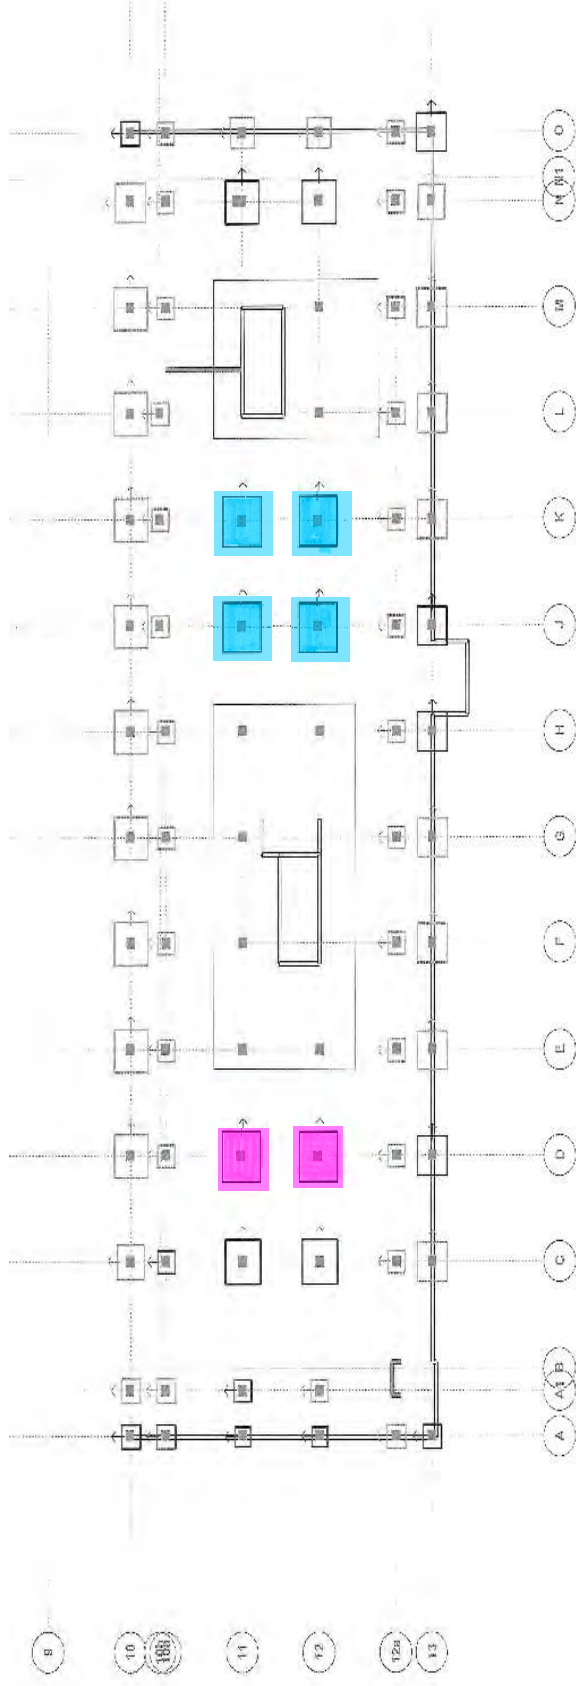
# BUILDING FOOTING DEFICIENCIES

Punching Shear Stress More Than 33% Greater Than Code Allowance

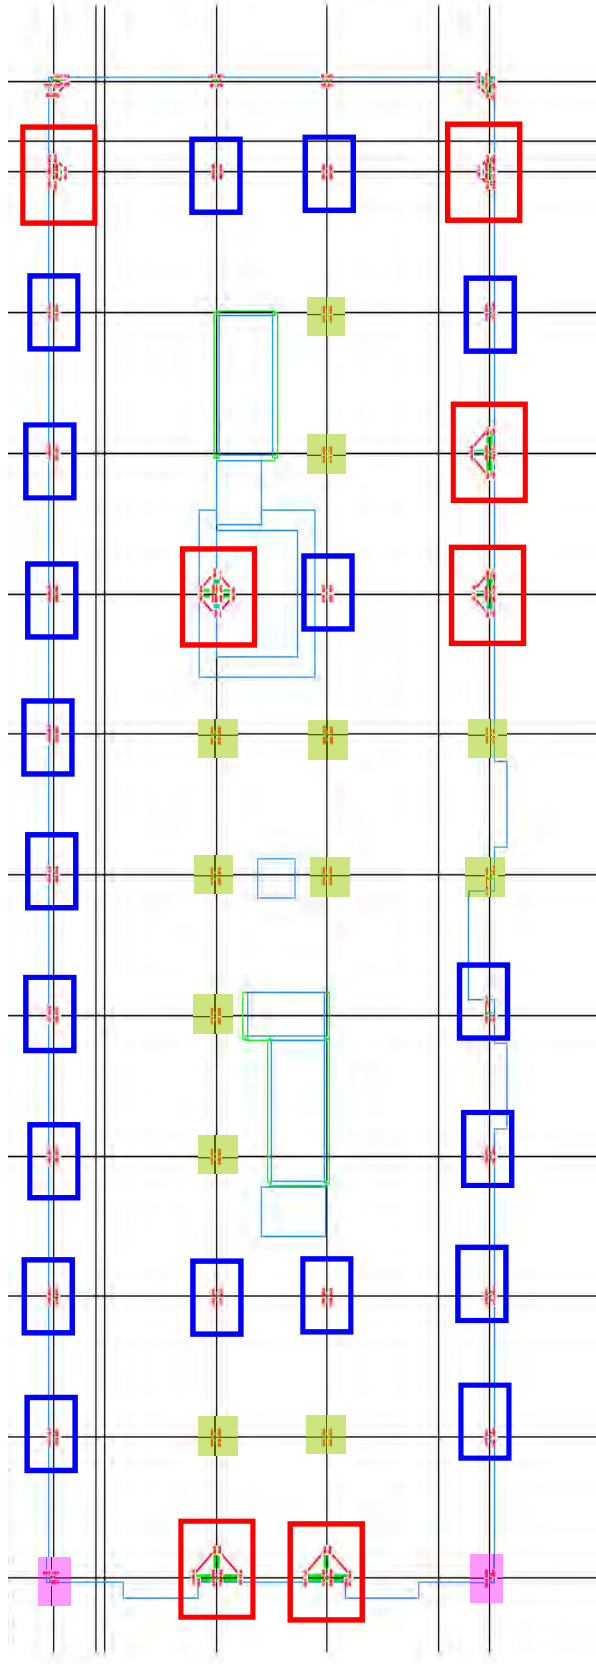
# FIFTH FLOOR: PUNCHING SHEAR STRESS PLAN

█ Exceeds Code Stress Limits w/5,000 psi Concrete Design Strength  
█ Exceeds Stress Limits using Actual Code Strengths  
█ Stress More than 33% Greater than Code Allowable Based on Actual Core Strengths ("Dangerous" Condition)  
█ Stress more than 33% Greater than Code Allowance Based on Original Design Strength (5,000 psi) and Actual Core Strengths ("Dangerous" Condition)

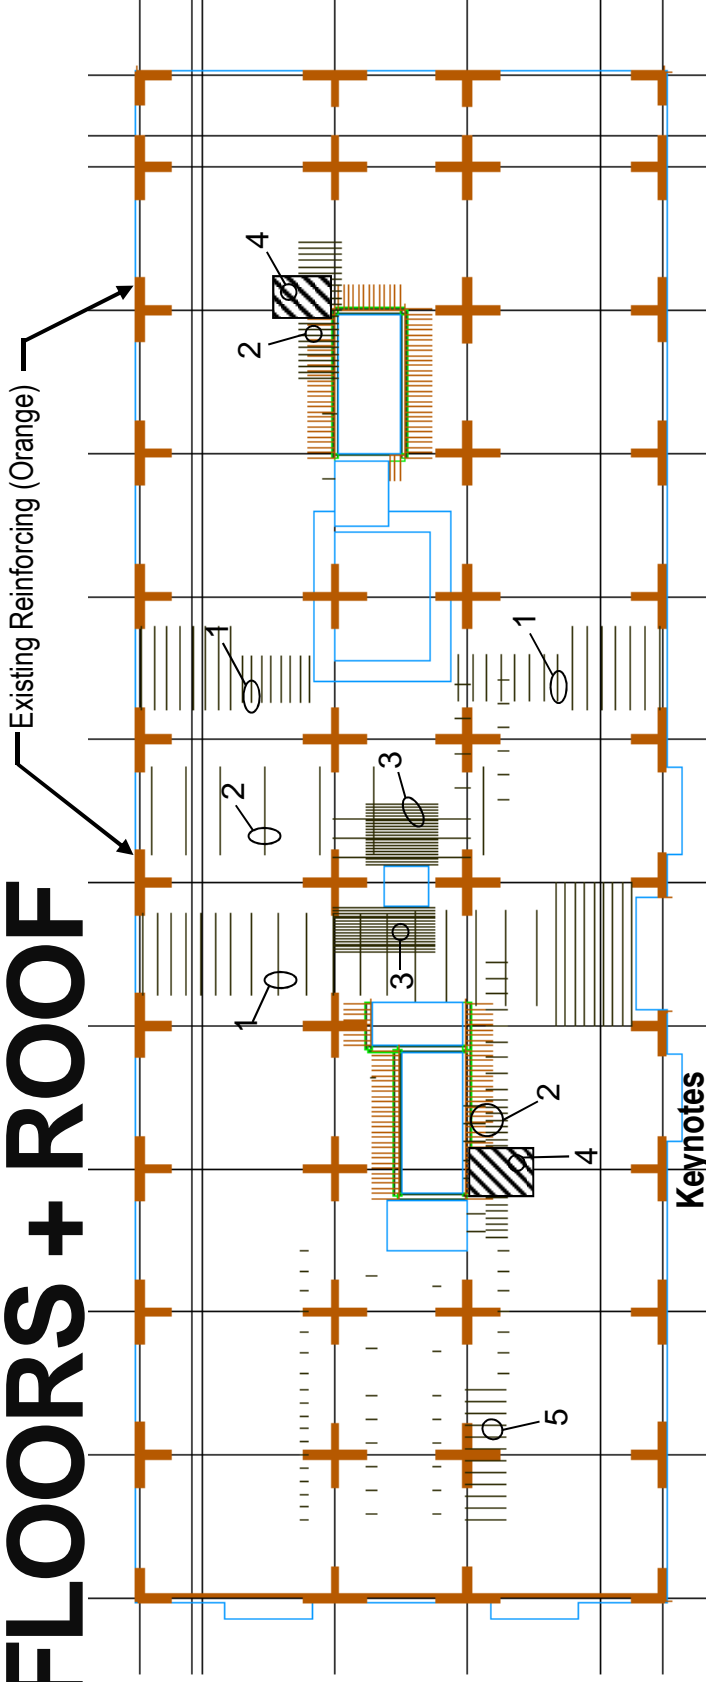
# TYPICAL SLAB TOP REINFORCING STEEL DEFICIENCIES AT 2ND-5TH FLOORS + ROOF

1. Insufficient Top Reinforcing under Service Loads
2. Insufficient Top Reinforcing for Flexural Strength
3. Insufficient Top Reinforcing for Service and Strength
4. Column strip top Stress Exceeded
5. Insufficient Top Reinforcing Steel at 3<sup>rd</sup>, 4<sup>th</sup> Floors

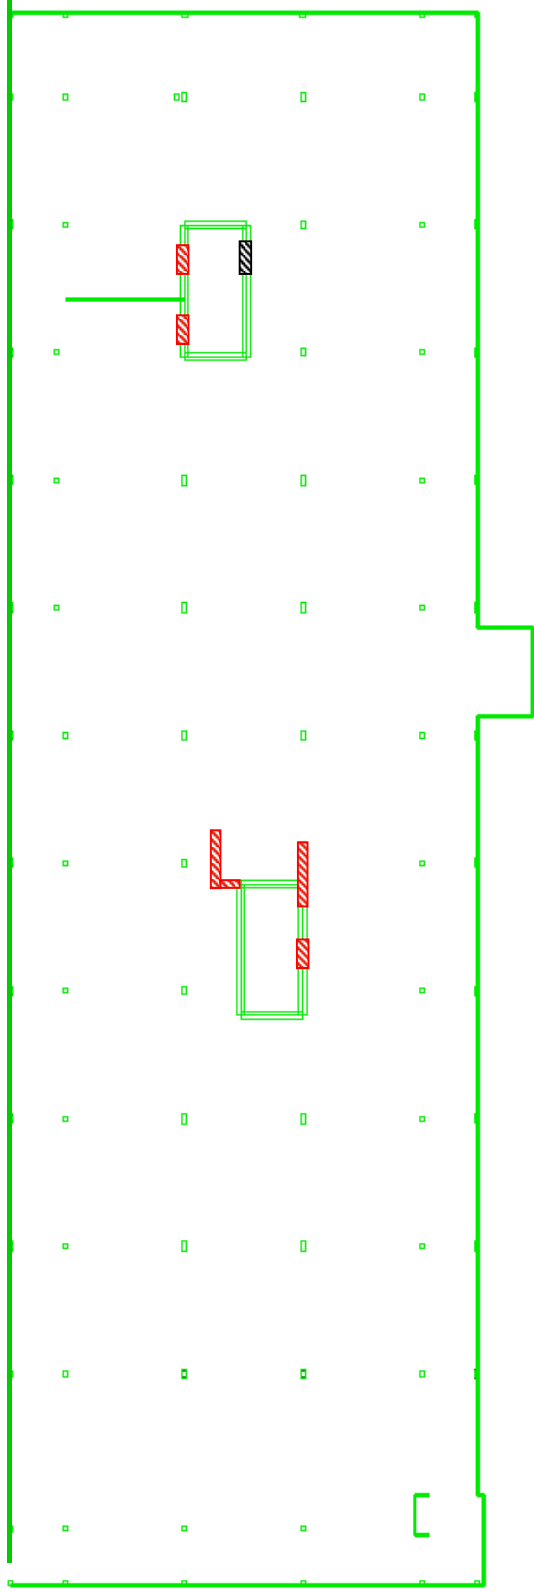
# FIRST FLOOR SHEAR WALL DEFICIENCIES

- Shear Strength Deficiency
- Boundary Element Deficiency
- Header Beam Deficiency

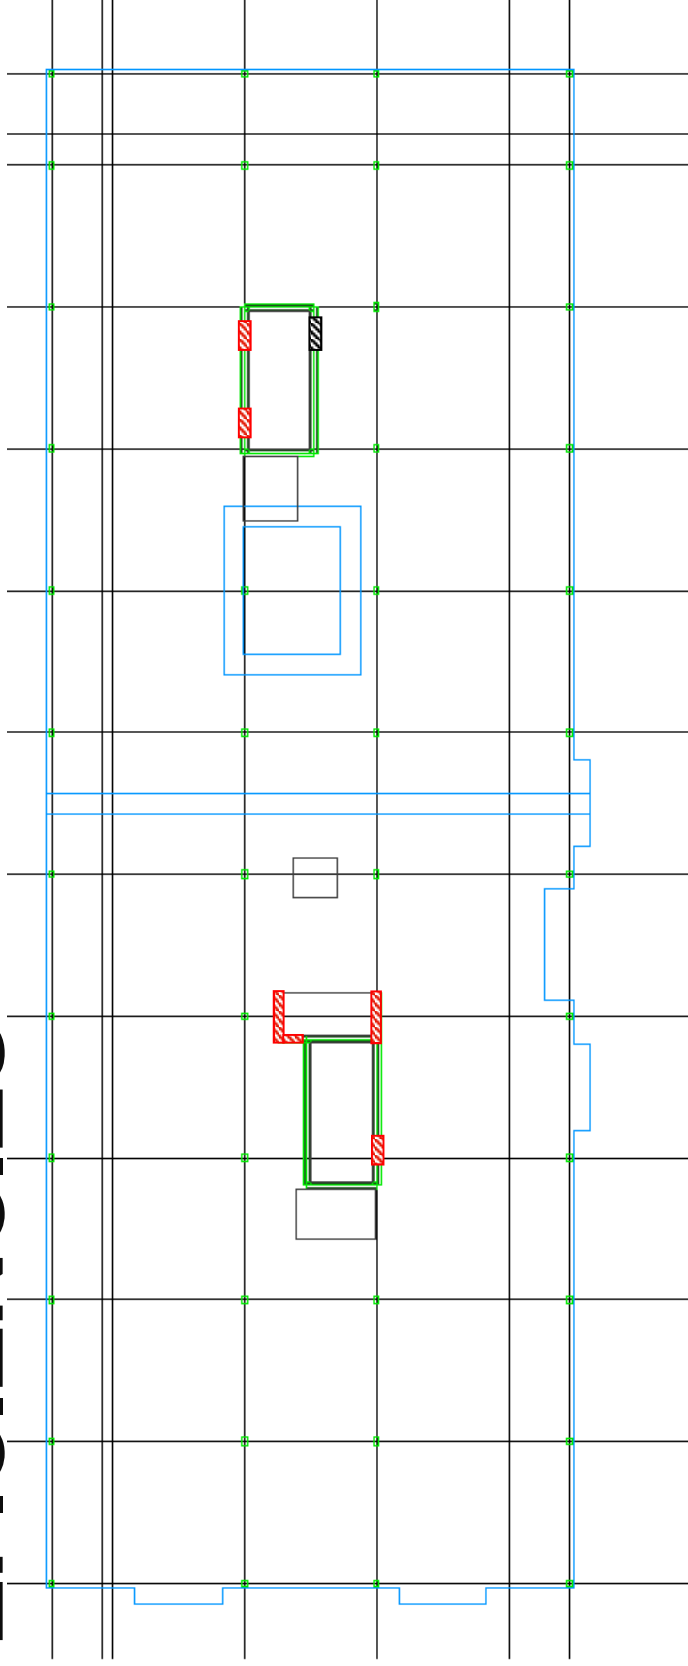
# THIRD FLOOR SHEAR WALL DEFICIENCIES

- Shear Strength Deficiency
- Boundary Element Deficiency
- Header Beam Deficiency

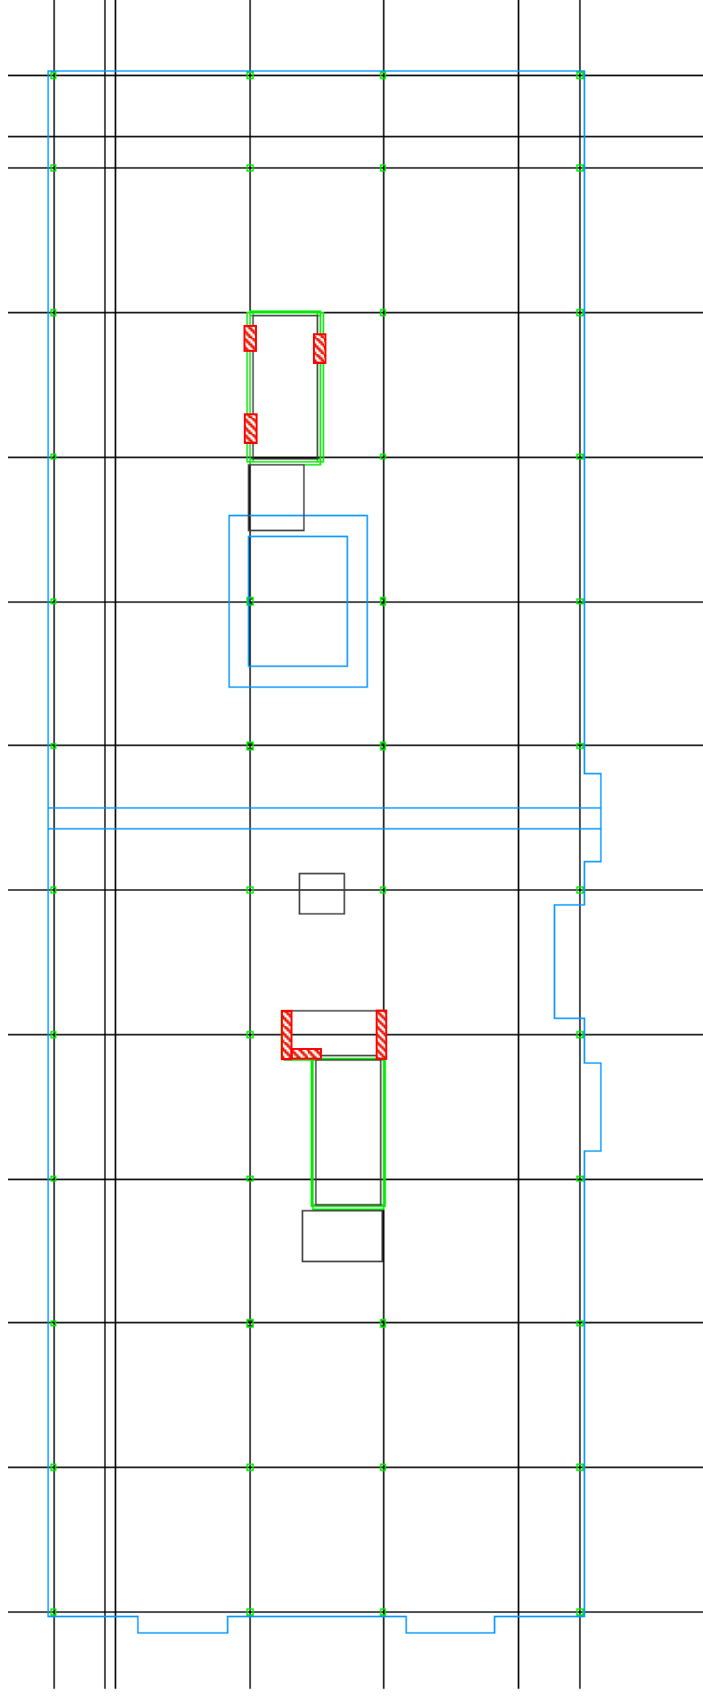
# FIFTH FLOOR SHEAR WALL DEFICIENCIES

- Shear Strength Deficiency
- Boundary Element Deficiency
