**Marion County Courthouse Square  
555 Court Street NE, Salem Oregon  
Remediation Study Final Report  
February 07, 2011**

**Volume Four of Six**

Marion County  
Courthouse Square Structural Remediation  
Project Summary  
June 09, 2010

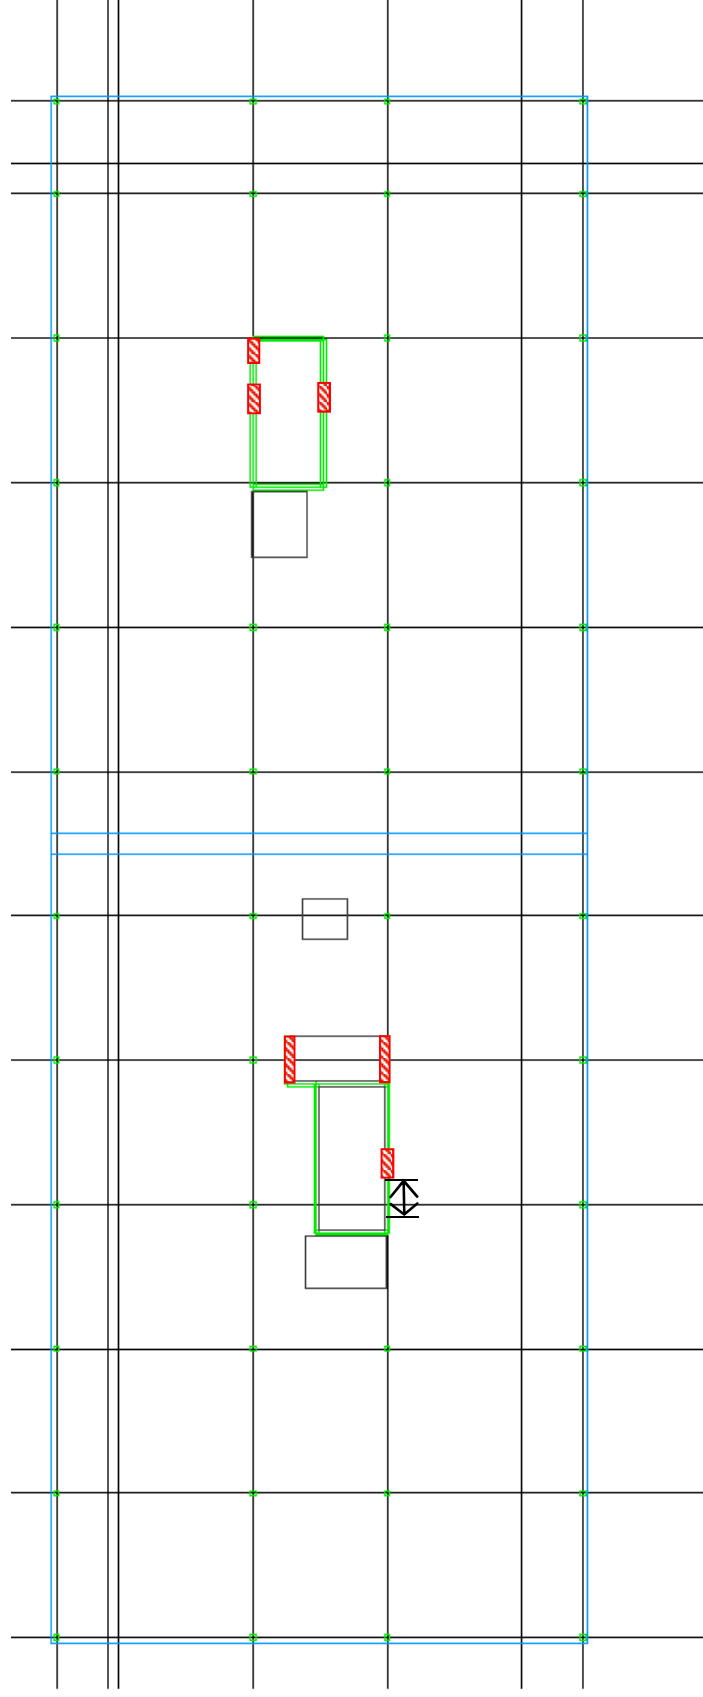
# ROOF SHEAR WALL DEFICIENCIES

Shear Strength Deficiency

Boundary Element Deficiency
