# Forensic Investigation of Courthouse Square

555 Court Street NE  
Salem, Oregon

May 2, 2011

Project No. 103-93451.100

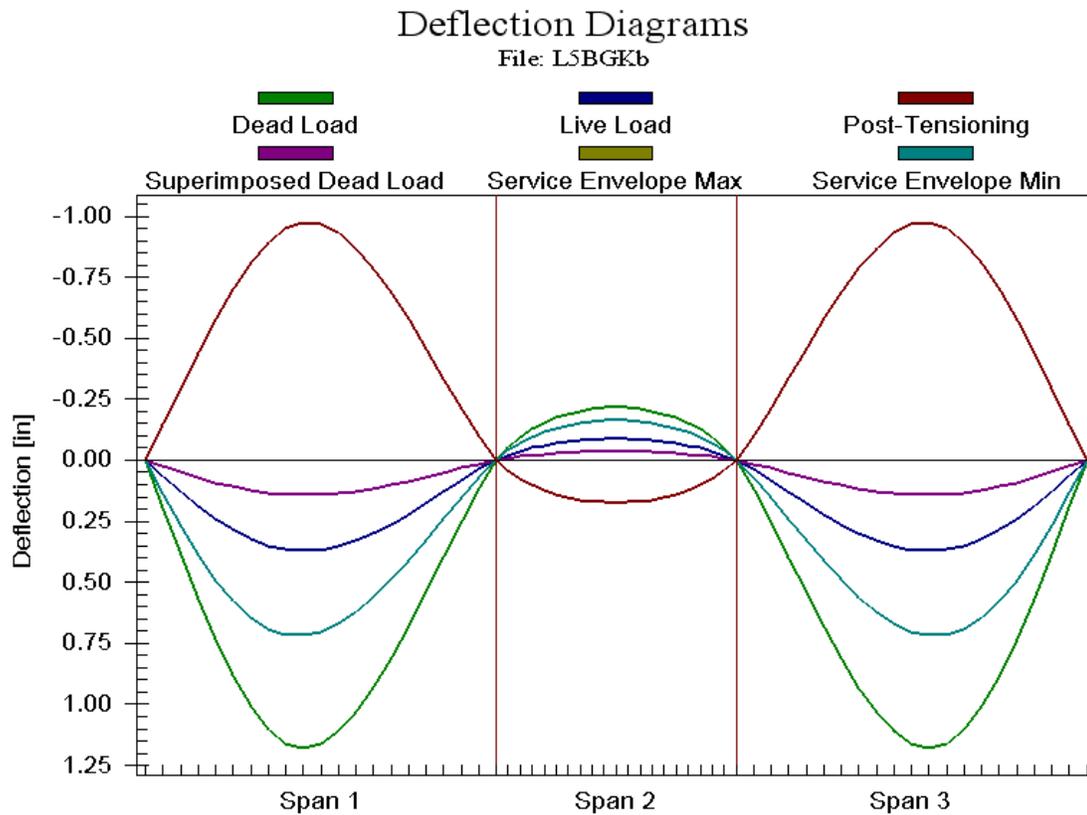
**Figure 1 – Office - Grid K with full live loads**

Figure 1 below shows a typical deflection pattern for the transverse (north-south) direction. The exaggerated effects of the two end spans can be clearly seen by reviewing the Service Envelope Min pattern. Figure 2 shows the crowning experienced by the slabs in the longitudinal (east-west) direction due to post-tensioning forces.

Deflection Diagrams Figures show short term deflections only (long term deflections are assumed by the program to be twice the amount shown in these diagrams) and are separated into individual effects (dead, live, post-tensioning, etc.). To understand the deflected shape of the slab immediately after stressing, it is necessary to add the post-tensioning, dead and superimposed dead load effects. The combination of these is shown by the Service Envelope Minimum line.

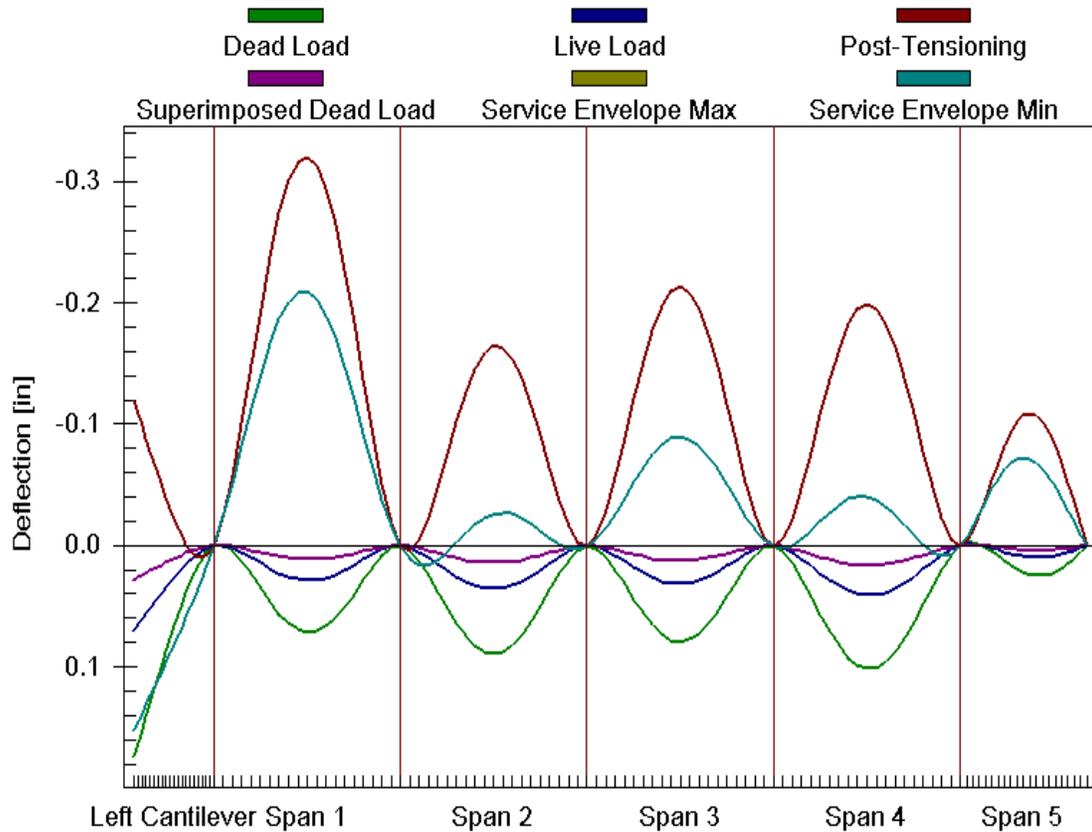
**Figure 2 – Office - Grid 11 with full live loads**

This ADAPT analysis, however, does not account fully for the measured movement in the slabs. Deflections calculated by the program vary between 1.25" in the transverse direction and -0.7" in the longitudinal direction, including the long term deflection increase of 100%. This is roughly half the measured deflections in the office building which, depending on the datum selected, are often as high as -1.5" in the longitudinal direction and 2.5" in the transverse direction.

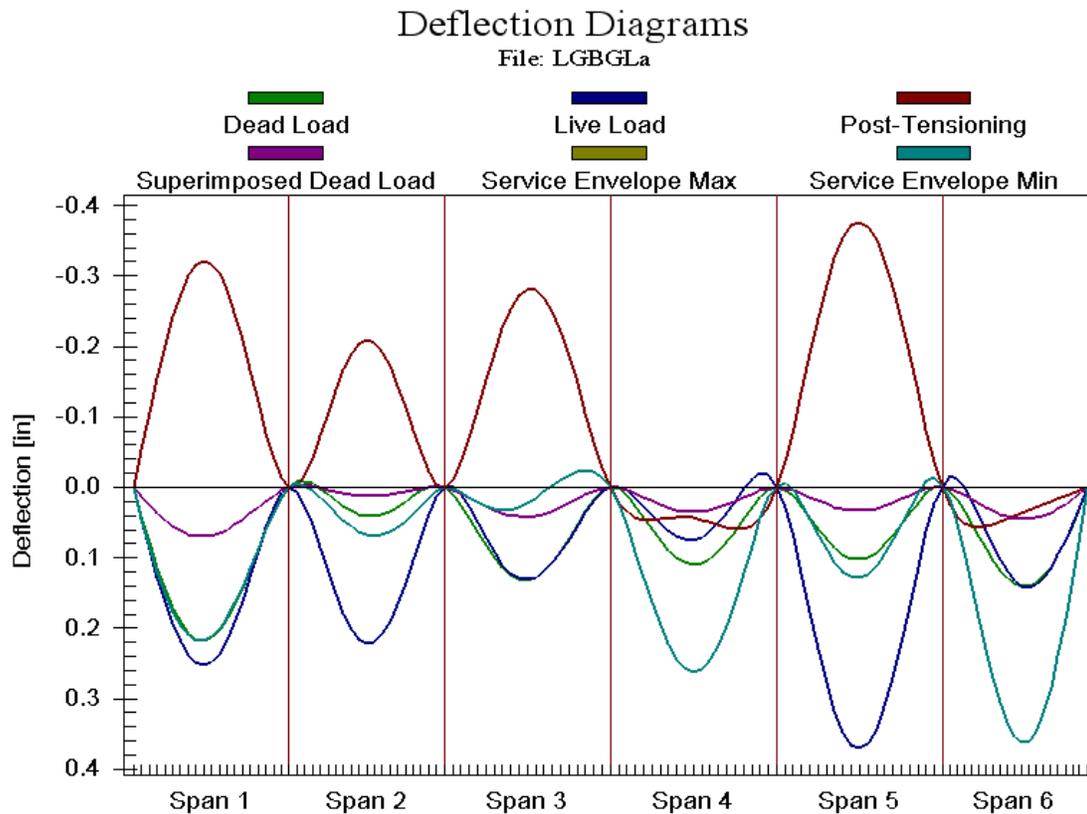
**Figure 3 – Bus Mall - Grid L with reduced live loads**

In the Bus Mall, compressive stresses due to post-tensioning vary between 315 psi and 424 psi. Due to heavy topping and high transit loading, however, even these high stress levels do not balance dead loads and would require significantly more mild reinforcement than provided to resist tensile stresses. Analysis indicates that, in some places, an additional 250% of bottom reinforcement would be required and an additional 500% of top reinforcement.

Figure 3 shows the initial deflections due to various loads for grid L at the Bus Mall Level. (Please see the discussion regarding interpretation of these diagrams under Office Building Slabs section above.) At the Bus Mall level, deflections generally are not an issue. Of more concern are the tensile stress levels, both top and bottom, and the shortening of the slab due to both elastic shortening and creep.

For post-tensioned slabs this large it is customary and desirable to provide slip joints to reduce cracking due to compression shortening and creep. A detail for a slip joint between walls and the slab was provided. The location of these joints appeared to be in the corners of the slab edge with the exception of the north wall, where no slip joints could be located using the drawings. While this pattern of joints may be adequate for slabs with moderate compressive stress, it does not appear sufficient to
