Situs: 2052 KENNEDY CIR NE # 45 KEIZER, OR 97303

Last Date Appraised: 07/12/2024 Appraiser: THERESA SWEARINGEN Retag: Y N Tag info: 2025 - REPAIR/R MODEL STRUCTURE (MS REMODEL)

Improvement Detail

Stat Class 446 - MANUF STRUCT, CLASS 4 24' WIDE DOUBLE

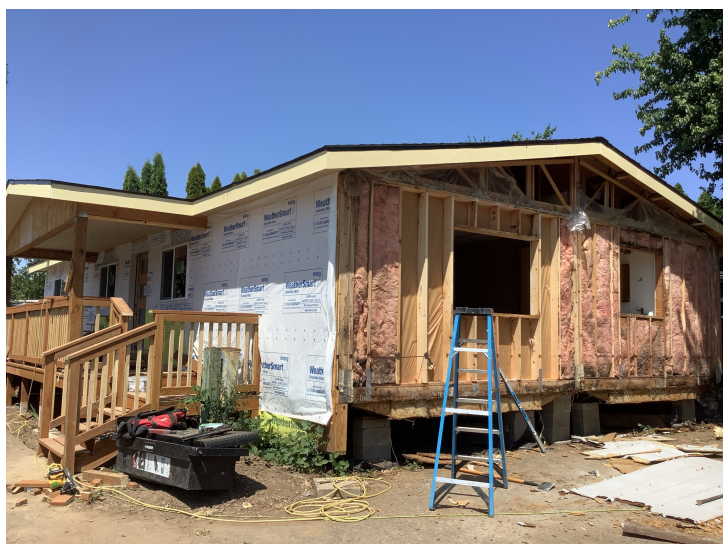
WINNER photo

mrs needs repairs need extensive repairs

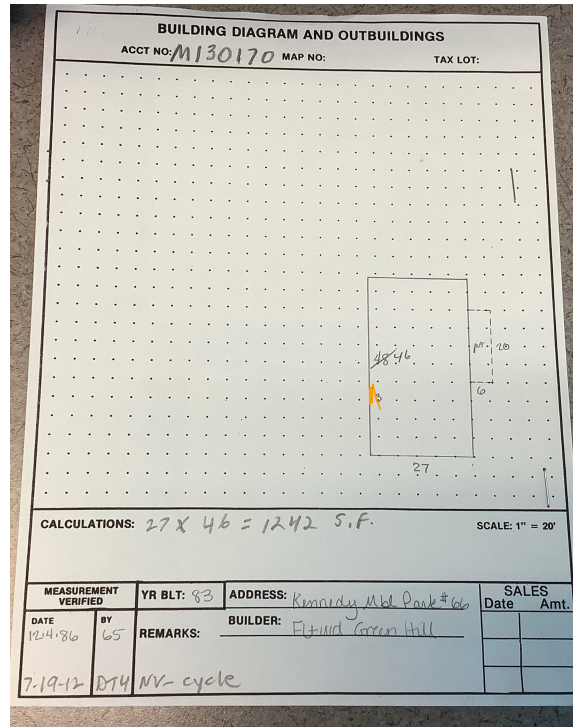
Seg. Type MA Seg. # 1.1 Method M04 Class 4D Area 1242 Eff Area 1242 Length 46 Width 27
 Make: FLEETWOOD Model: GREEN HILL Int'finish: GYPSUM Roof Cover COMP
 Heat: FA Fireplace: Inter. Comp: DW: DSP H+F Bedrooms: 3 Plumbing BATH2
 Year Built 1983 Eff. Year Built 1977 Cond. P F A G E
 Adj Codes MSLCMD Qty 4 % Comp ___ Func ___ Econ ___ RMV 13,740
 Lump Sum ___ Except Code/Year ___ Comments exterior needs new paint
degraded maintenance issues (mold in ceiling), siding issues
Accessory Improvements Not likely to be repaired soon.

mold in ceiling & wall near ceiling
not getting worse. (found)

- lots of rot issues in siding
- she thought painting over it would help.
