**ASBESTOS AND LEAD SURVEY
AND HAZARDOUS MATERIALS
SURVEY RESULTS**

**Goodman Property
Salem, Oregon**

RE: Asbestos and Lead Survey and
Hazardous Materials Survey Results
Goodman Property, Salem, Oregon

GOODMANBUILDING
ASBESTOS SURVEY & LEAD PAINT SCREEN TR# 1420-01
525 COURT STREET NE. SALEM, OREGON 97301

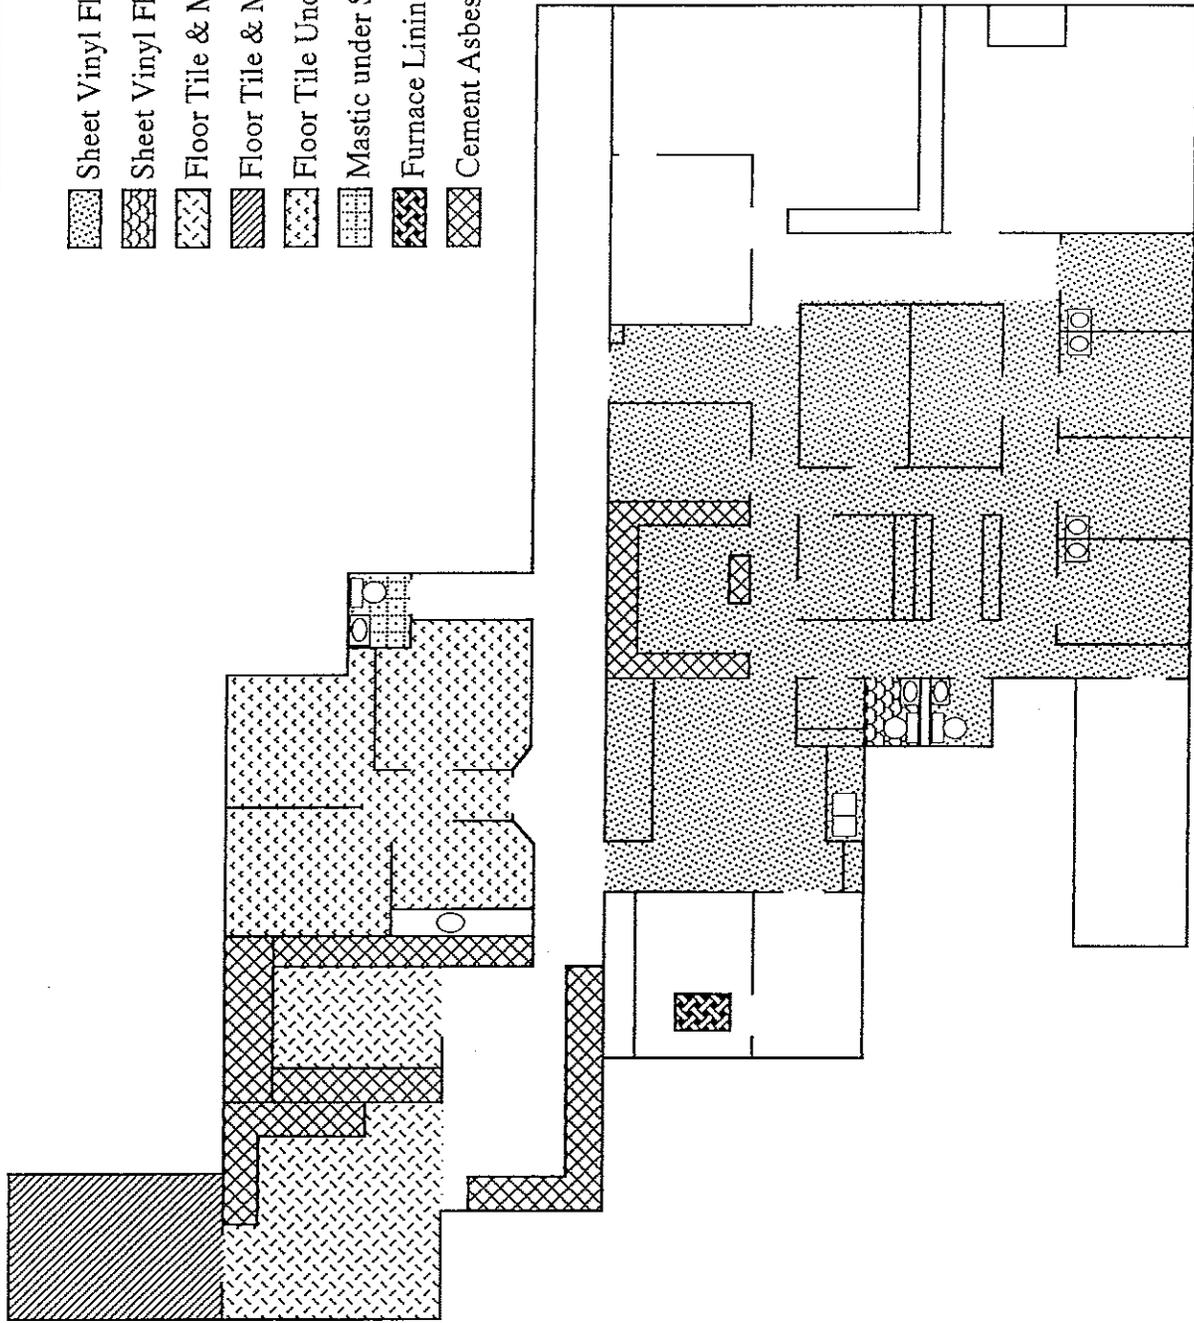
**POSITIVE MATERIAL LOCATIONS
 DIAGRAM**

- Sheet Vinyl Flooring
- Sheet Vinyl Flooring
- Floor Tile & Mastic
- Floor Tile & Mastic
- Floor Tile Under Sheet Vinyl
- Mastic under Sheet Vinyl
- Furnace Lining
- Cement Asbestos Board

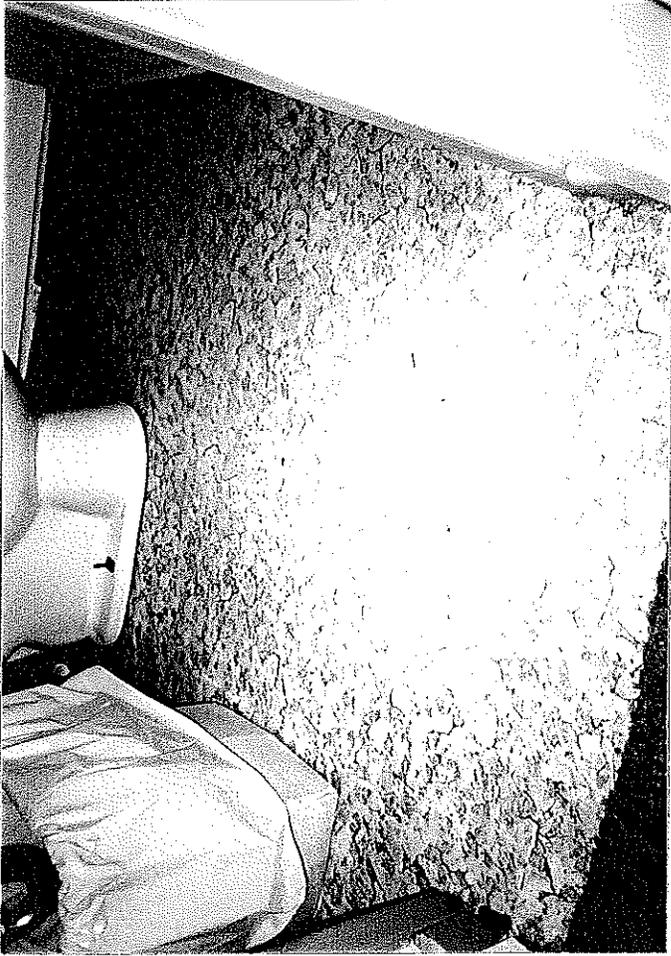
Picture No. 9

Material: Sheet Vinyl Flooring white & beige

Description: Sheet vinyl flooring, white & beige, which contains approximately 22.5% chrysotile asbestos.

Locations: N. Womans Restroom

Quantity: Approximately: 20 sq. ft.

- 1) At the time of or prior to demolition, asbestos-containing materials, lead-based paint, and hazardous materials should be properly handled, removed, and disposed of by a qualified contractor.
