**Marion County Courthouse Square  
555 Court Street NE, Salem Oregon  
Remediation Study Final Report  
February 07, 2011**

**Volume Four of Six**

Marion County  
Courthouse Square Structural Remediation  
Project Summary  
June 09, 2010

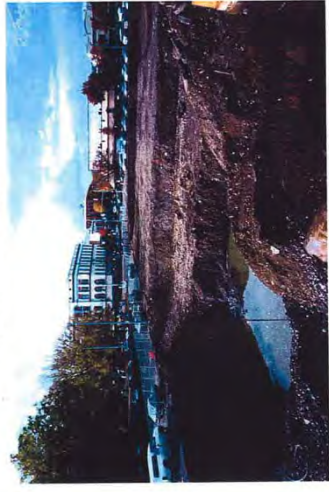
Photograph 2. Site 6 - Recharging groundwater in excavation, facing southwest.

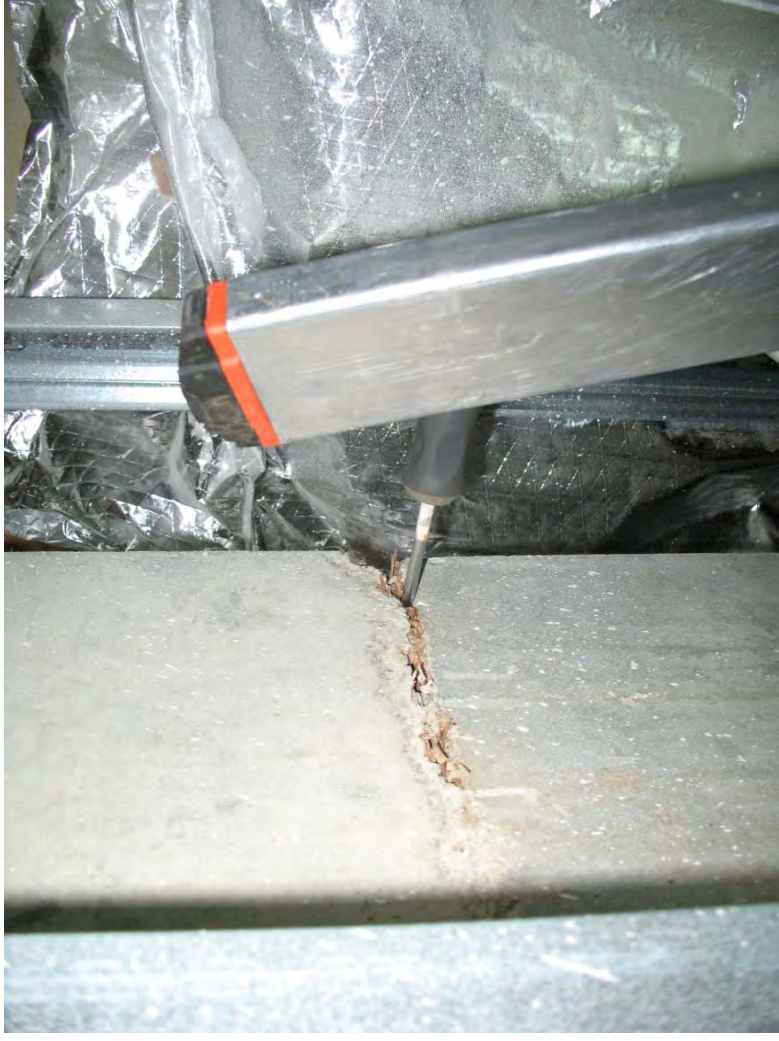
Wood Chips Cast Into Concrete Column

Poor construction methods were used during the construction of the slab; as a full layer of debris was allowed to be cast into the concrete column at Fourth Floor Grid D-13 effectively placing a bond breaker approximately 2' below the fifth floor slab. The screw driver was easily driven approximately 2" into the concrete column.

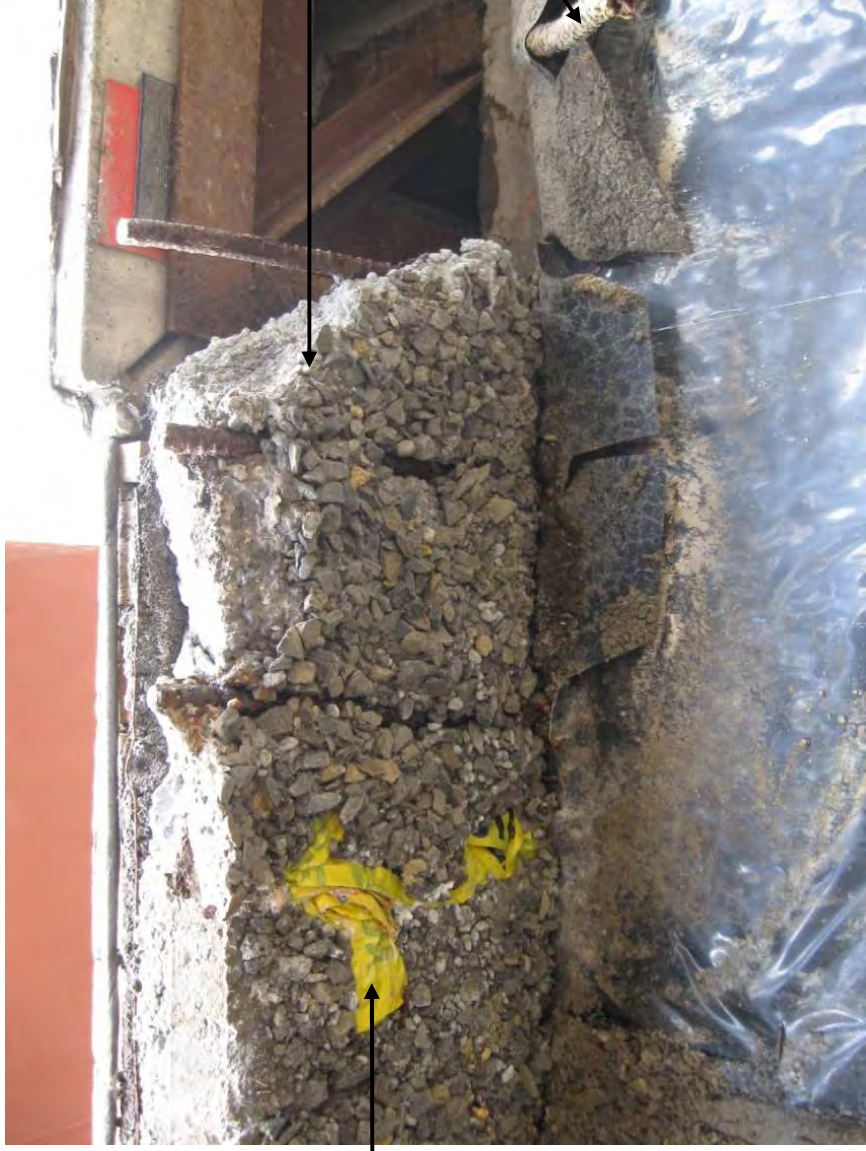
DEBRIS IN  
CASTING BED

REINFORCING BARS  
LAYING IN  
CASTING BED

REBAR BENT AND  
NOT REPAIRED  
DURING  
CONSTRUCTION

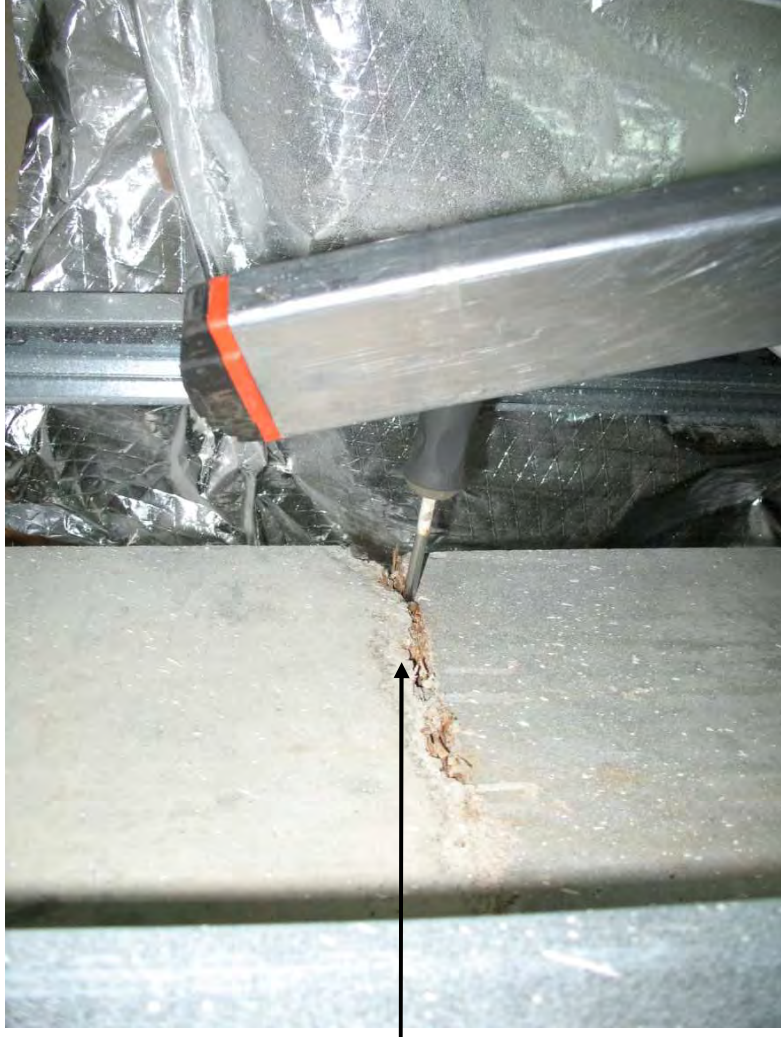
Wood Chips Cast Into Concrete Column

SCREWDRIVER WITH  
2 INCHES OF  
EMBEDMENT
