**ASBESTOS AND LEAD SURVEY
AND HAZARDOUS MATERIALS
SURVEY RESULTS**

**Goodman Property
Salem, Oregon**

RE: Asbestos and Lead Survey and
Hazardous Materials Survey Results
Goodman Property, Salem, Oregon

GOODMANBUILDING
ASBESTOS SURVEY & LEAD PAINT SCREEN TR# 1420-01
525 COURT STREET NE. SALEM, OREGON 97301

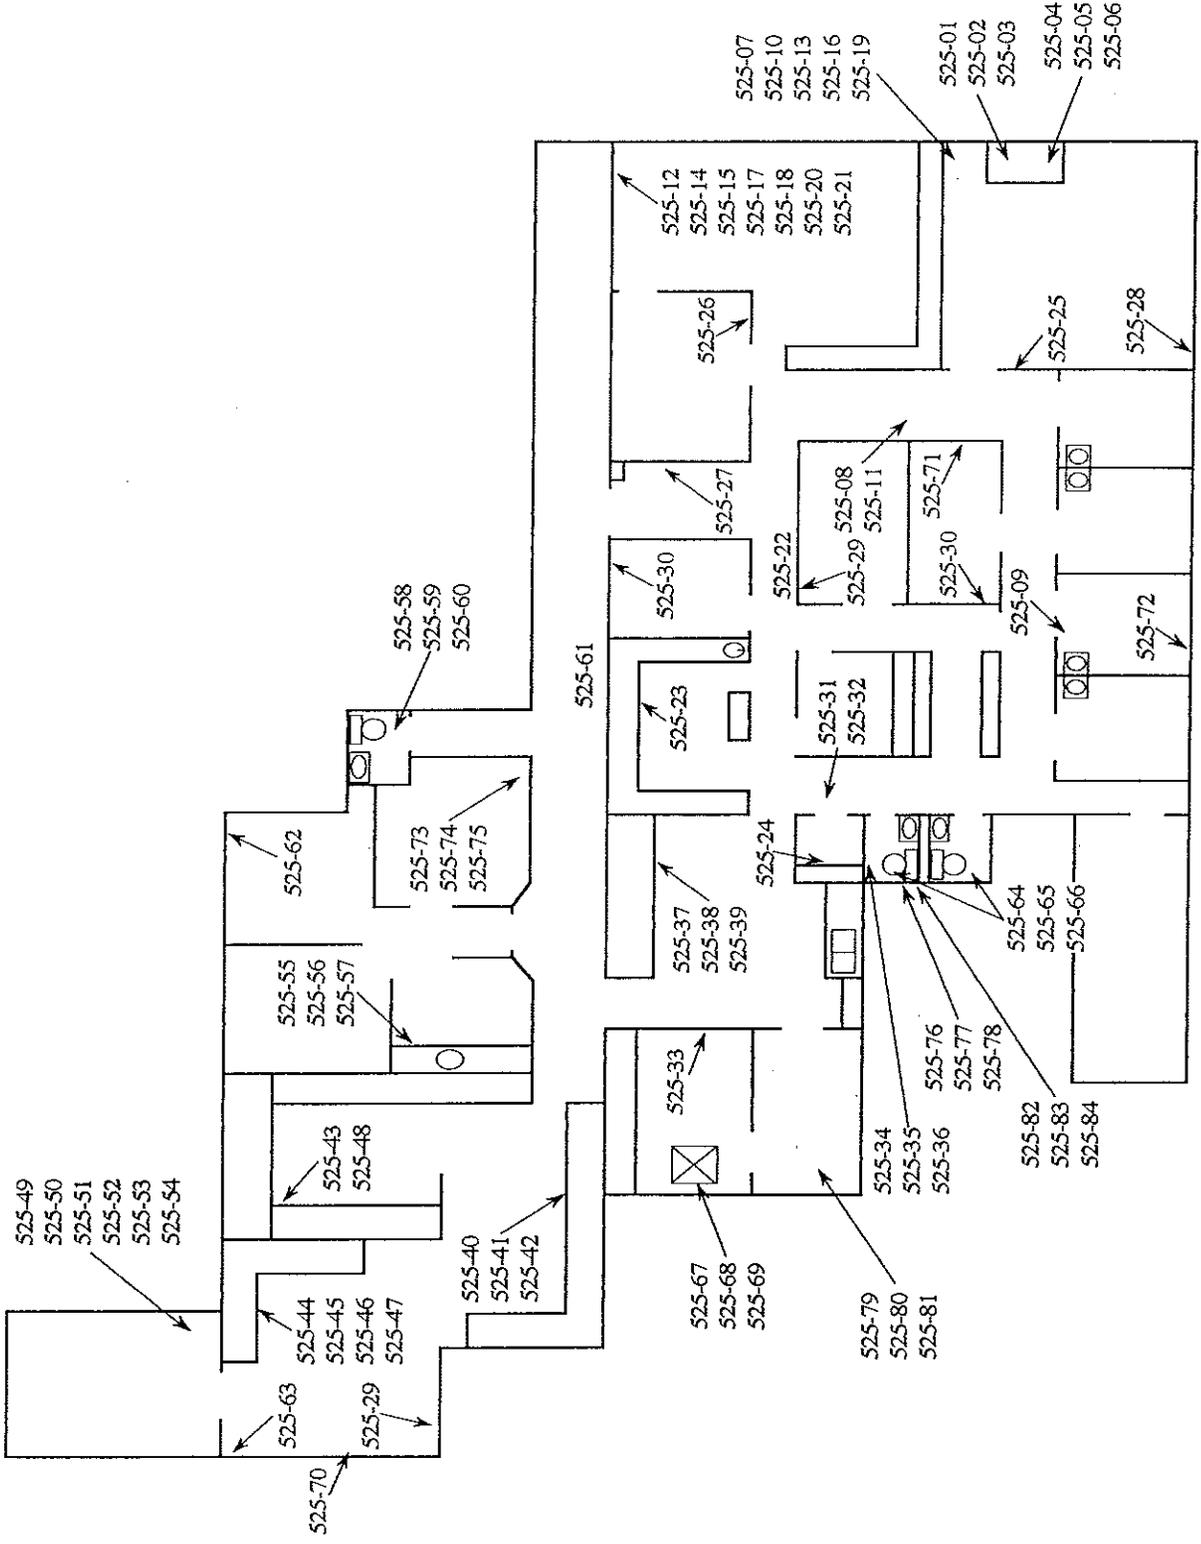
ASBESTOS SAMPLE LOCATIONS
DIAGRAM

Sample #	Material Description	Sample Location	Photo #	Asbestos %
525-77	Roofing Built-up	N. Side of Roof	20	Not Analyzed
525-78	Roofing Built-up	N. Side of Roof	20	Not Analyzed
525-79	Roofing Material (rolled-on)	N. Side of Roof	21	0%
525-80	Roofing Material (rolled-on)	N. Side of Roof	21	0%
525-81	Roofing Material (rolled-on)	N. Side of Roof	21	0%
525-82	Wall Surfacing	N. Side of Bldg. Exterior	22	0%
	Tar	N. Side of Bldg. Exterior	22	25%
525-83	Wall Surfacing	N. Side of Bldg. Exterior	22	0%
525-84	Wall Surfacing	N. Side of Bldg. Exterior	22	0%
	Cement Asbestos Board	Mechanical Room door covering & jam	23	Assumed
	Cement Asbestos Board	Cast Room counter tops	24	Assumed
	Cement Asbestos Board	Central Lab counter tops	25	Assumed
	Thermal Systems Insulation	Throughout	N/A	Assumed
