**Marion County Courthouse Square
555 Court Street NE, Salem Oregon
Remediation Study Final Report
February 07, 2011**

Volume Two of Six

**MARION COUNTY COURTHOUSE SQUARE & BUS MALL
555 COURT STREET NE
SALEM, OREGON**

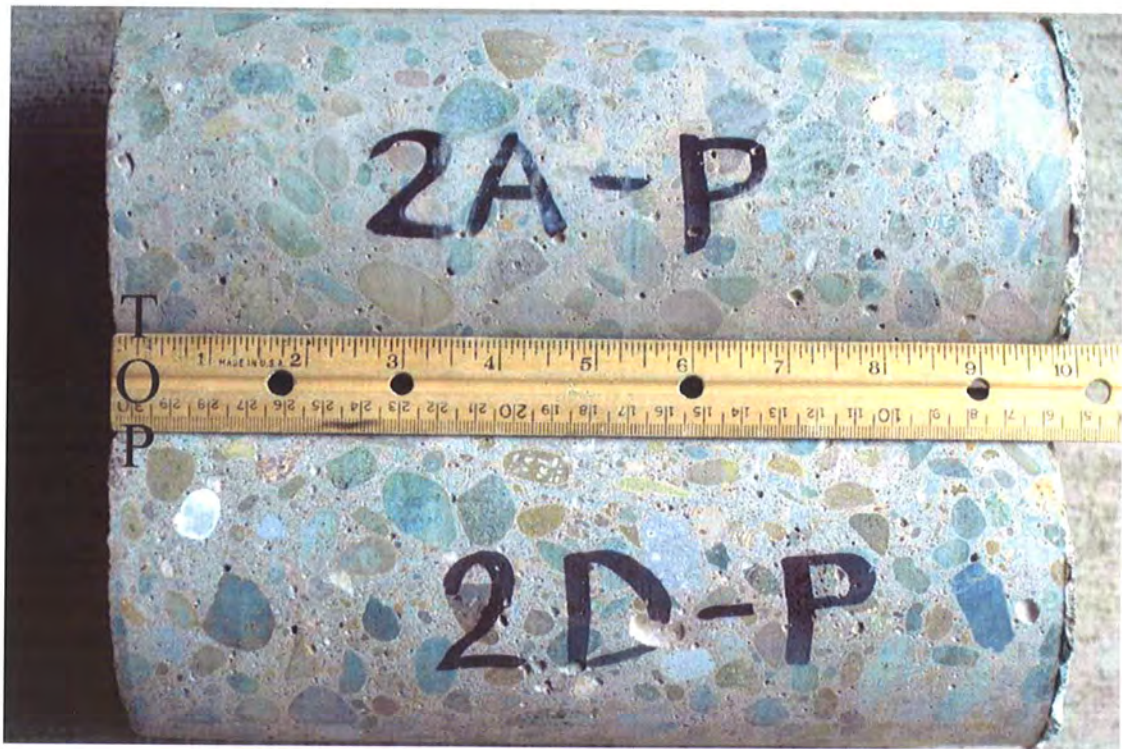
FIGURE 8 Side of 2-P Series cores as received shows aggregate size, shape and distribution and larger voids.

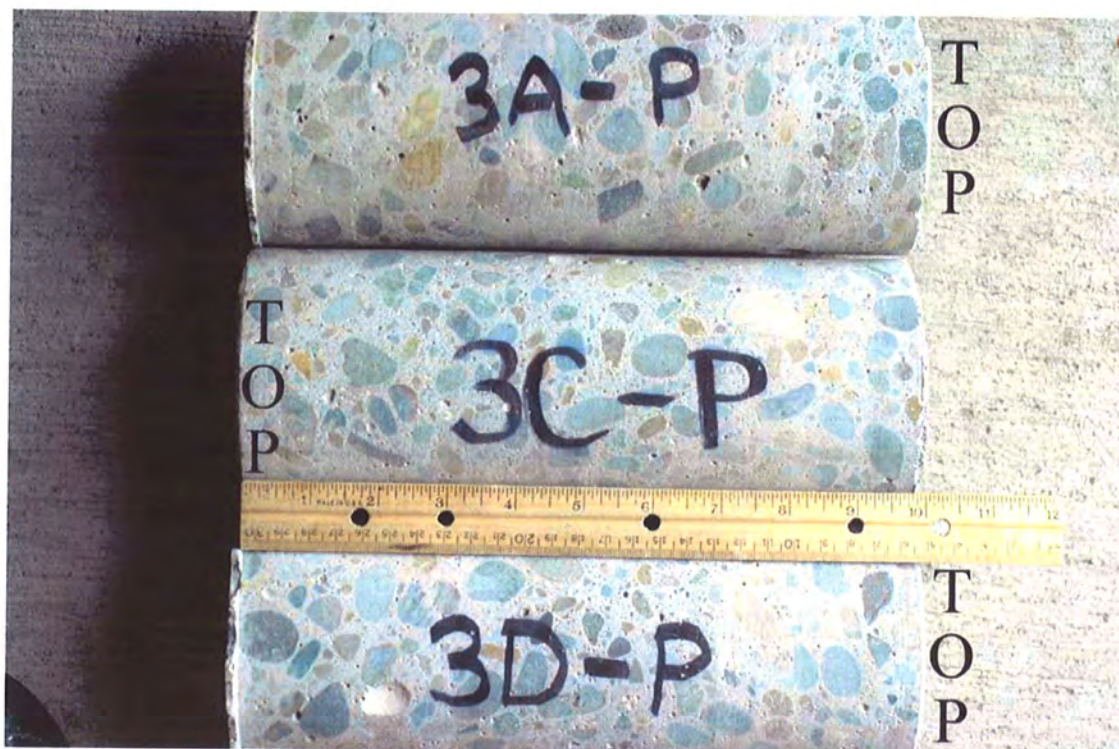
FIGURE 14 Side of 3-P Series cores as received shows aggregate size, shape and distribution and larger voids.

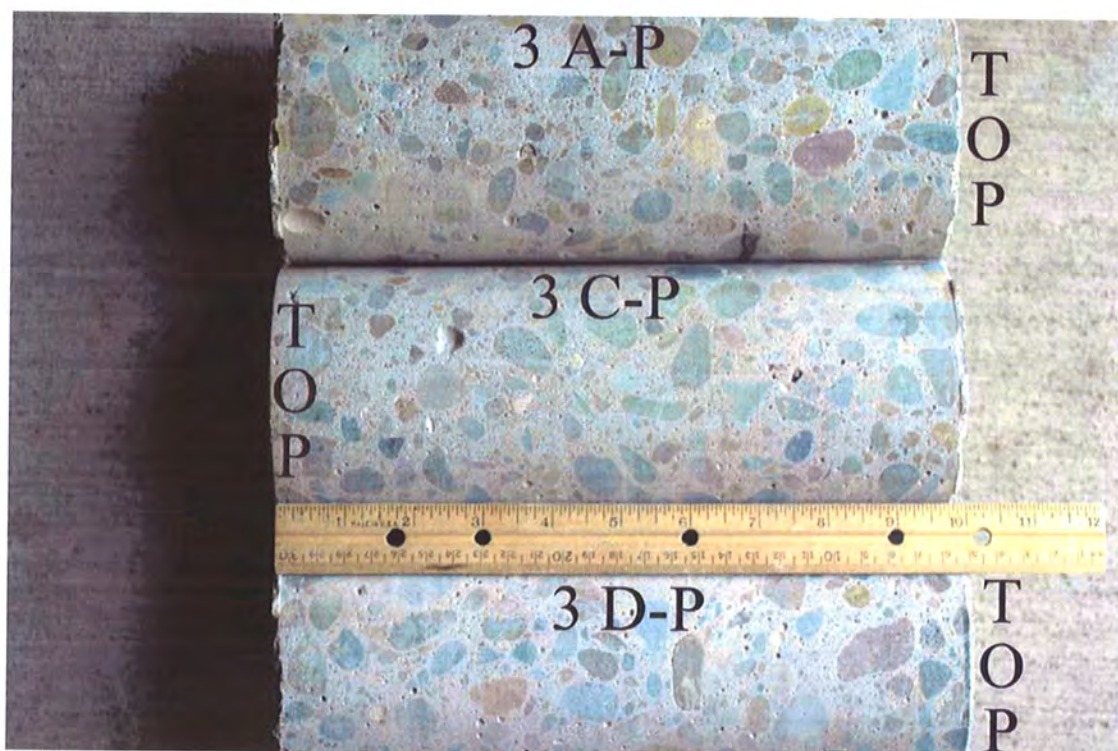
FIGURE 15 Opposite side of 3-P Series cores as received shows similar features.

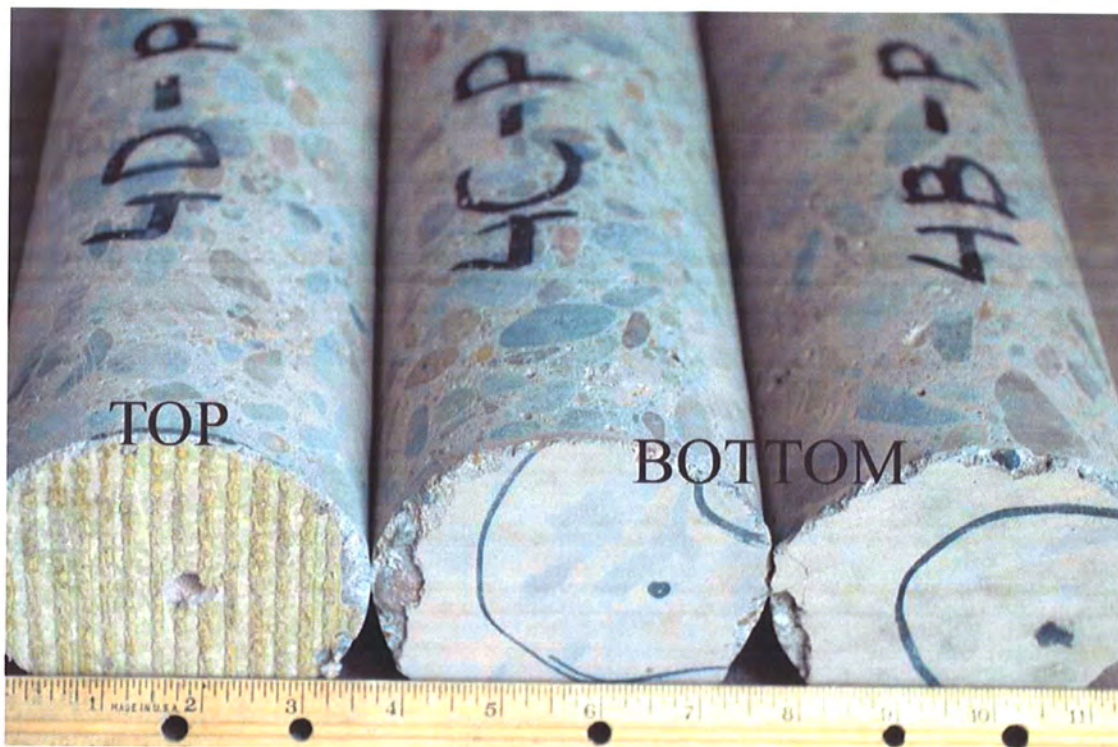
FIGURE 25 Opposite ends of 4-P Series cores as received.

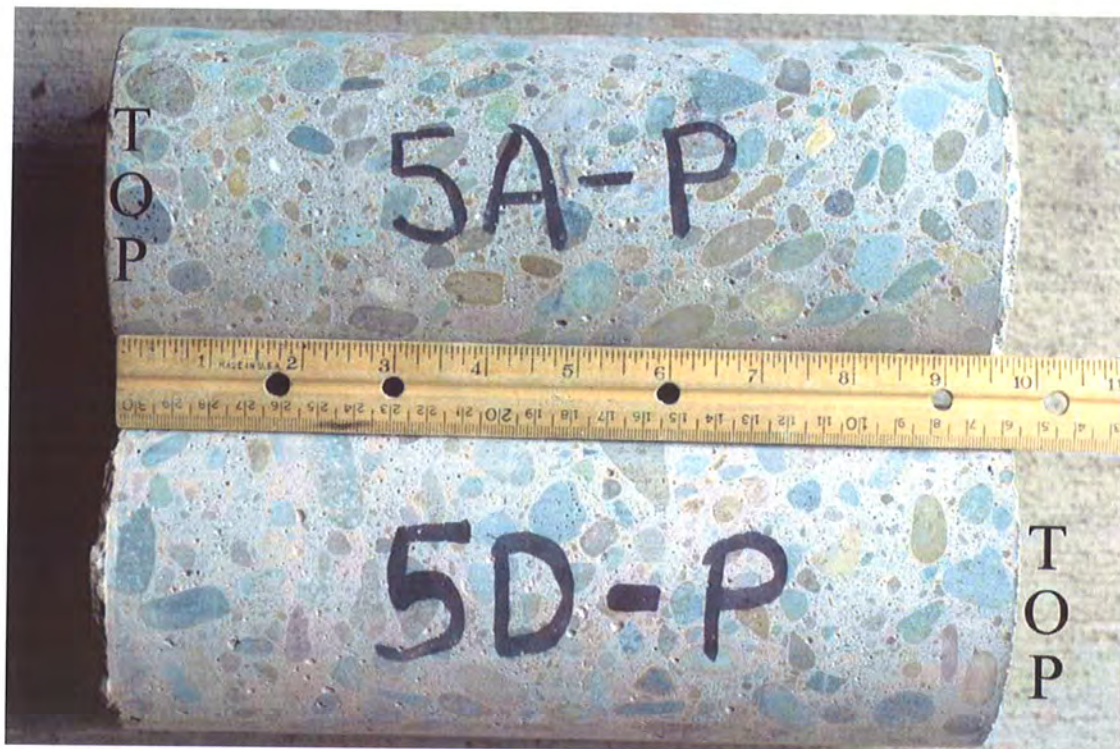
FIGURE 29 Side of 5-P Series cores as received shows aggregate size, shape and distribution and larger voids.

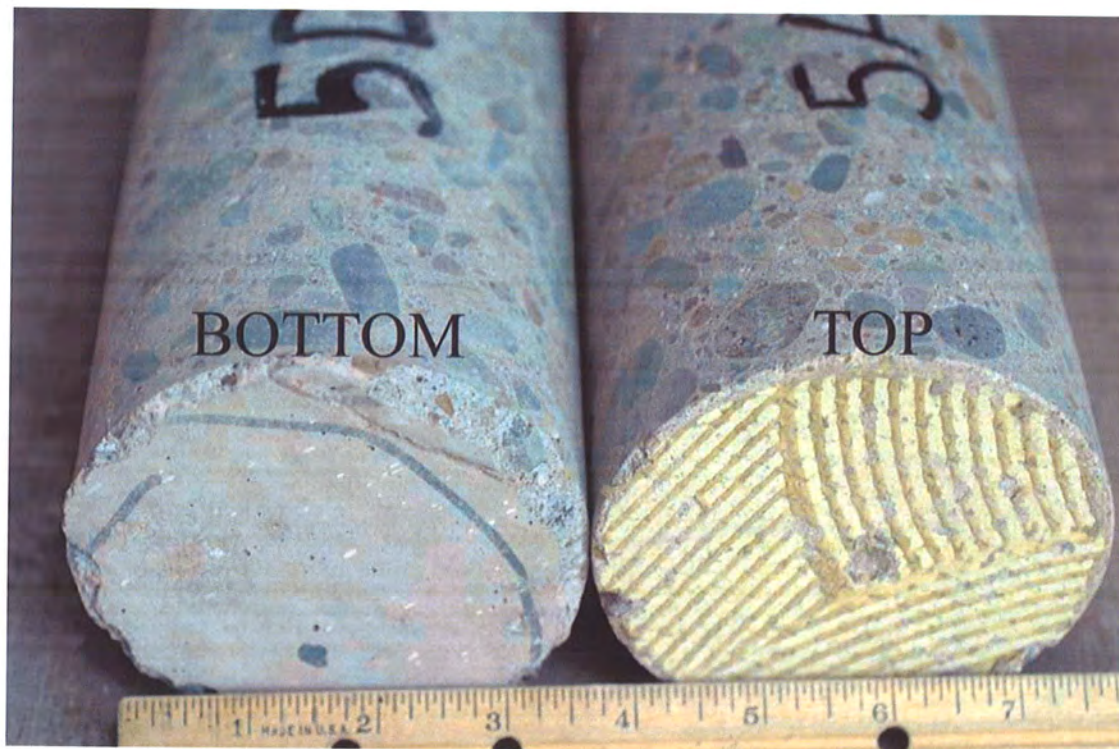
FIGURE 32 Opposite ends of 5-P Series cores as received.

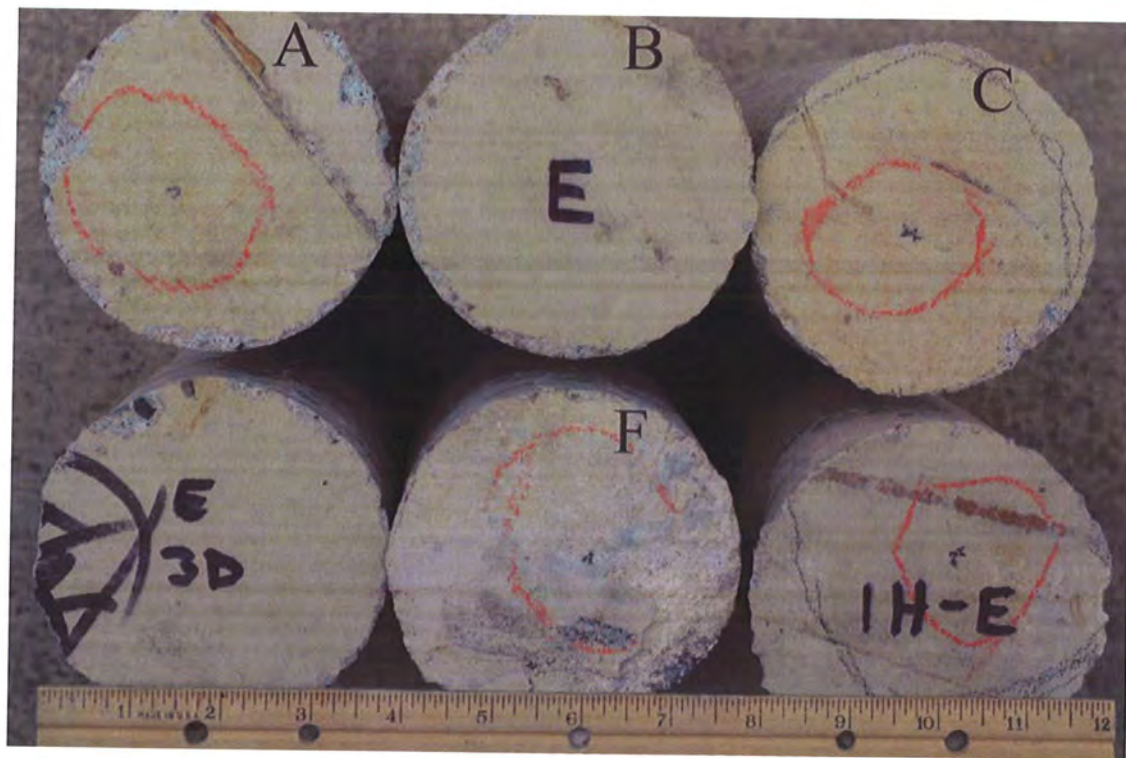
FIGURE 4 Bottoms of cores as received.

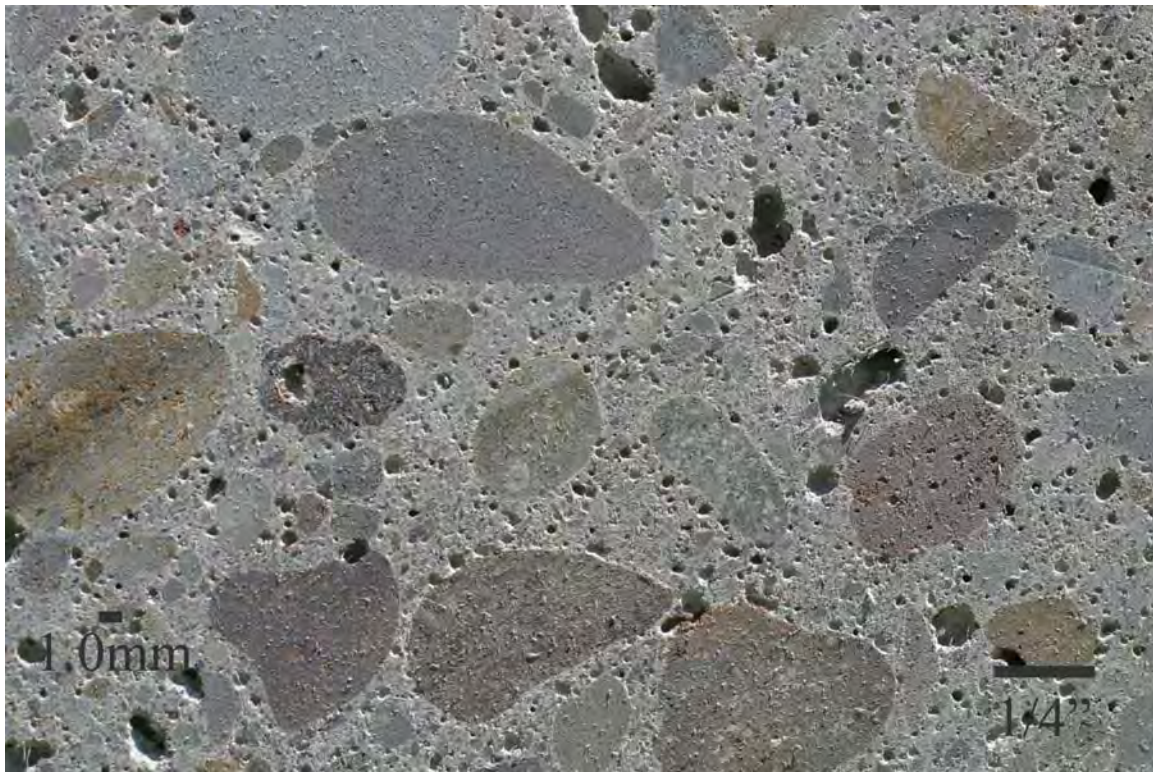
FIGURE 5 Sawed longitudinal surface shows typical appearance of aggregates and air-void system.

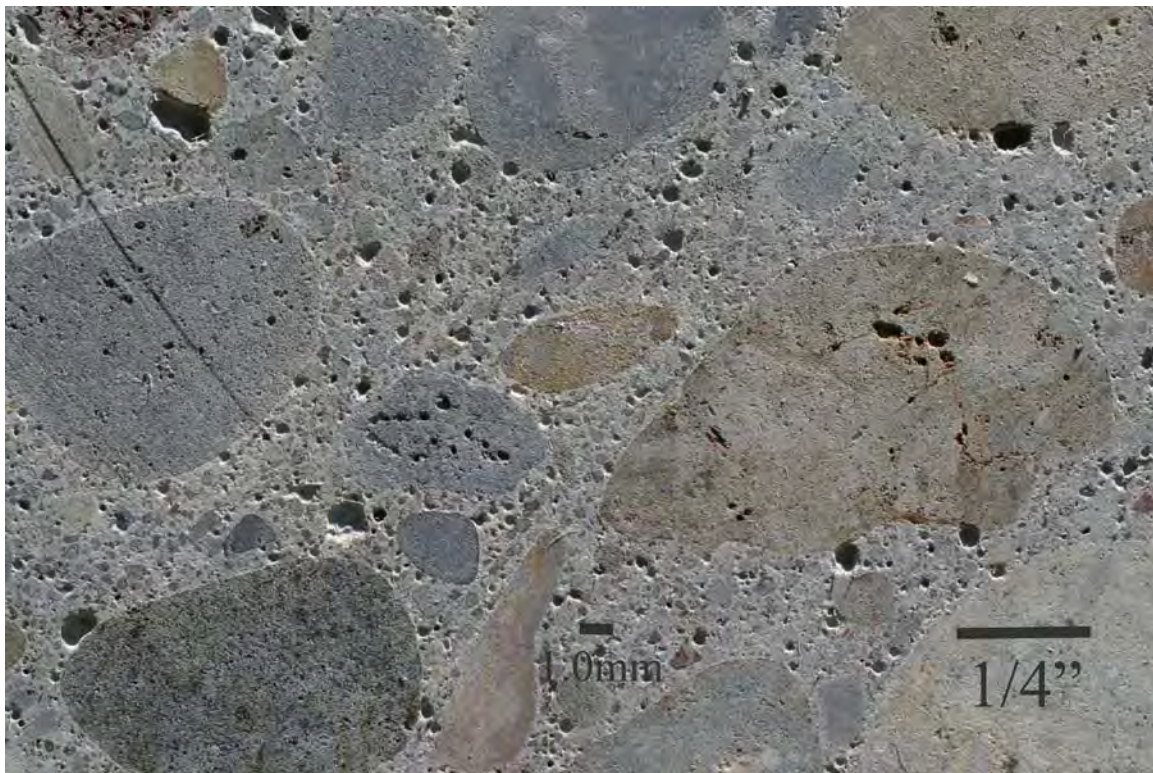
FIGURE 6 Another sawed longitudinal surface shows similar features.

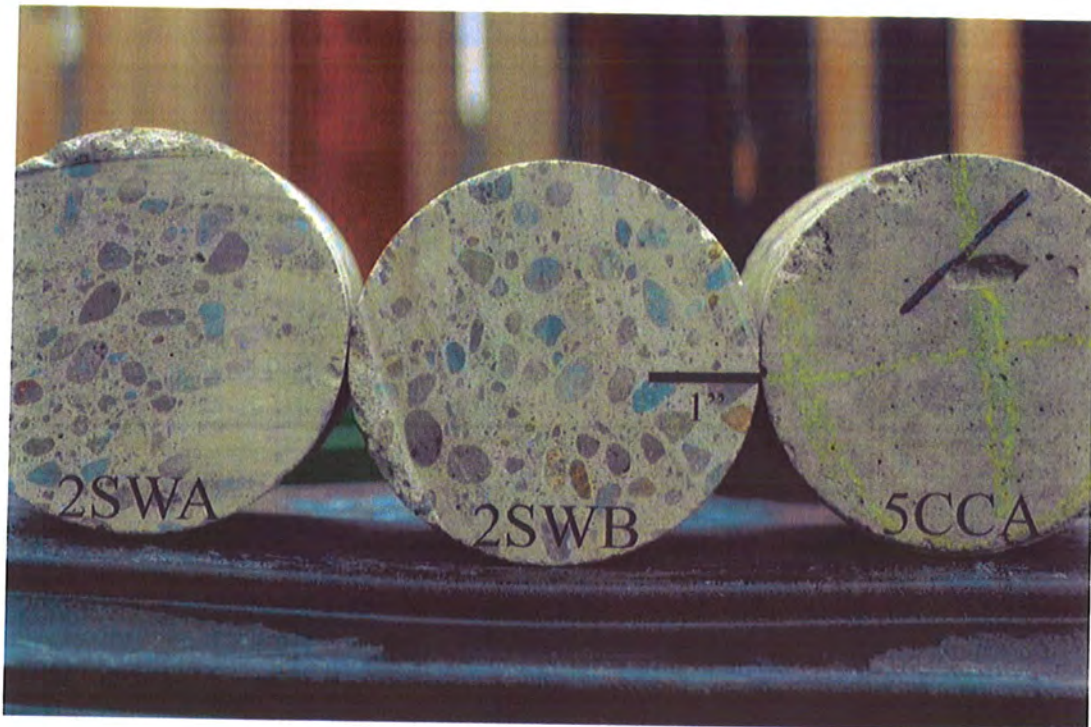
FIGURE 3 Top of cores as received for examination and analysis.

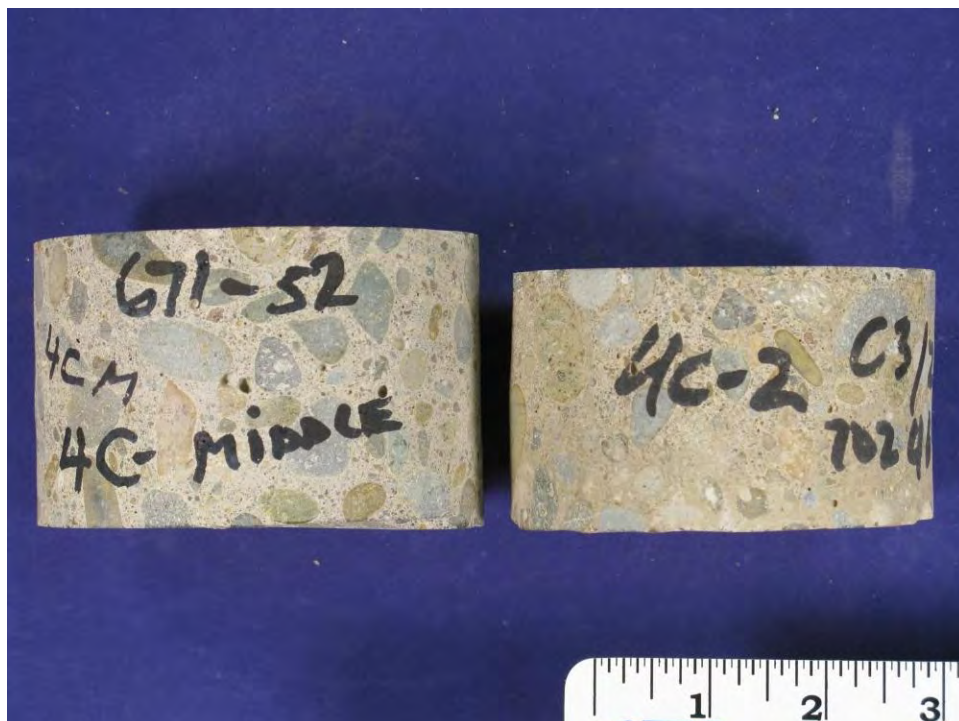
Fig. 3 Cores 4C-MIDDLE and 4C-2 (fourth floor) as received for examination. Scale is marked in inches.

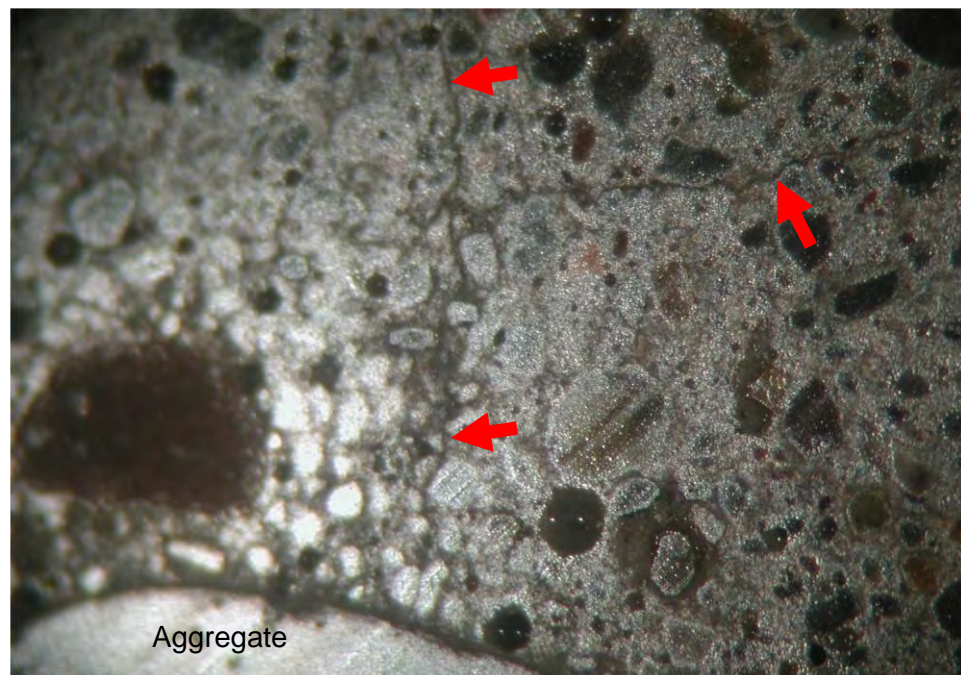
- A hairline crack is observed in Core 3C-MIDDLE near the core top edge, passing around aggregate particles. No other visible cracks are observed in any of the cores. The cores exhibit common to frequent microcracks in the paste between aggregate particles (Fig. 10). A network of interconnected microcracks is locally observed in Core 3C-MIDDLE. Significance and exact cause of these microcracks are not fully revealed. The submitted cores do not exhibit any evidence of external chemical attack or deleterious chemical reactions (such as alkali-aggregate reactions) involving aggregates or any paste constituents of the concrete.

Fig. 10 Stereomicroscope image of a cut and lapped cross-sectional surface of Core 3C-MIDDLE, showing microcracks in the paste between coarse aggregate particles (arrows). The image was taken using oblique illumination shortly after the surface was wetted to highlight the microcracks. Field of view is approximately 0.5 in. across.
