**Marion County Courthouse Square
555 Court Street NE, Salem Oregon
Remediation Study Final Report
February 07, 2011**

Volume Three of Six

Miller Consulting Engineers, Inc.
Structural Photographic Documentation

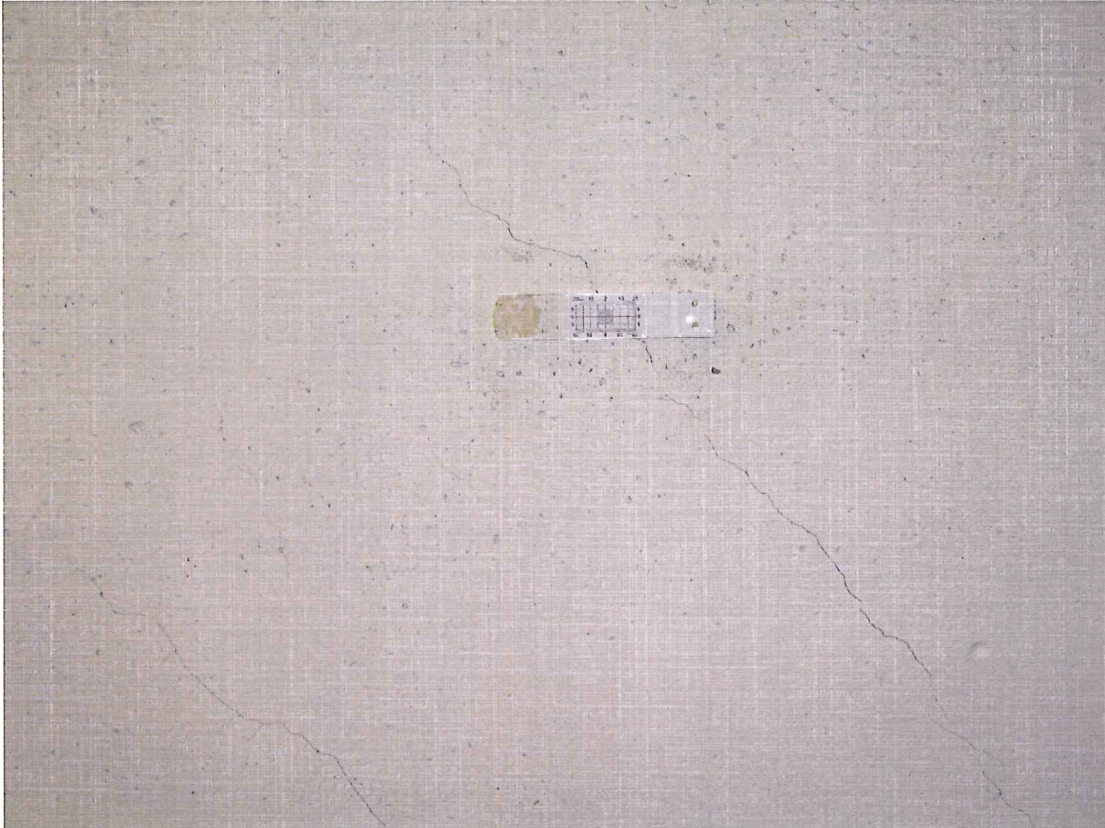
1.3 Building West Stair Tower, Third Floor on North Wall

No Movement
Date: April 14, 2010

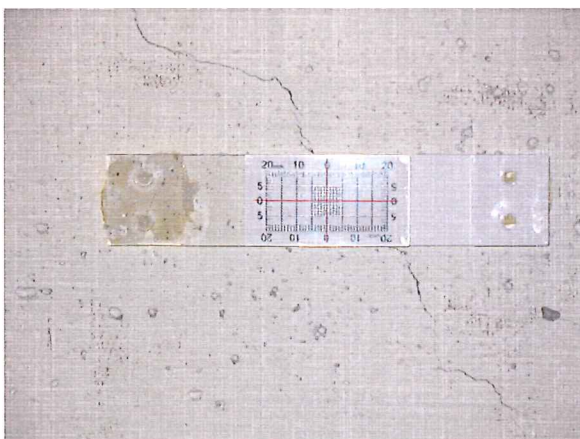
No Movement
Date: October 13, 2010

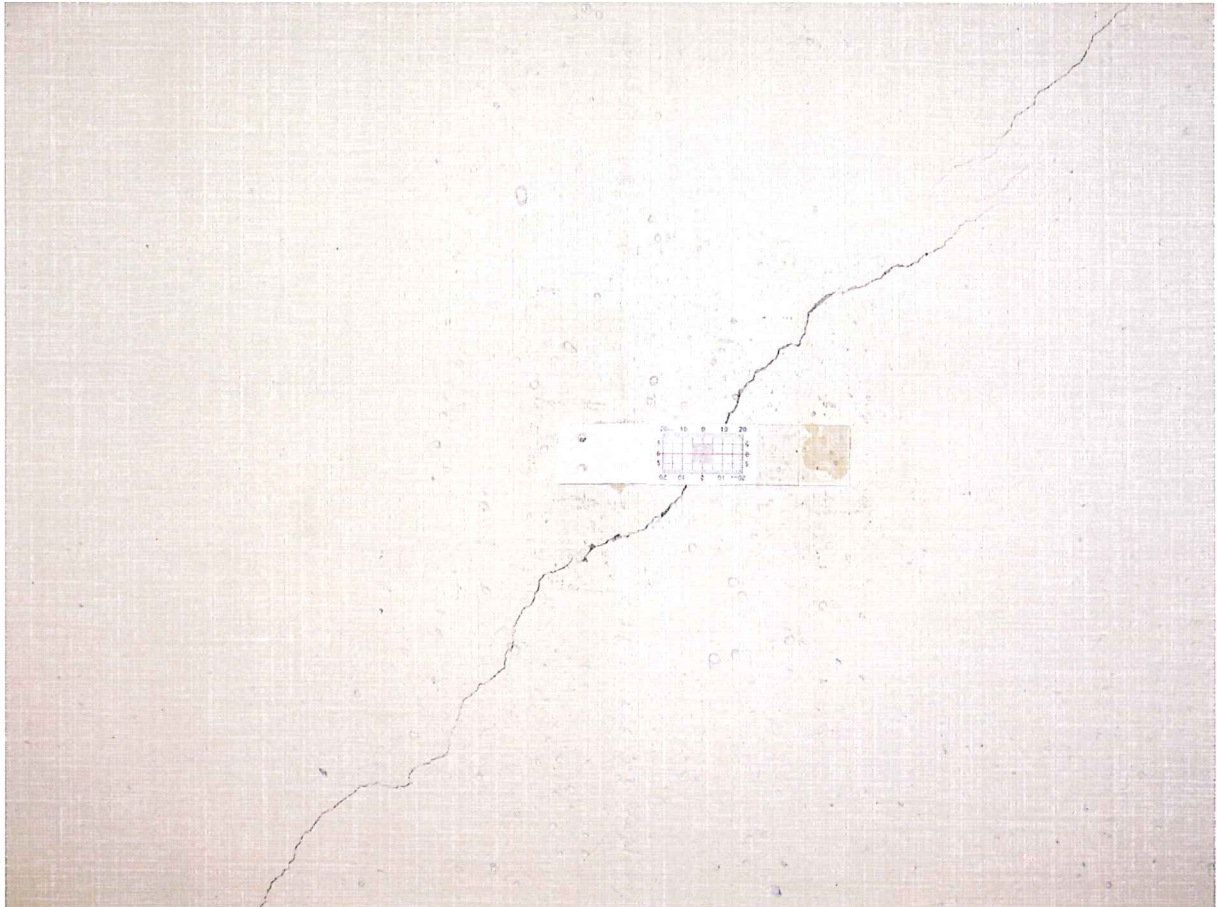
1.5 Building East Stair Tower, Fifth Floor on South Wall

No Movement
Date April 14, 2010

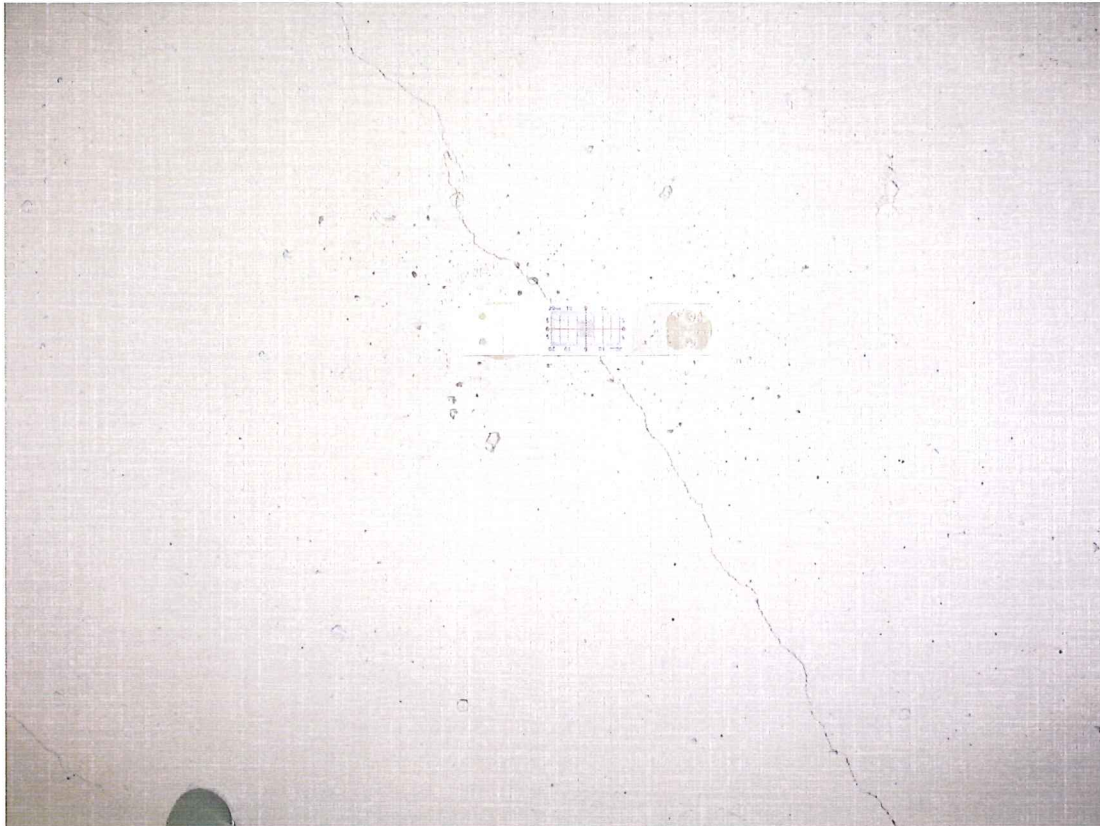
1.6 Building East Stair Tower, Third Floor on South Wall

Movement on Bottom Hash toward the West
Date: April 14, 2010

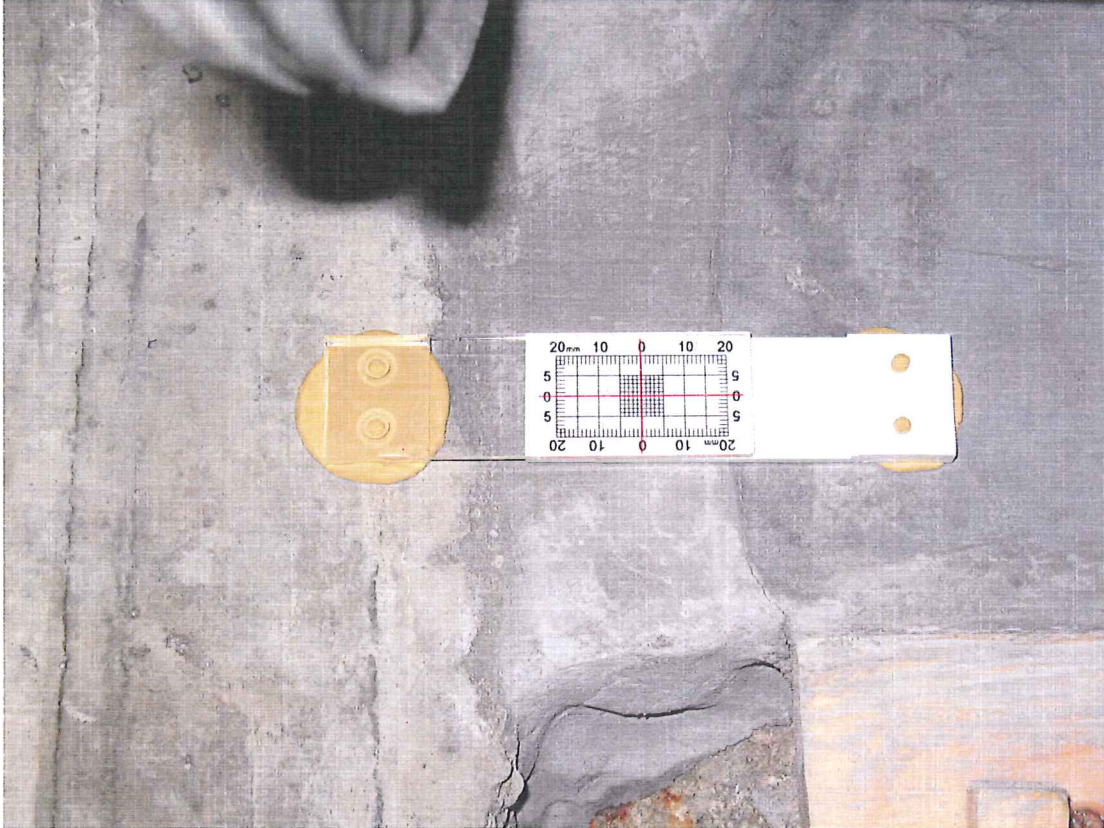
1.9 East Basement (Grid O-10)

Movement of Top Hash toward the North
Date: October 13, 2010

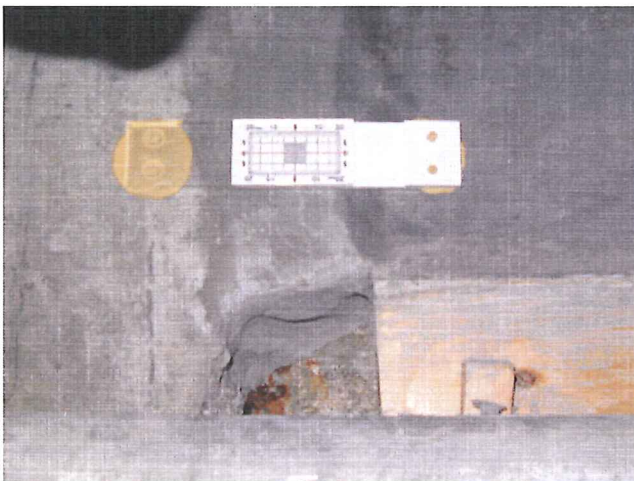
Initial Crack Gauge Installation
Date: June 3, 2010

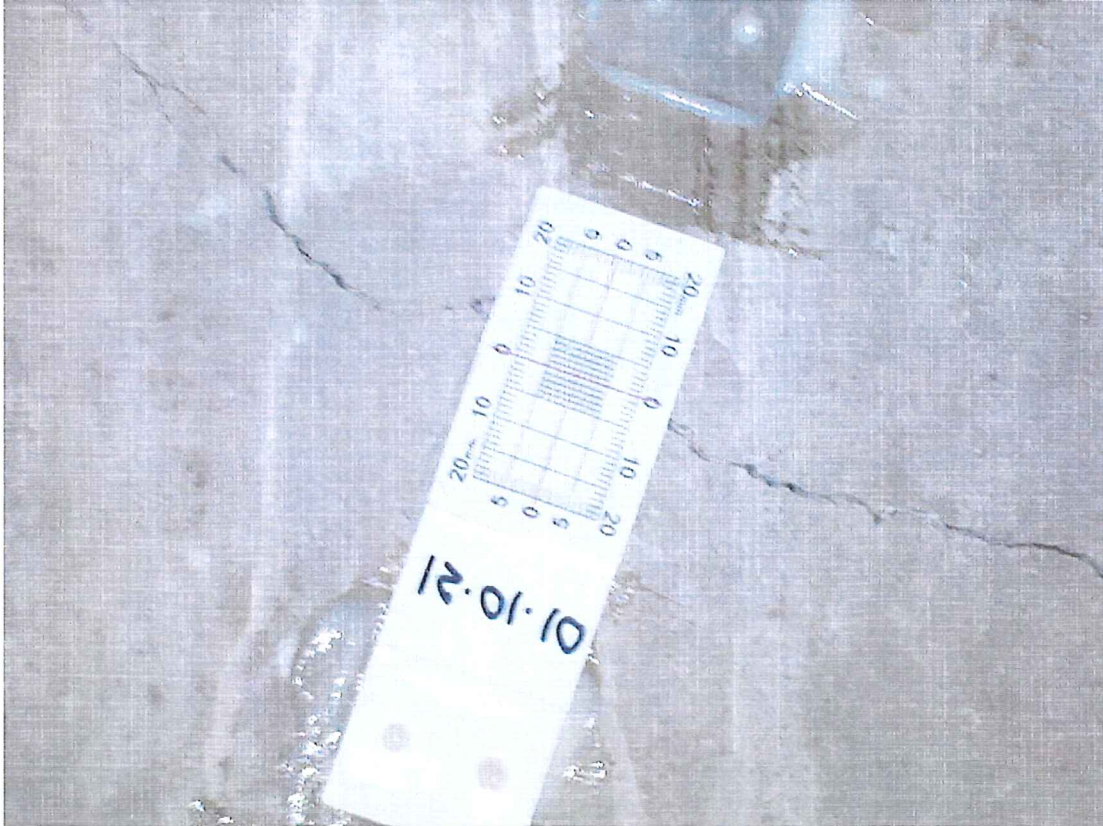
1.11 Column at Grid N-10 (North Face)

**Movement of Top Hash .01 mm to the east
Date: December 22, 2010**

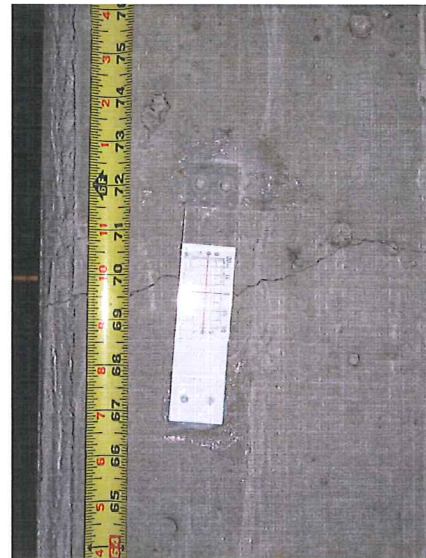
**Initial Crack Gauge Installation
Date: December 1, 2010**

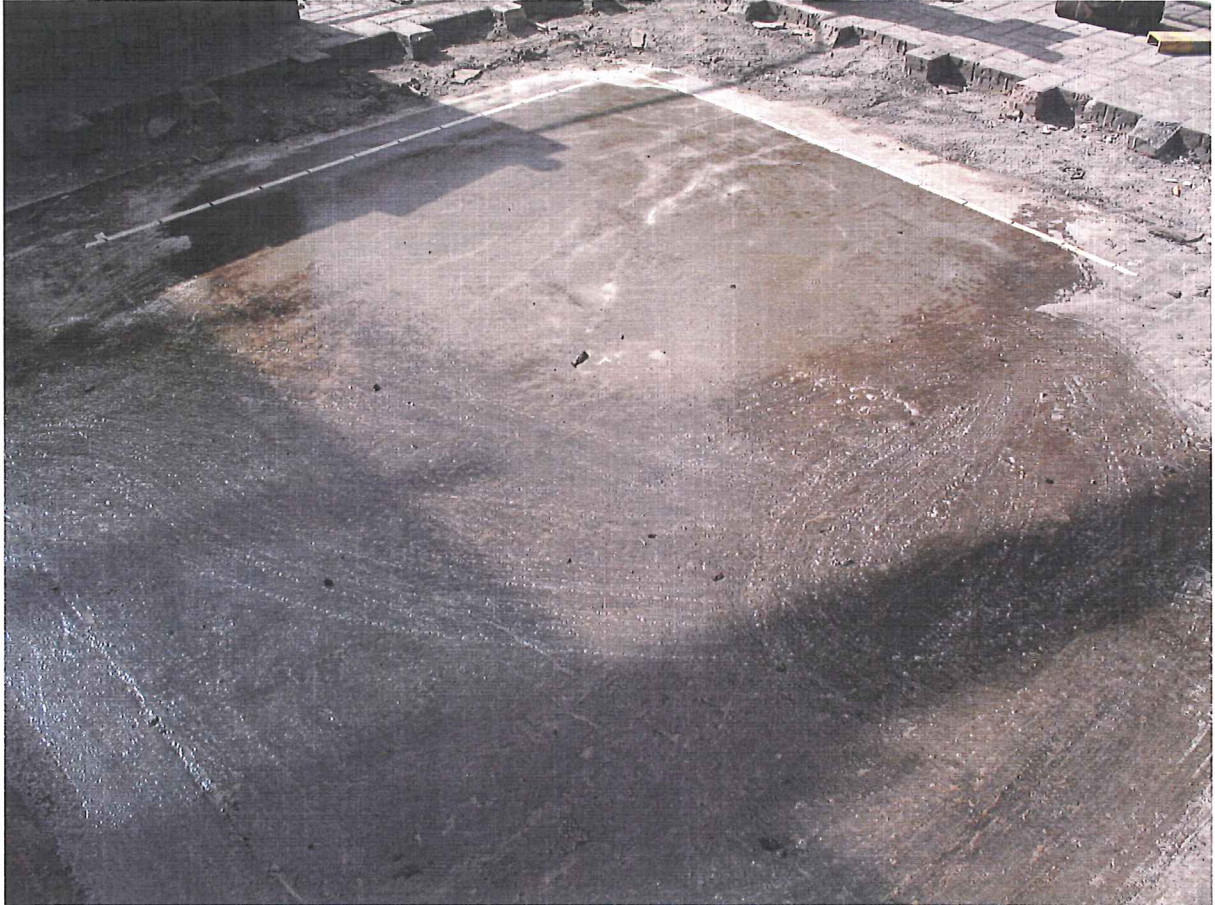
2.1 Evaluation Location #1 (Grid M-8)

Bus Mall Punching Shear Location Grid M-8
Date: June 30, 2010

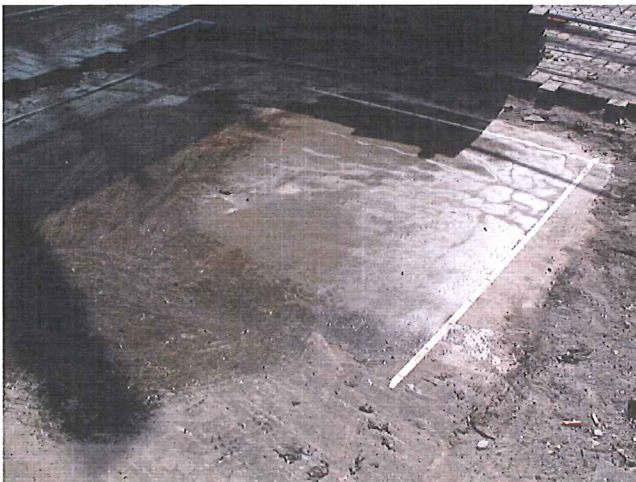
Bus Mall Punching Shear Location Grid M-8
Date: June 30, 2010

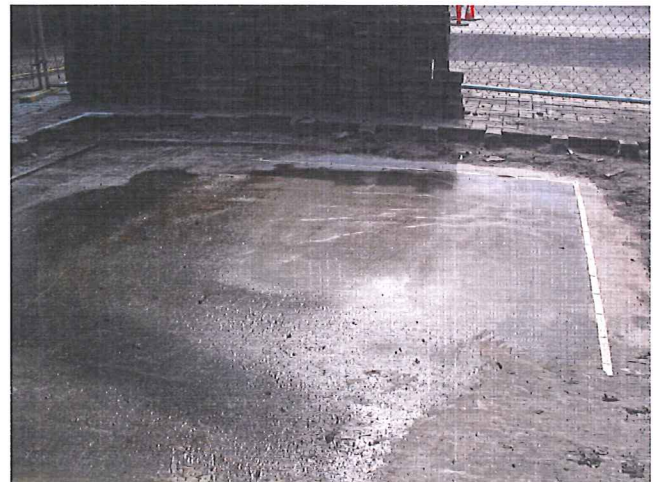
Bus Mall Punching Shear Location Grid M-8
Date: June 30, 2010

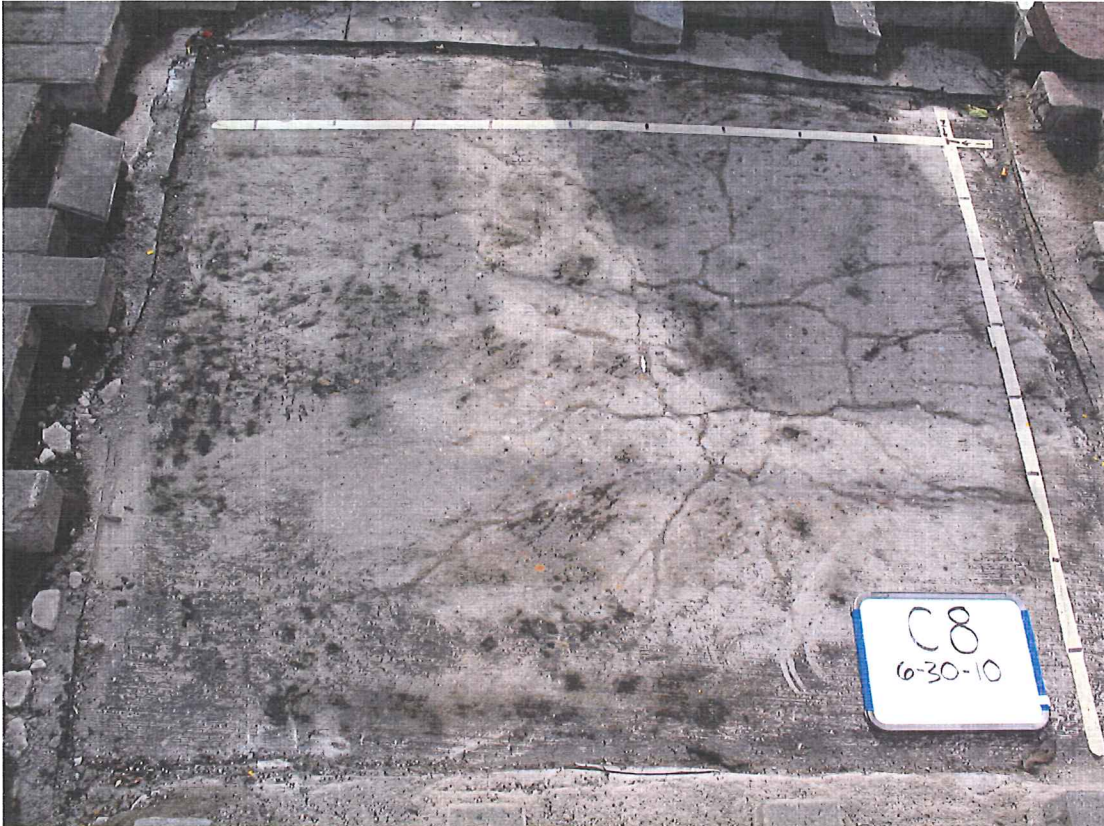
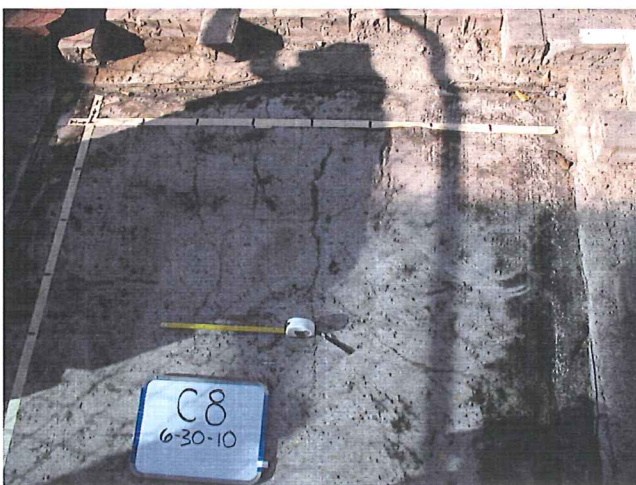
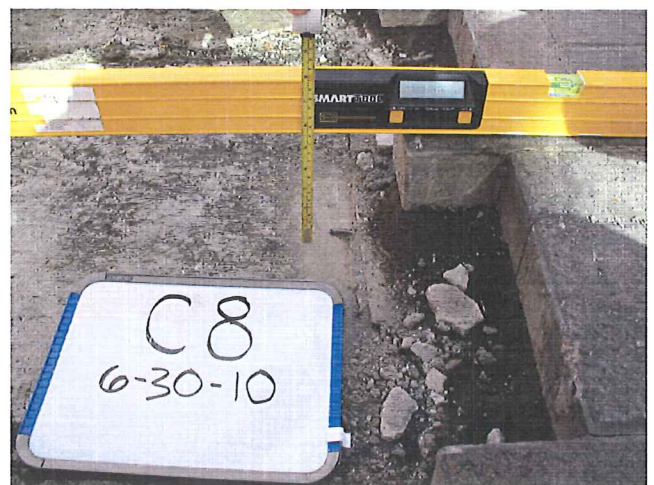
2.2 Evaluation Location #2 (Grid C-8)

Bus Mall Punching Shear Location C-8
Date: June 30, 2010

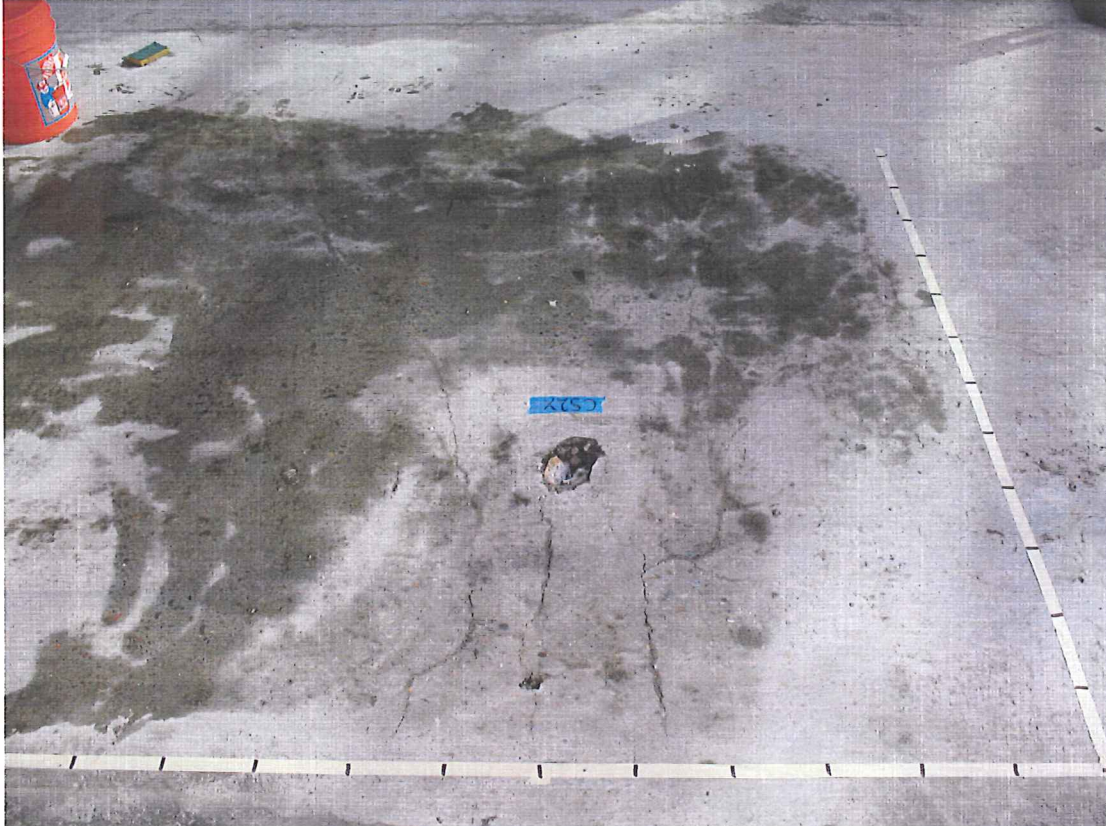
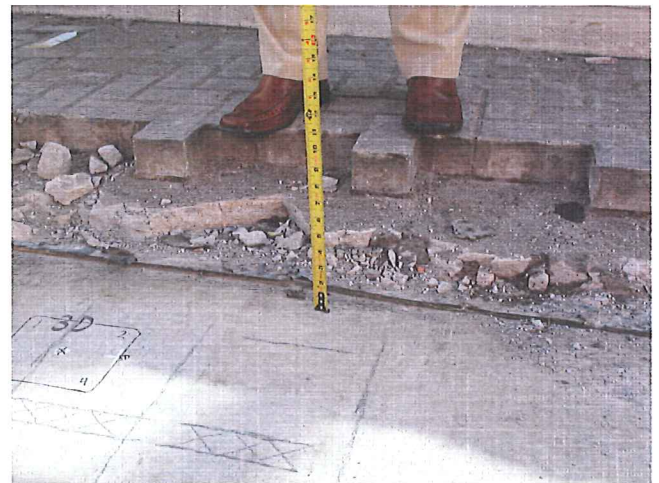
2.3 Evaluation Location #3 (Grid E-8)

Bus Mall Punching Shear Location E-8
Date: June 30, 2010

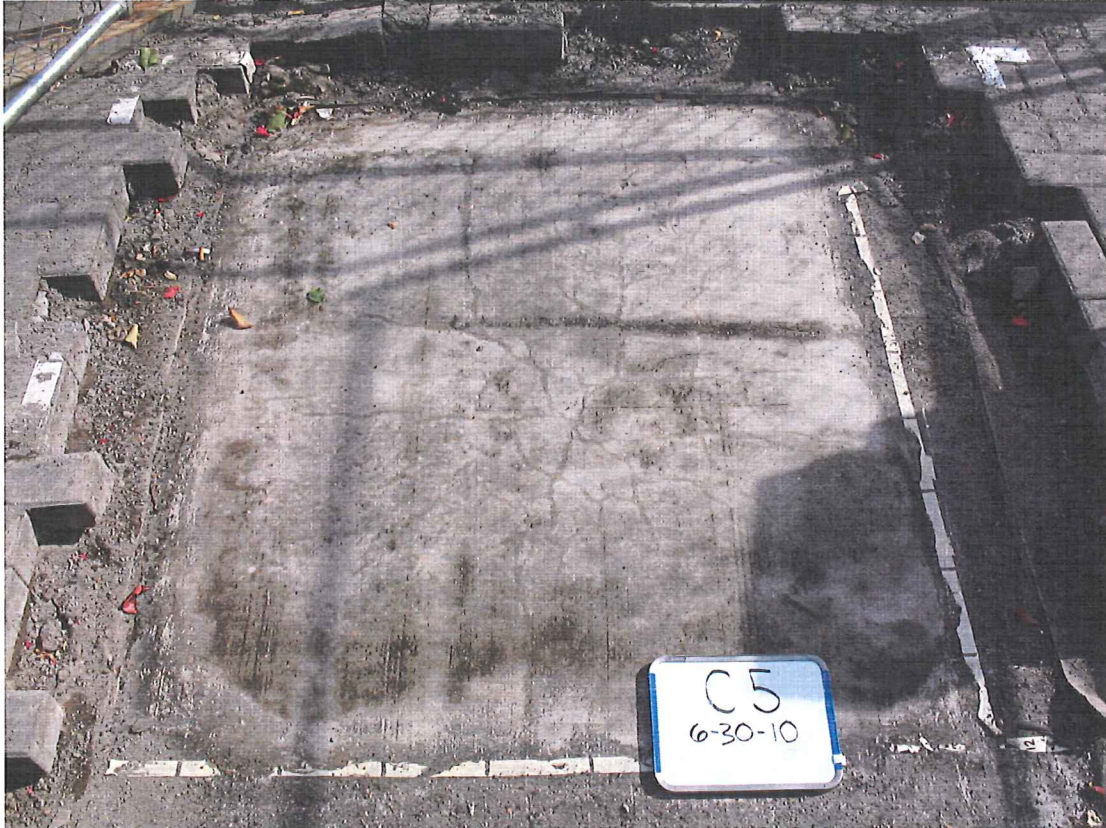
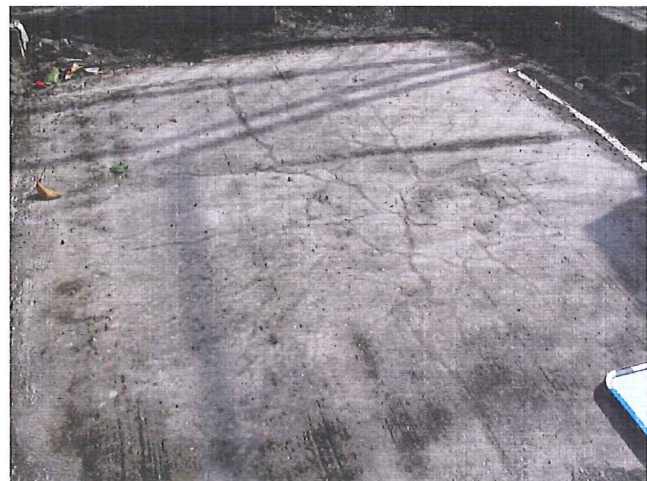
2.4 Evaluation Location #4 (Grid C-5)

Bus Mall Punching Shear Location C-5
Date: June 30, 2010

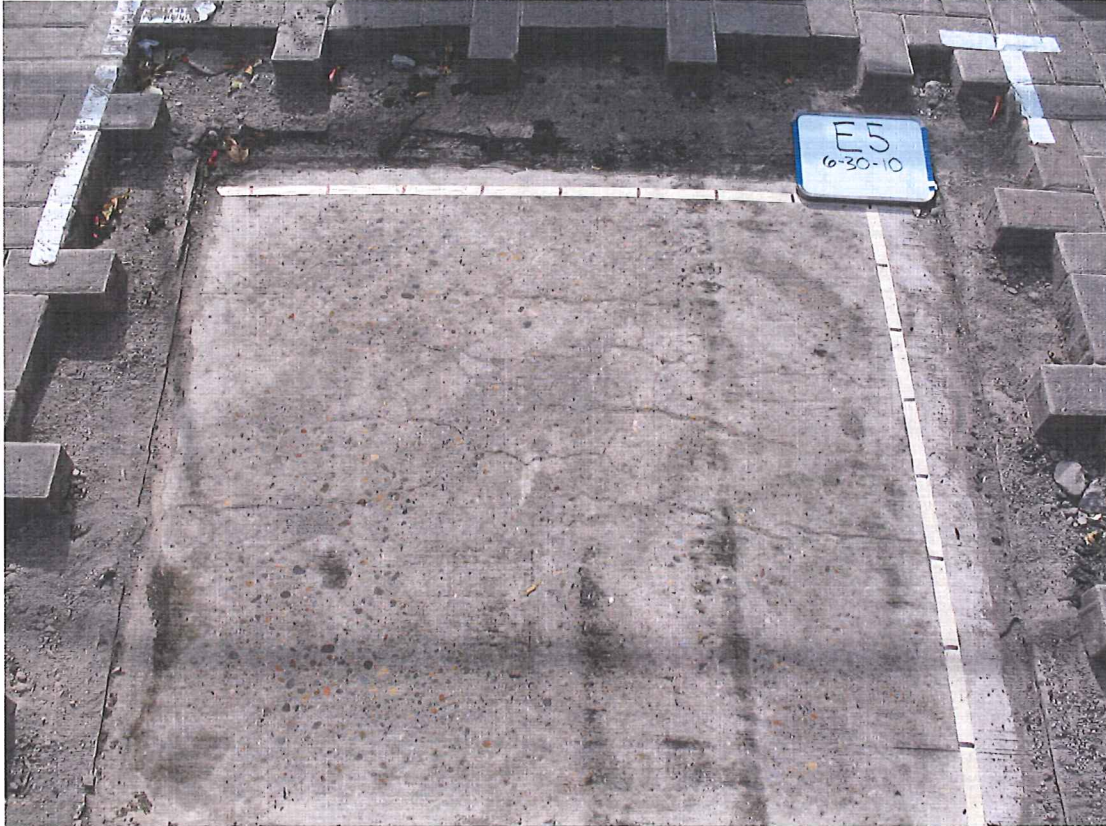
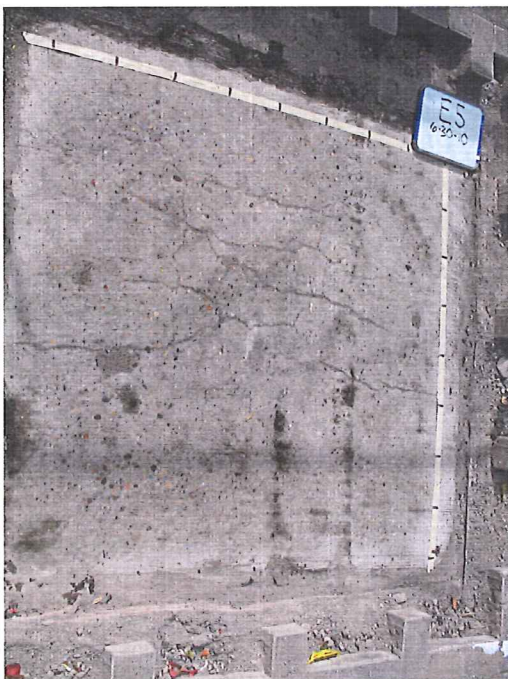
2.5 Evaluation Location #5 (Grid E-5)

Bus Mall Punching Shear Location E-5
Date: June 30, 2010

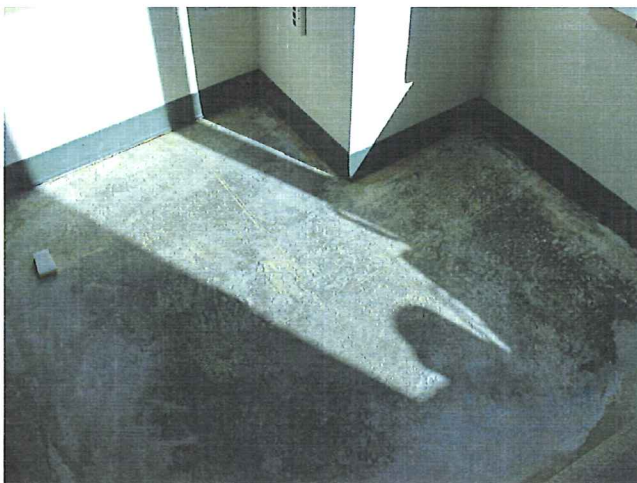
Level 5, Grid C-10
Date: July 24, 2010

1. Typically observed diagonal cracking across the corner at corner columns.
2. Additional cracking was observed beyond the column parallel with the slab edge on each side.

Cracks are highlighted for ease of viewing.

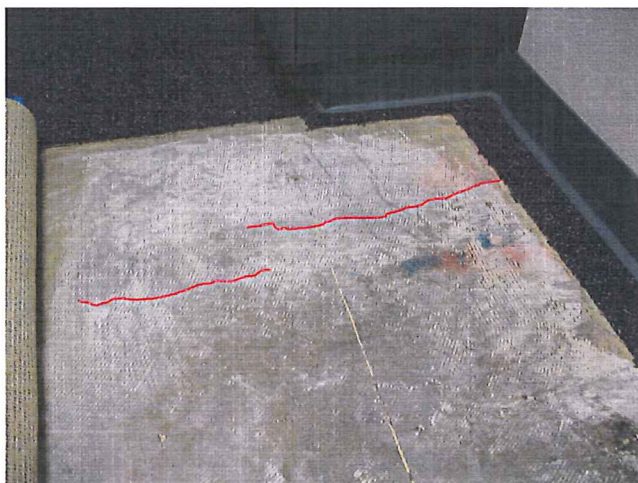
Level 4, Grid L-12
Date: July 24, 2010

1. At the interior columns, cracking was observed in the north-south direction.

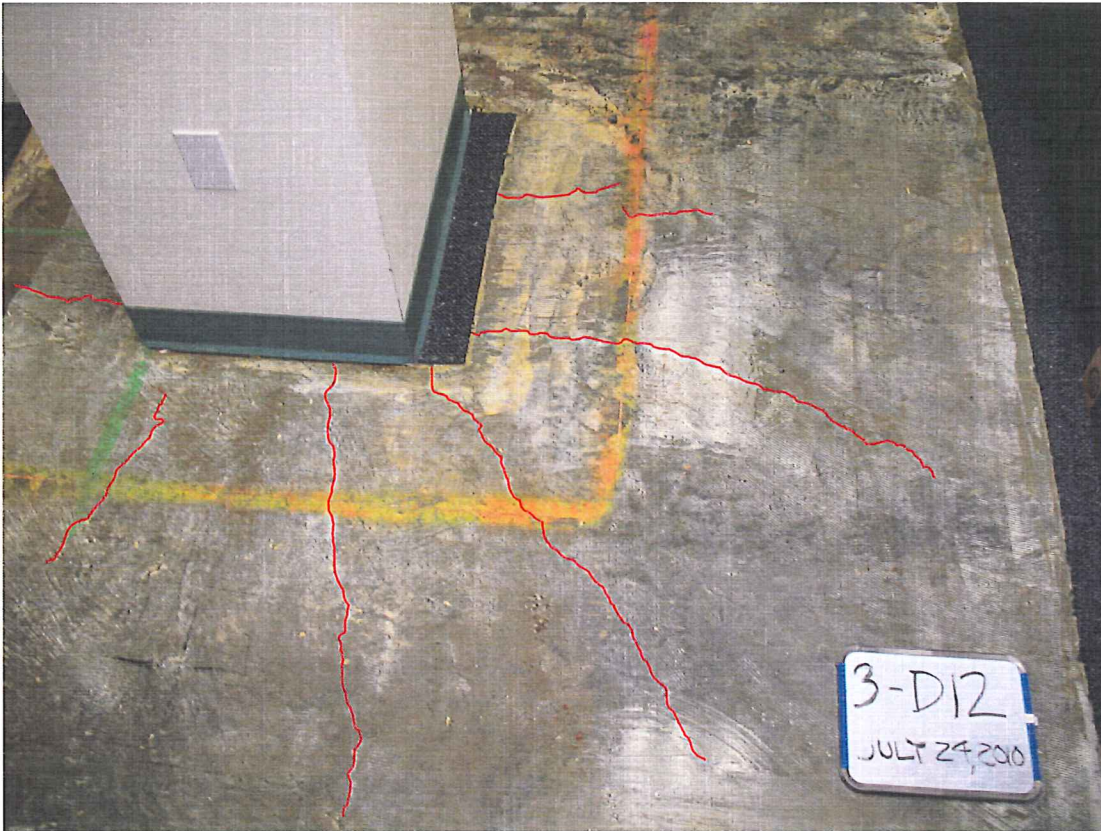
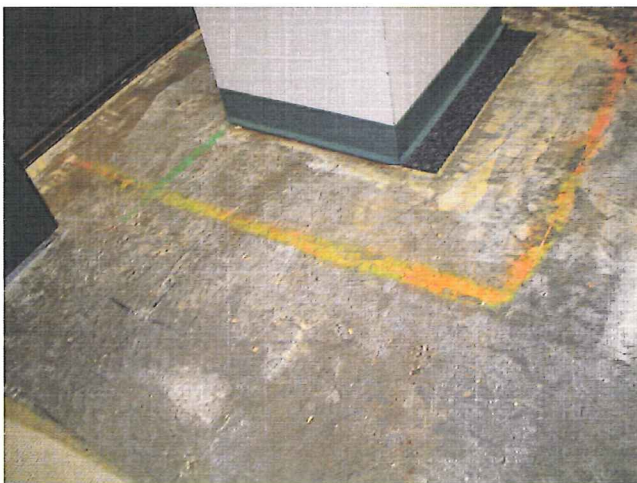
Level 3, Grid D-12
Date: July 24, 2010

1. At Grid D-12 approximately a dozen diagonal cracks were observed emanating from the column in all directions.

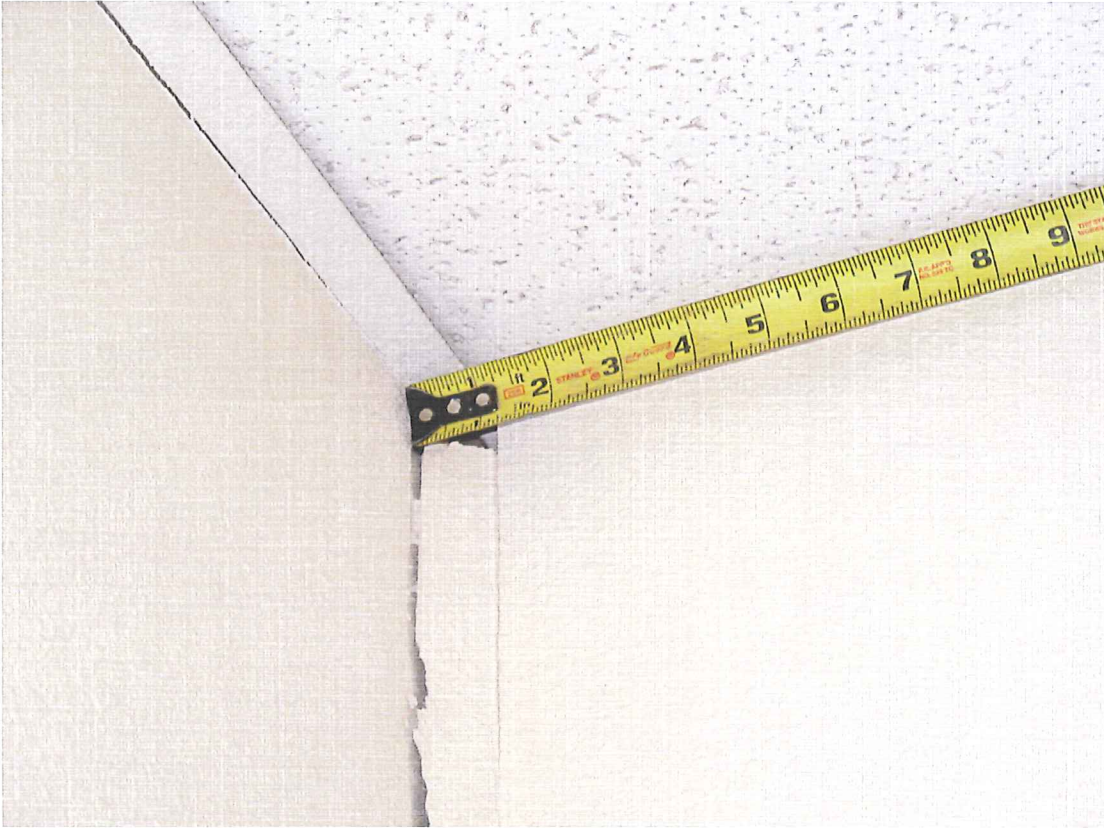
Interior partition walls pulling away from exterior wall with up to 1¼ inch movement measured on the fifth floor

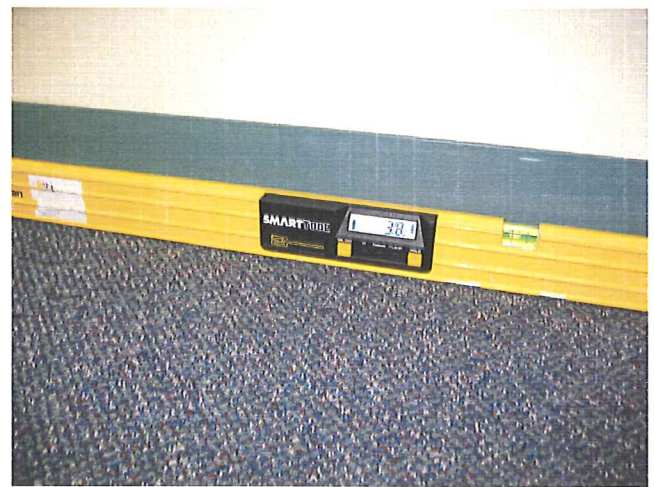
Sloping floors with up to 3/8" per 4 feet measured on the fifth floor

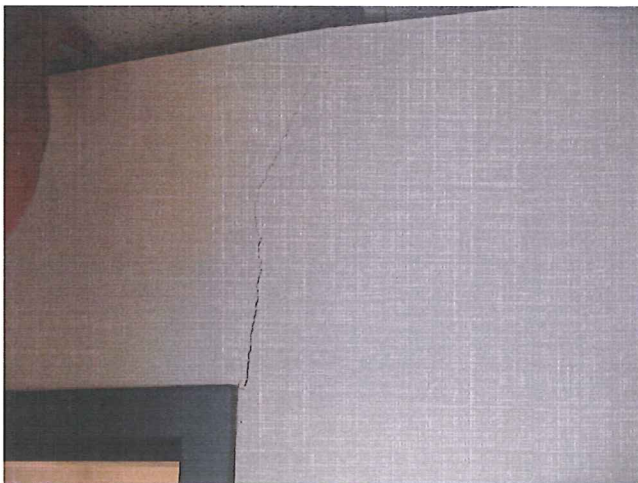
**Racking of door frames and cracking of the wall finish
Date: April 14, 2010**

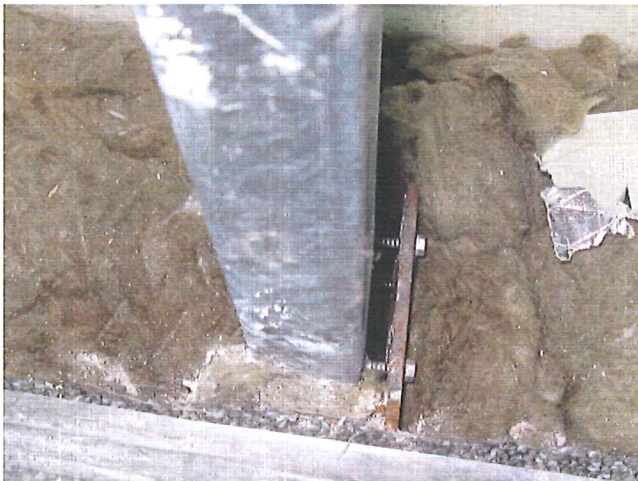
Separation between the exterior structural light gauge steel stud and connection plate
Date: June 3, 2010

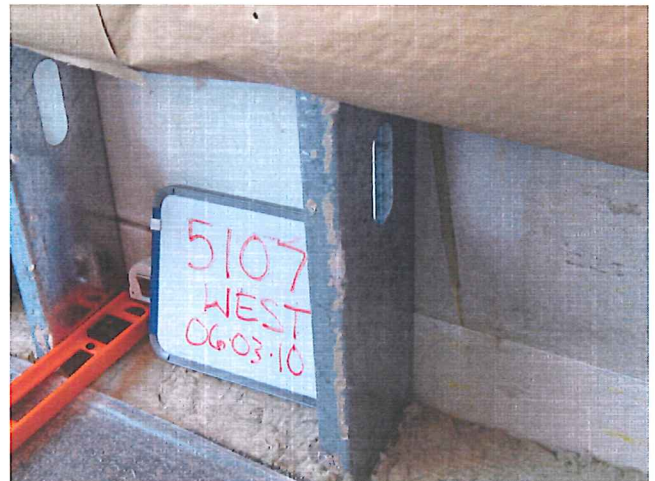
Twisting of the exterior structural light gauge steel studs
Date: June 3, 2010

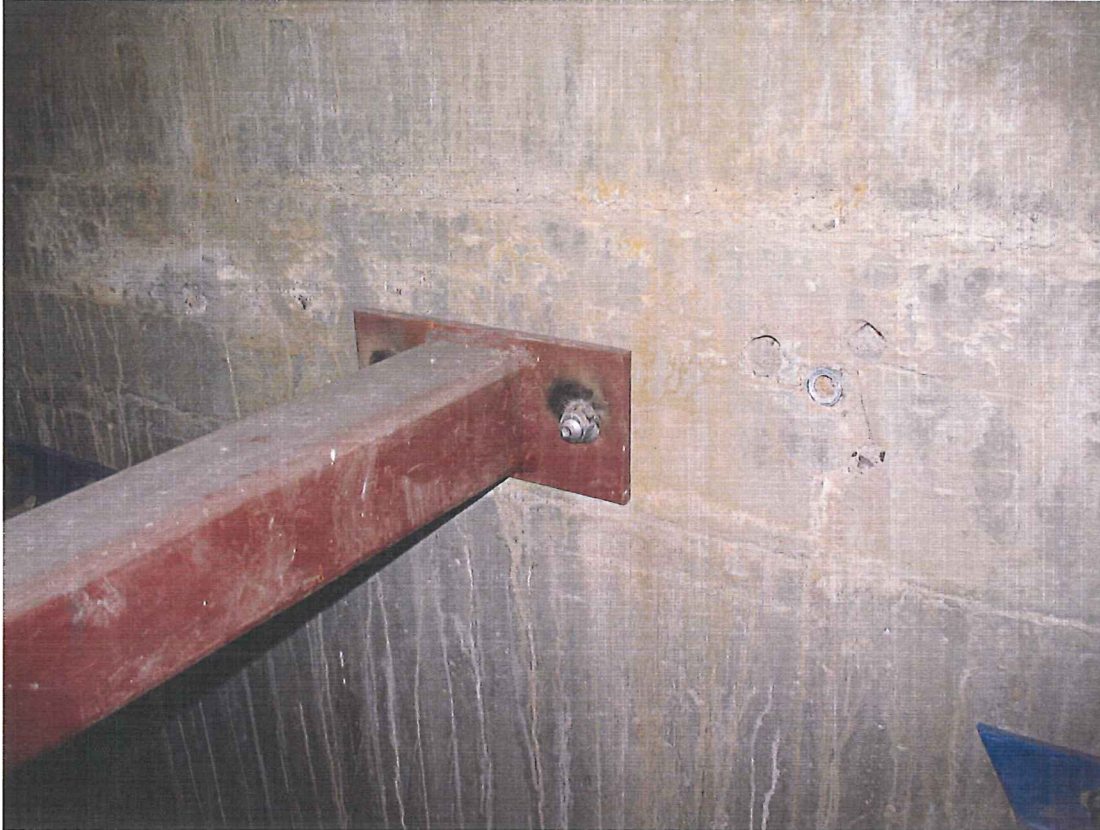
Elevator Hoistway – Stabilizing bar installation at floor slab (excess drop-in anchors visible to the left)
Date: April 14, 2010

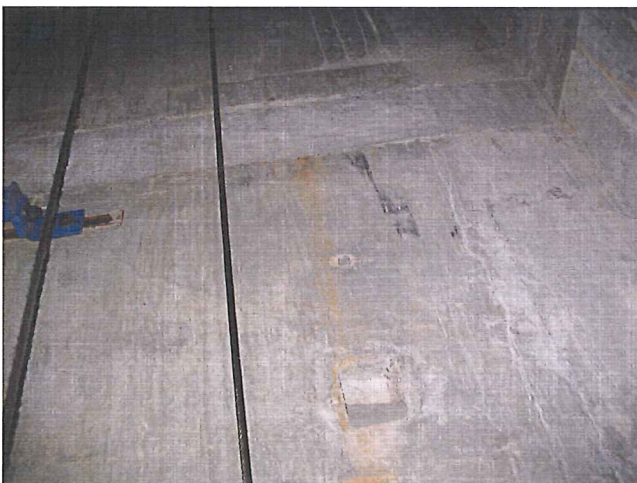
Elevator Hoistway – Diagonal crack near a floor slab
Date: April 14, 2010

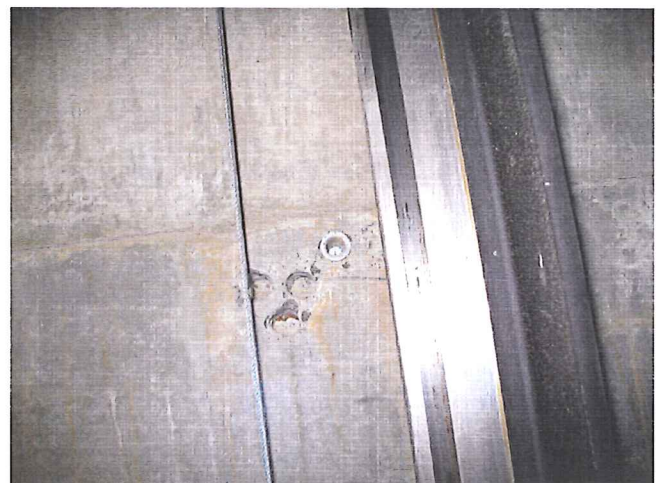
**Elevator Hoistway – Installation of a drop-in anchor
(Reinforcement is visible as a result of previous anchor
installation attempts)**
Date: April 14, 2010

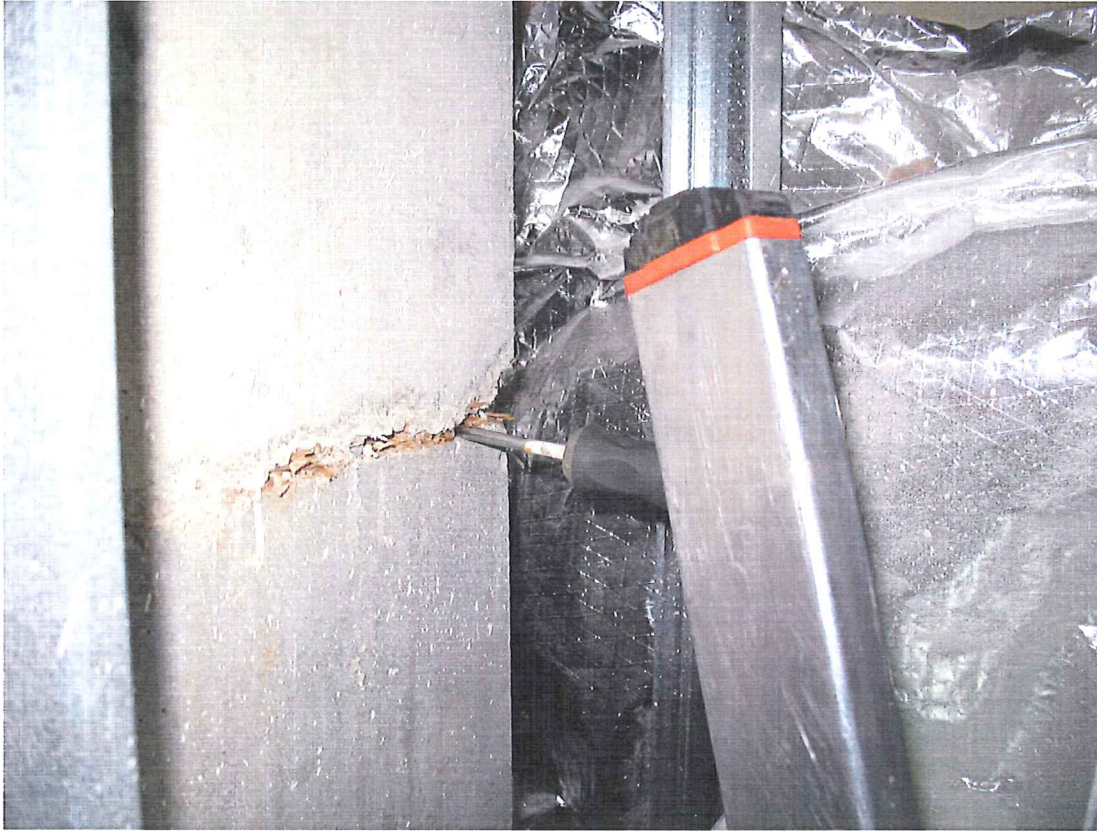
Screwdriver penetrating 2 inches into the concrete column
Date: April 14, 2010

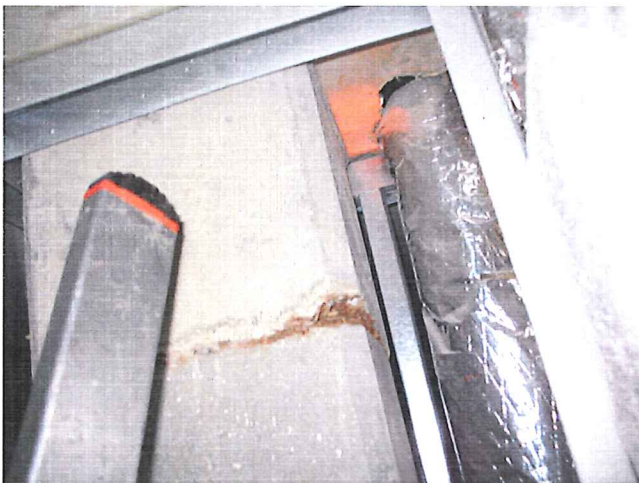
Wood fibers cast into the concrete column
Date: April 14, 2010

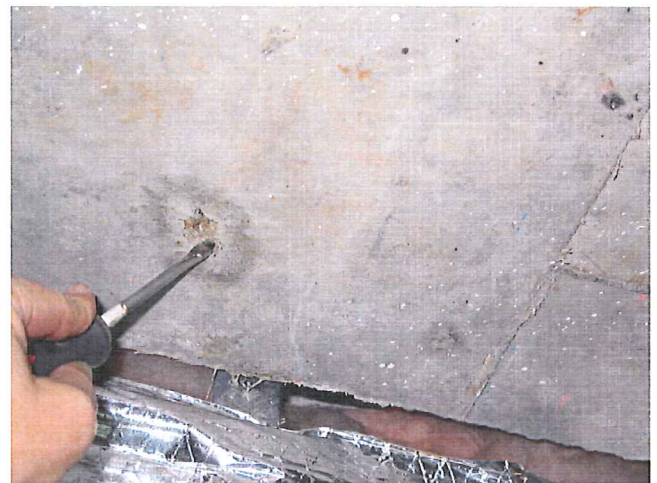
Debris inside slab
Date: April 14, 2010

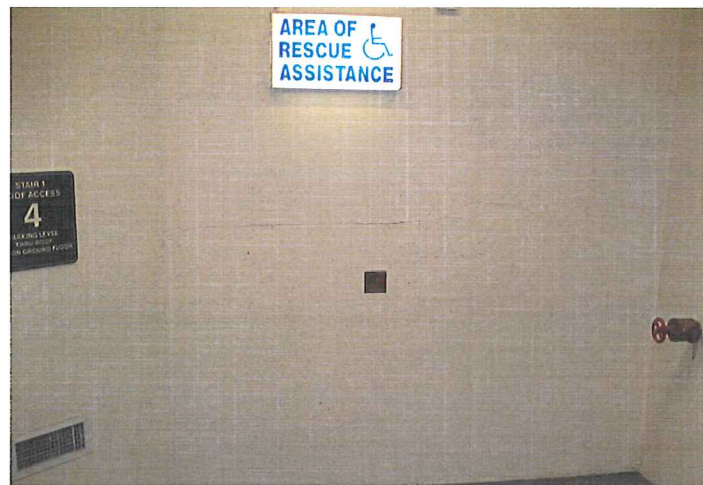
Horizontal cracking of concrete stairwells, Level 4, West stair
tower
Date: April 14, 2010

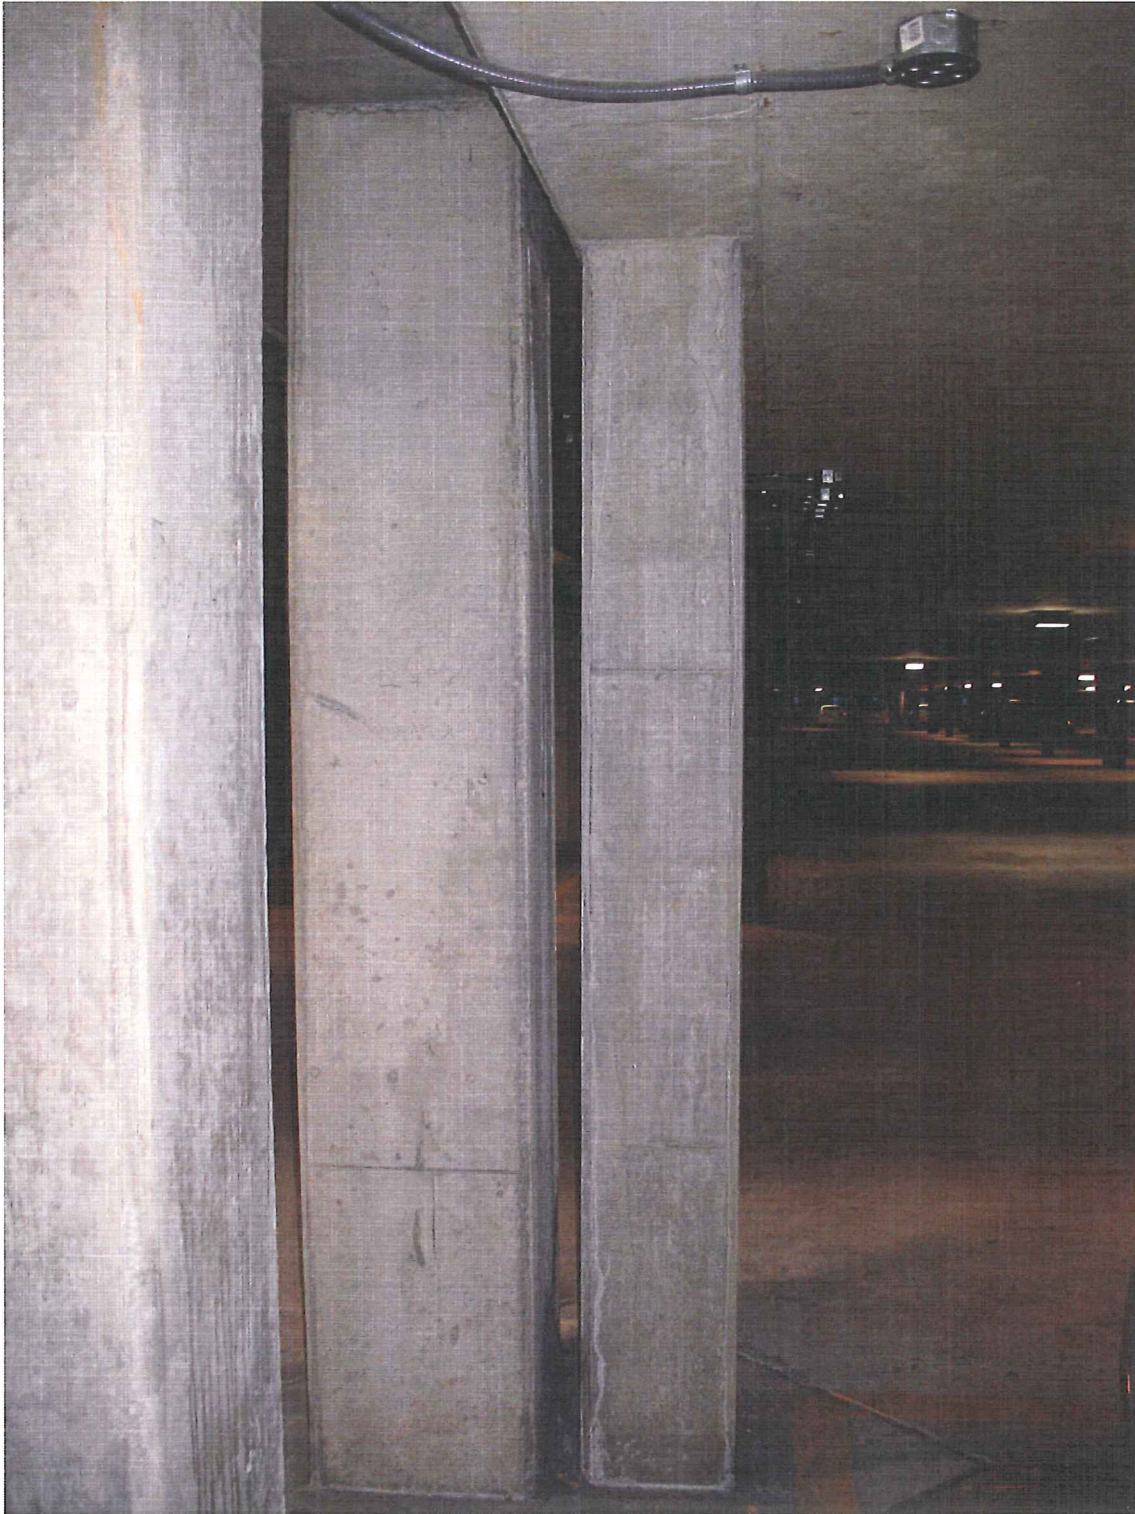
Between Marion County Courthouse Building and Bus Mall
Column leans to the North $1\frac{1}{2}$ " at the top along Gridline 10
Date: April 14, 2010
