**Marion County Courthouse Square
555 Court Street NE, Salem Oregon
Remediation Study Final Report
February 07, 2011**

Volume Three of Six

Miller Consulting Engineers, Inc.
Structural Photographic Documentation

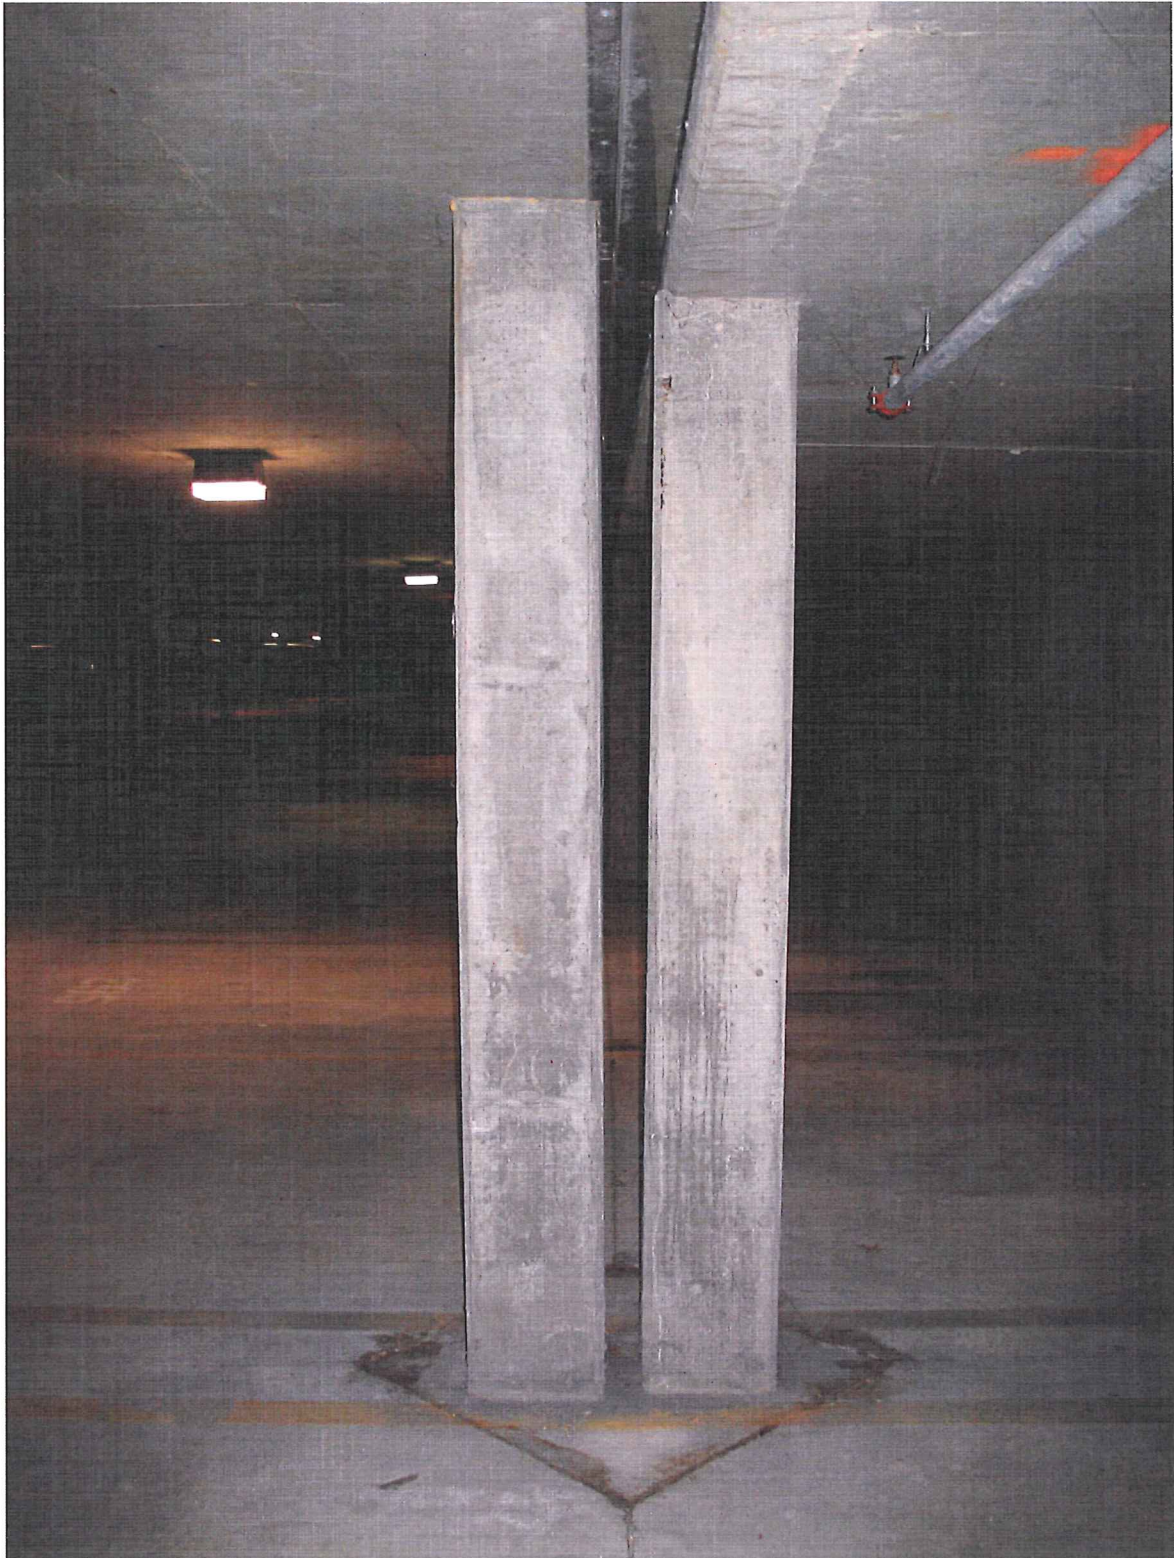
Between Marion County Courthouse Building and Bus Mall (Grid E-3a)
Column leans to the South 1½" at the top along Gridline 3a
Date: April 14, 2010

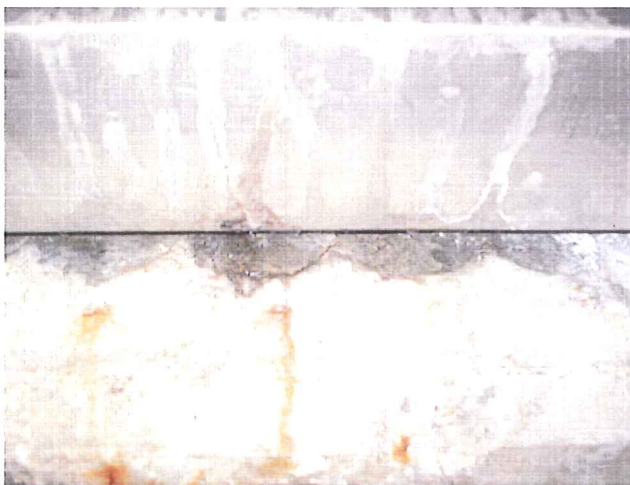
Close-up of grout pockets at Bus Mall
Date: April 14, 2010

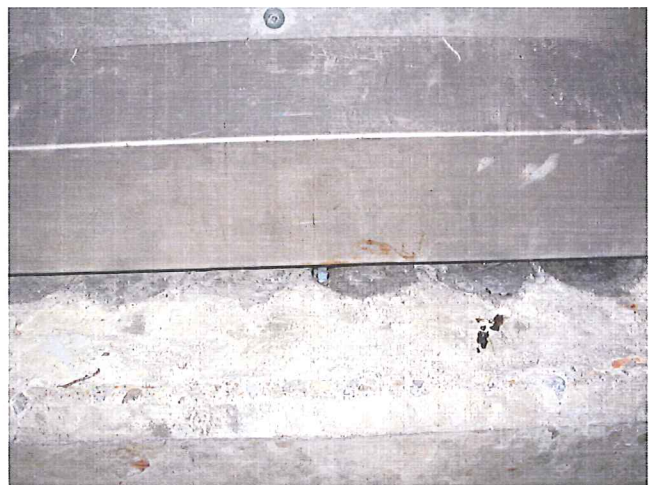
Close-up of grout pockets at Bus Mall
Date: April 14, 2010

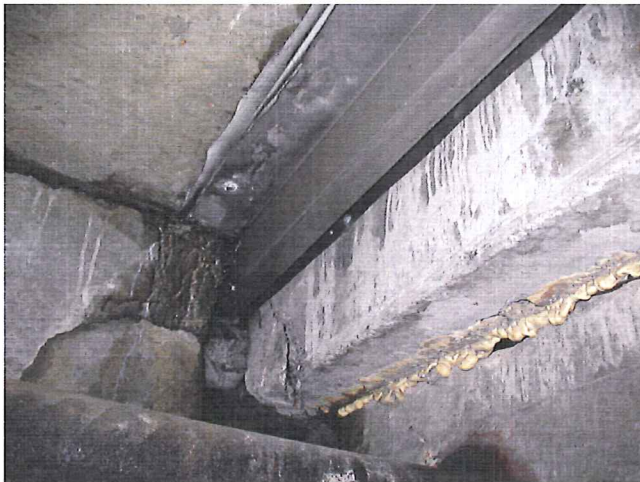
**Significant cracking at the expansion joint between the
Bus Mall and the North Block
Date: December 1, 2010**

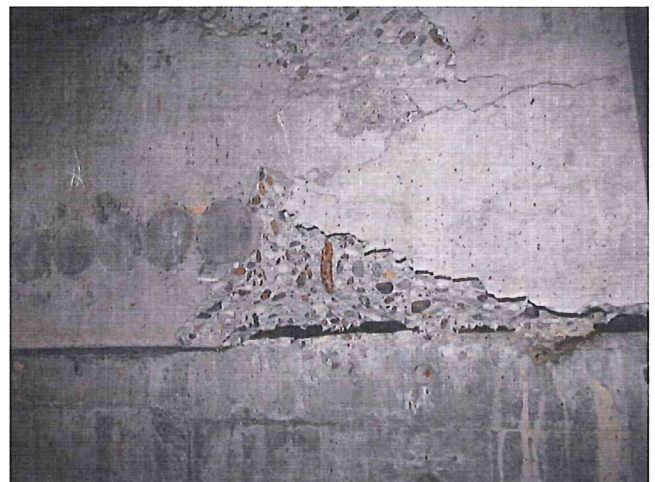
**Cracking of the Bus Mall slab edge visible from the North
Block along Gridline 3a
Date: December 1, 2010**

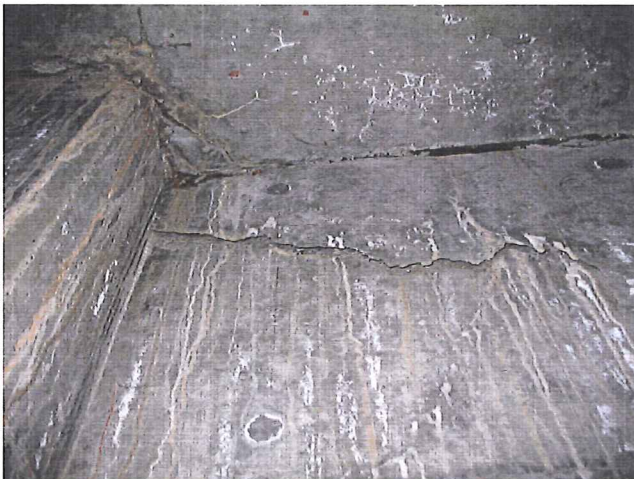
Significant cracking and efflorescence coming through concrete at Northeast corner column (Grid N1-1)
Date: April 14, 2010

1. Cracking was observed at the top of the wall at the northeast and northwest corners
2. Signs of moisture penetrating through the waterproof barrier

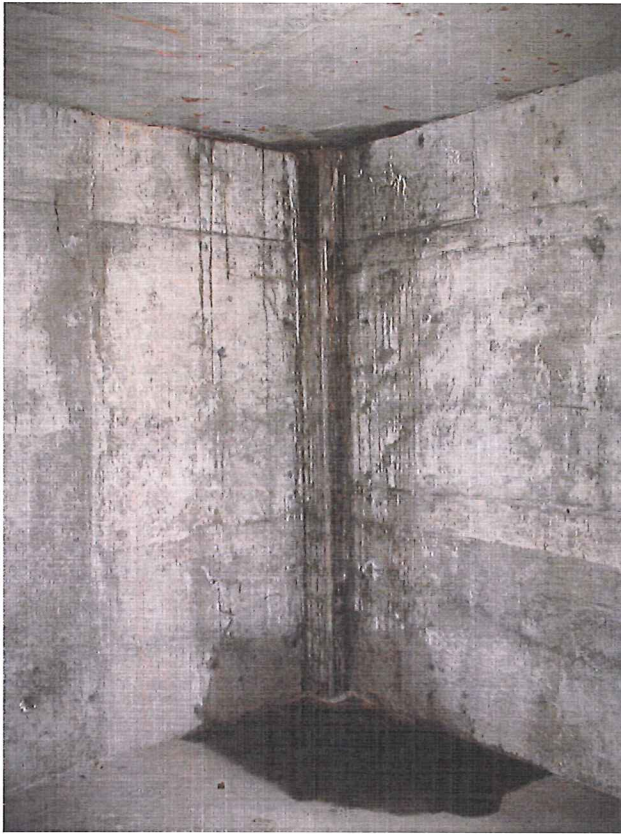
Significant cracking and efflorescence coming through concrete at Northeast corner column (Grid N1-1)
Date: December 1, 2010

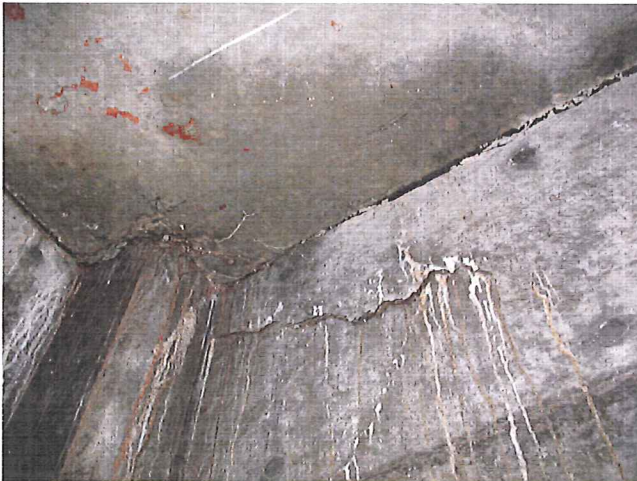
Significant cracking and efflorescence coming through concrete at Northeast corner column (Grid N1-1)
Date: December 1, 2010

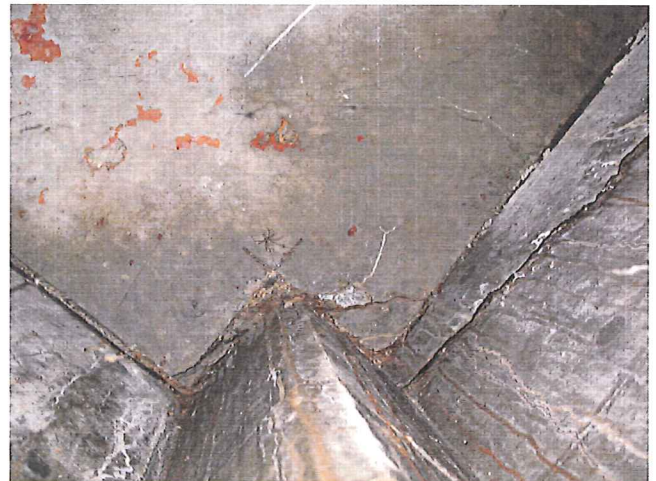
Significant cracking and efflorescence coming through concrete at Northeast corner column (Grid N1-1)
Date: December 1, 2010

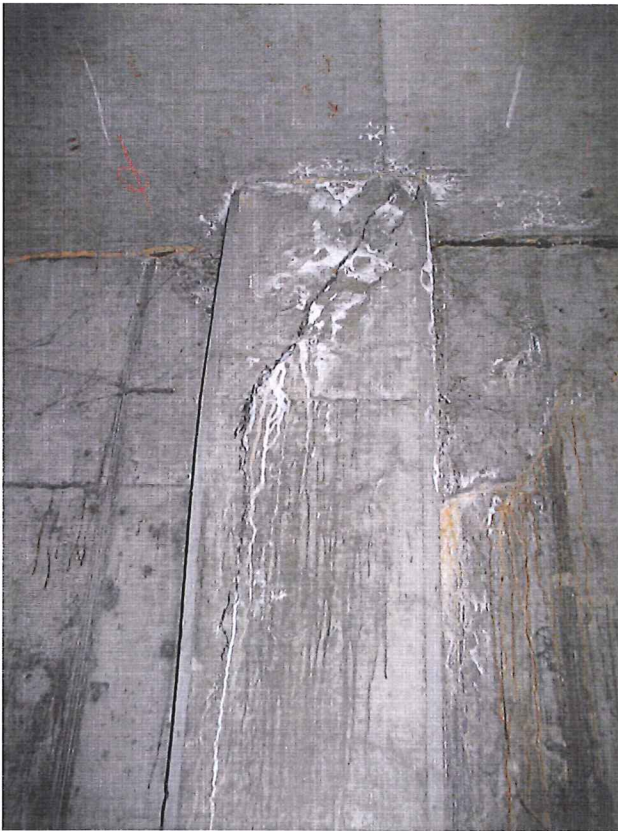
**Significant cracking and efflorescence coming through
Concrete column at Grid M-1**
Date: April 14, 2010

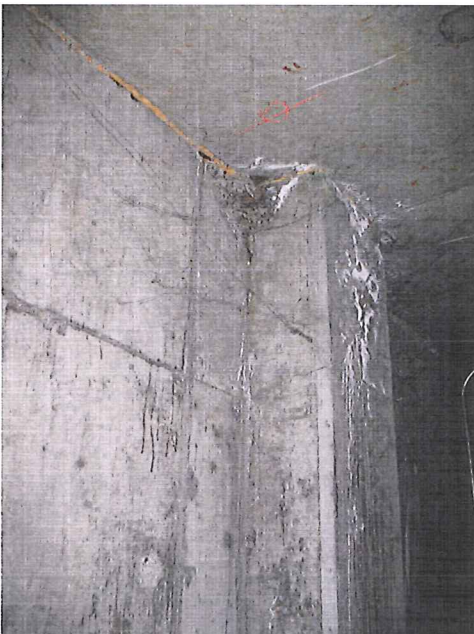
**Significant cracking and efflorescence coming
through concrete column at Grid M-1**
Date: April 14, 2010

1. This column was the only column in the North Block in this condition.

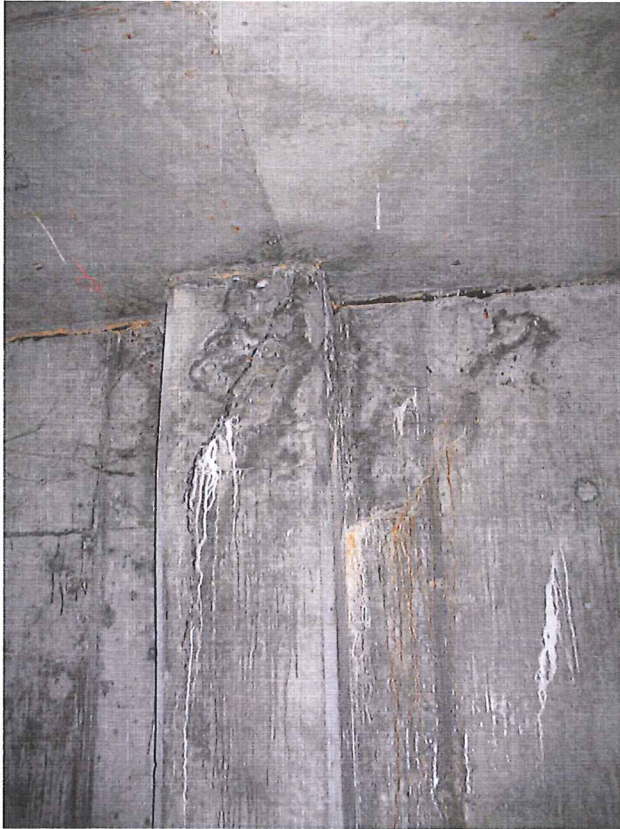
**Significant cracking and efflorescence coming through
Concrete column at Grid M-1
Date: January 5, 2011**

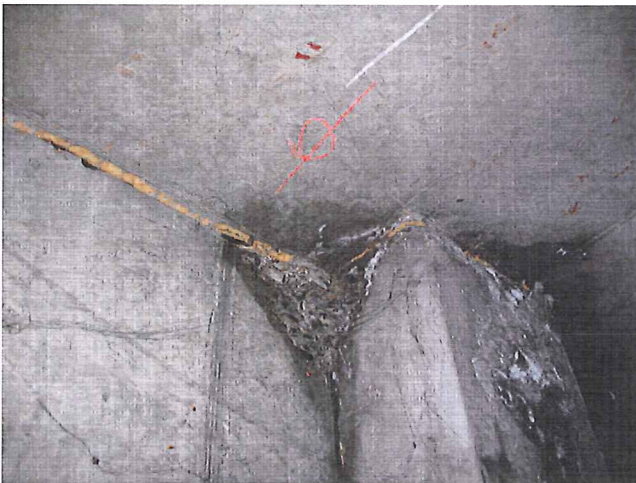
**Significant cracking and efflorescence coming through
Concrete column at Grid M-1
Date: December 1, 2010**

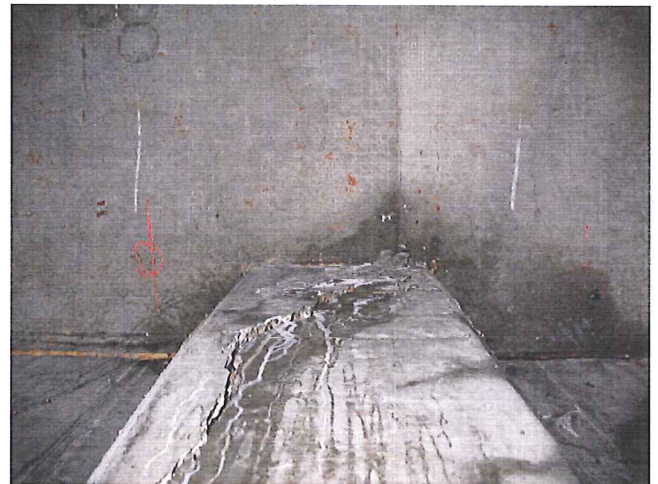
**Significant cracking and efflorescence coming through
Concrete column at Grid M-1
Date: December 1, 2010**

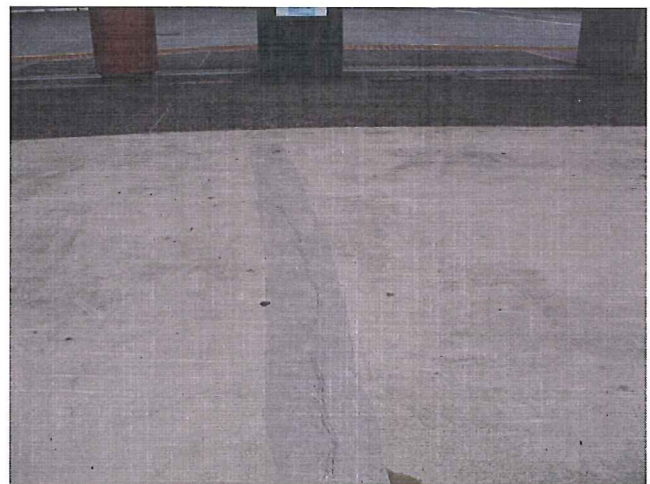
Jointed repair at the top of the PT slab
Date: June 1, 2010

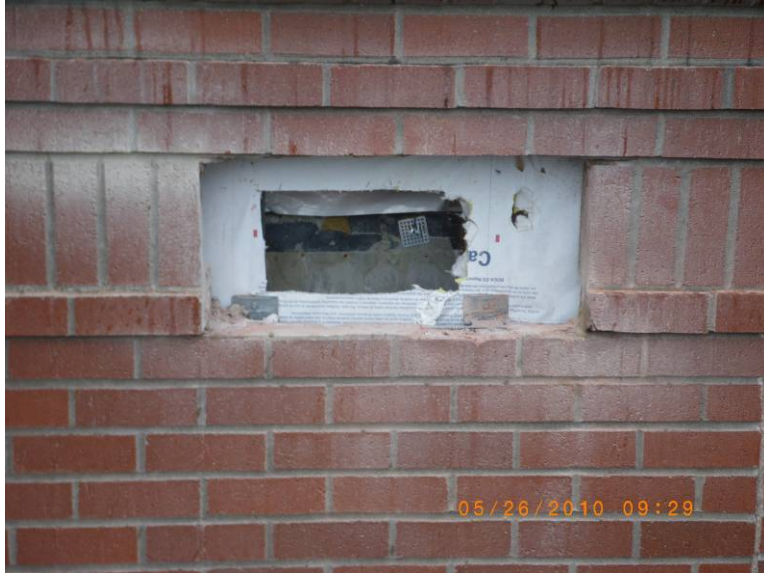
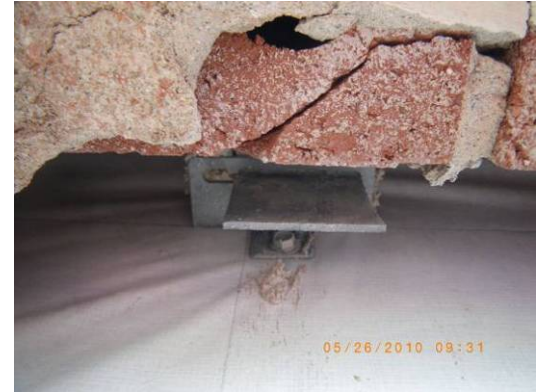
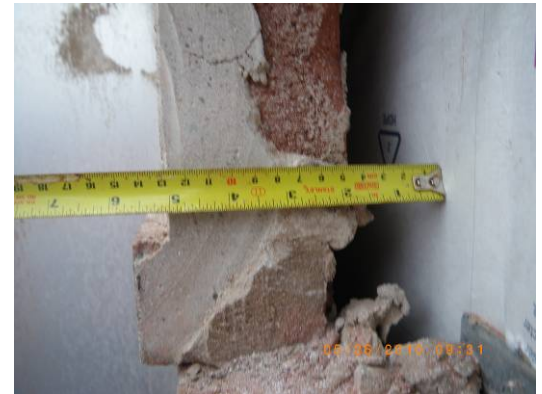
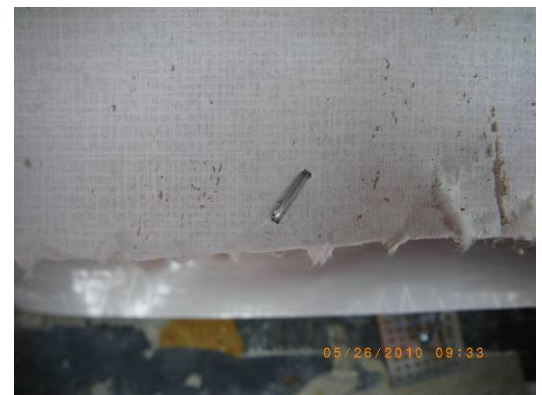
2.1 Brick Opening 4EA

We removed the soldier course brick, Tyvek WRB, and gypsum sheathing at this location.

- The brick cavity is less than 2" wide behind the soldier course.
- Tyvek staples are unsealed.
- A brick at the top of the opening is cracked.

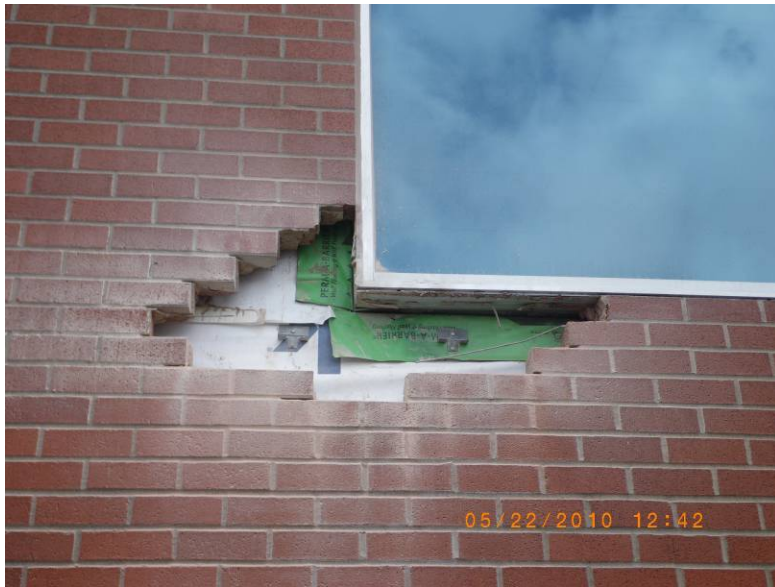
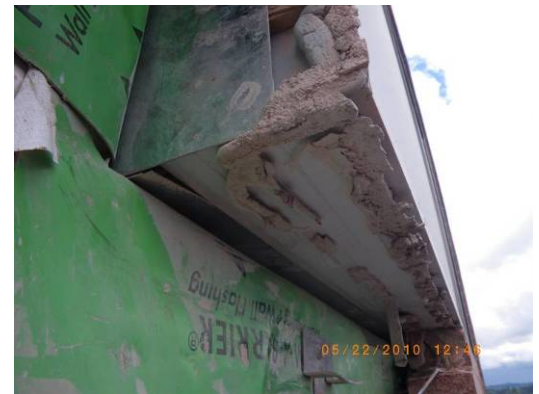
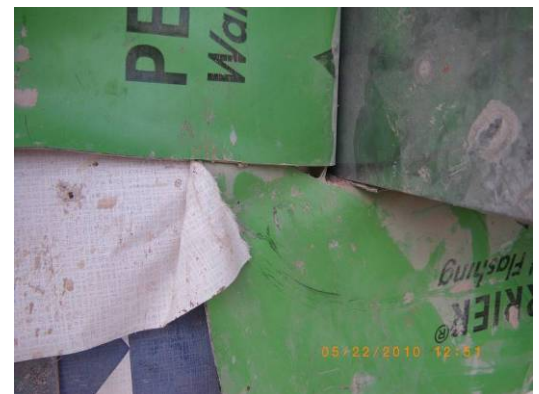
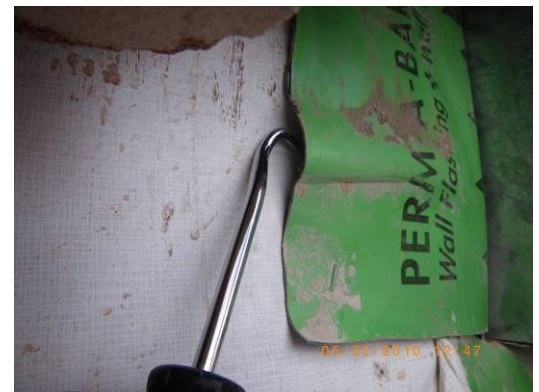
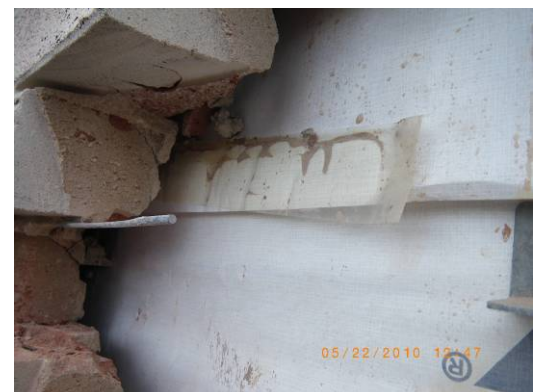
2.2 Brick Opening 4EB

We removed brick at the left jamb and sill interface of the window. Self adhered membrane is installed over the Tyvek WRB and wraps into the window rough opening. The window is located in the plane of the brick cladding exterior of the wall framing.

- The window sill pan is located outside of the metal surround & wall framing.
- A large pin hole exists in the self adhered membrane at the jamb and sill intersection.
- There is a large discontinuity at the jamb membrane.
- Tyvek joints are not taped.

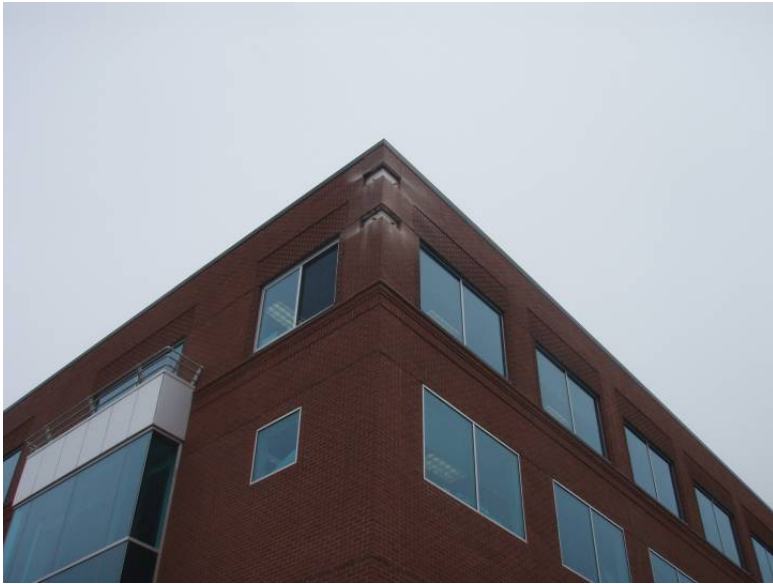
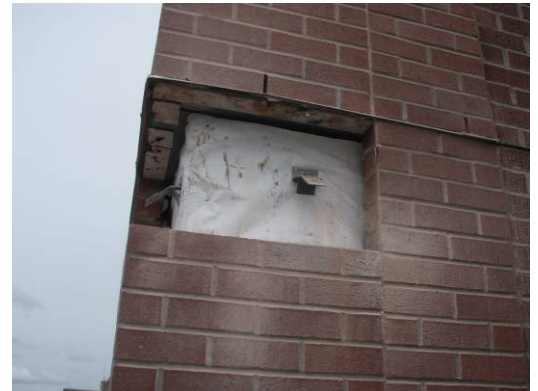
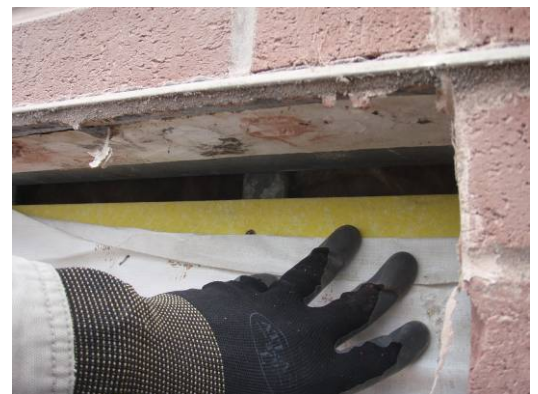
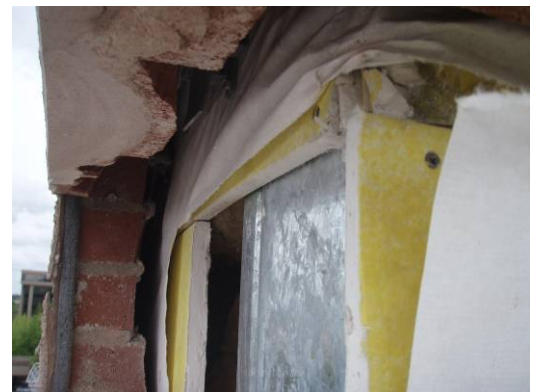
2.3 Brick Opening 5EA

We removed brick above and below the shelf angle and from the corner to the nearest control joint on each elevation. We also removed the Tyvek WRB and the exterior gypsum sheathing at the upper opening.

- There is a large gap below shelf angle between the sheathing and the shelf angle.
- The Tyvek butts up to bottom of shelf angle. The joint is not sealed.
- The shelf angle spans across the control joint to the brick reveal at the window.

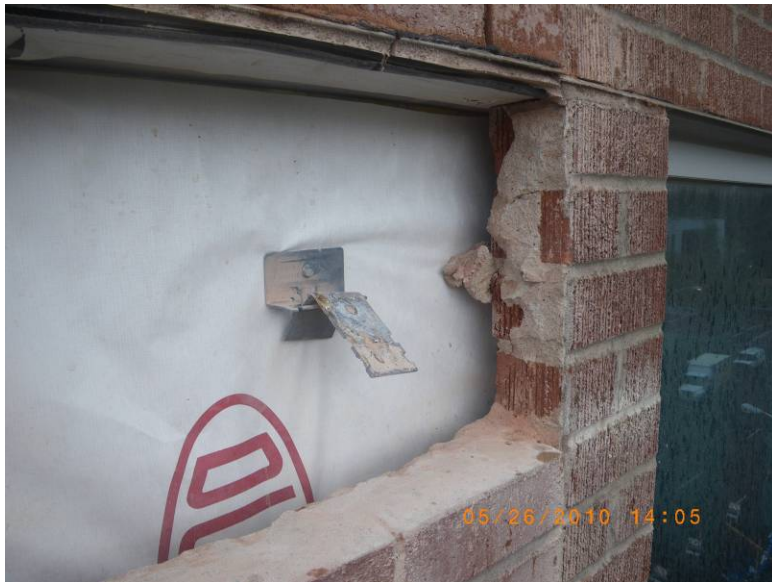
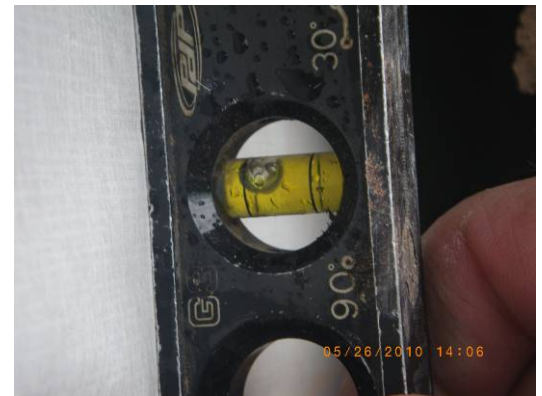
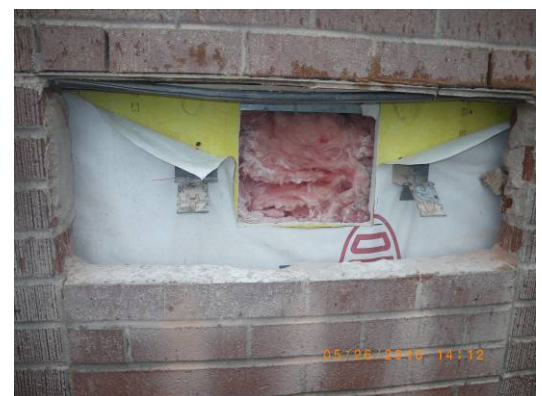
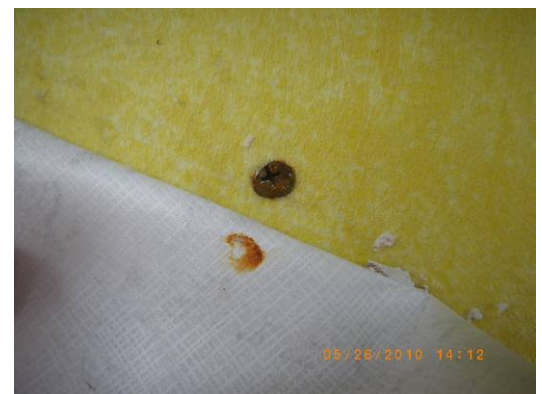
Brick Opening 5EB

We removed brick, Tyvek, and sheathing between windows and below the shelf angle.

- The Tyvek butts up to bottom of shelf angle. The joint is not sealed.
- Sheathing is out of plumb.
- Minor corrosion is present on sheathing fasteners.

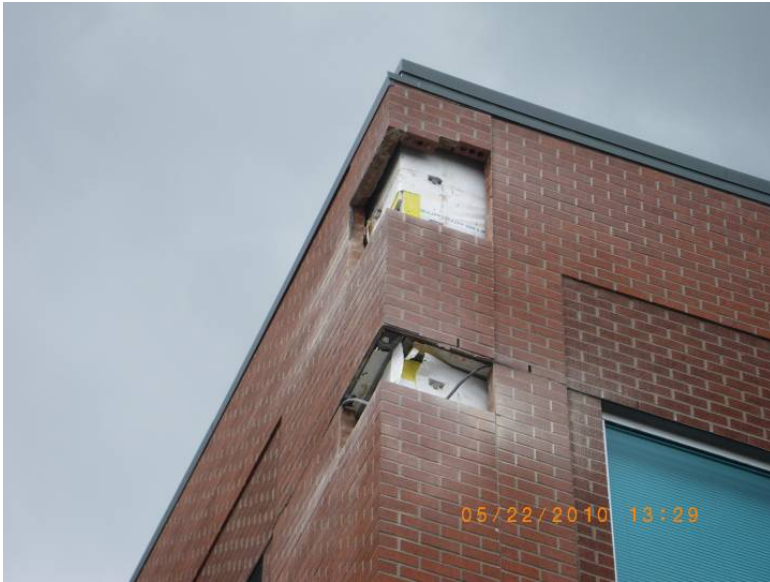
2.4 Brick Opening 5EC

- Minor corrosion is present on Tyvek staples. The staple penetrations through the Tyvek are unsealed.
- On the East elevation brick at the corner has shifted outward approximately $\frac{3}{4}$ ".
- The brick cavity is less than 2" on the South elevation.
- Tyvek butts up to the underside of the shelf angle. The joint is not sealed.
- Efflorescence is present on the underside of the shelf angle at the joint near the corner. The shelf angles are back sloped.
- The brick cladding is not plumb on either elevation. The exterior sheathing is plumb on the South elevation but not on the East elevation.

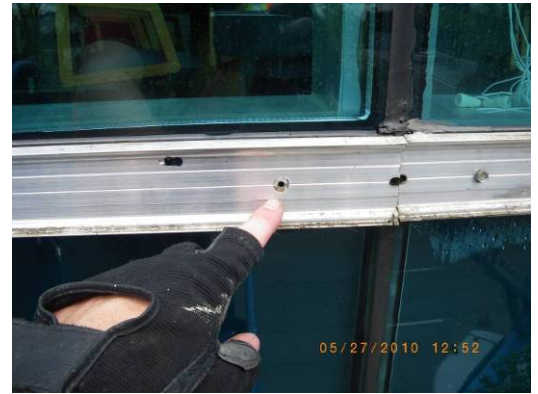
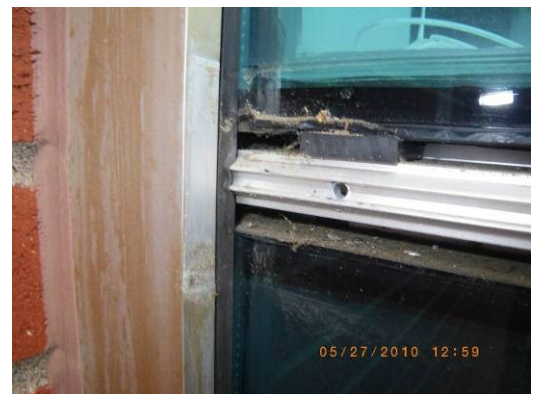
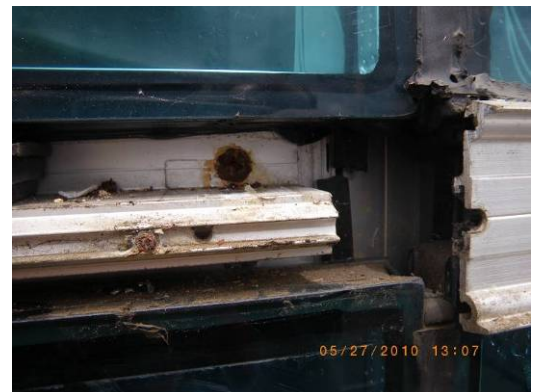
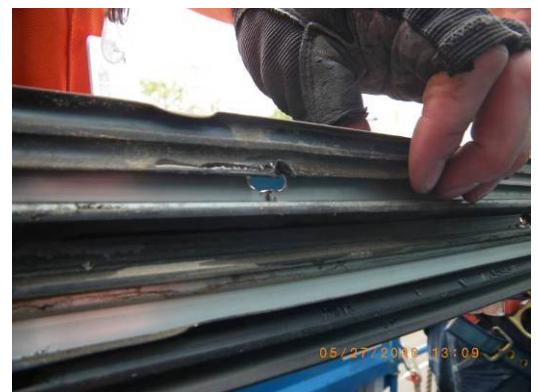
2.5 East Curtain Wall Bay Exterior

Location: 2CB-4CB, East Curtain Wall at South Elevation, Grid H-J

- A pressure plate screw is missing left of curtain wall center line at level 3.
- No end blocks are present where the curtain wall terminates and interfaces with the main wall at level 3.
- Fasteners are corroded near center line of curtain wall. The weep in the pressure plate near this location has been installed too high.

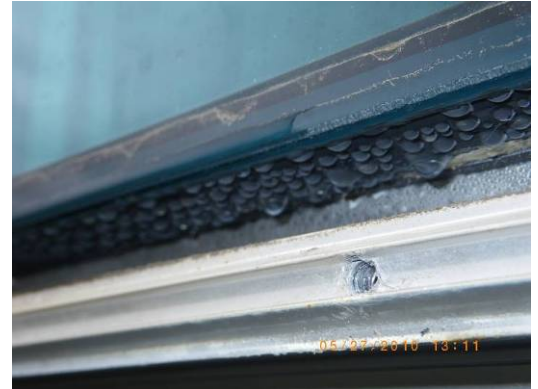
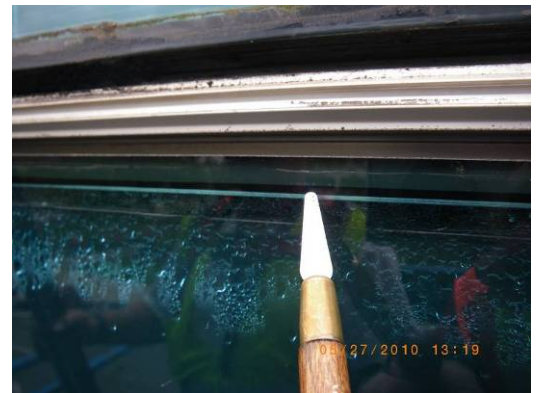
- Condensation is present on the bottom of an IGU at Level 2.
- We identified a failed bead seal and a potential leak point of the failed IGU at Level 2.
- There is a large sealant discontinuity at the back of the IGU.
- The Low-E coating is not ground away from the edge of glass.

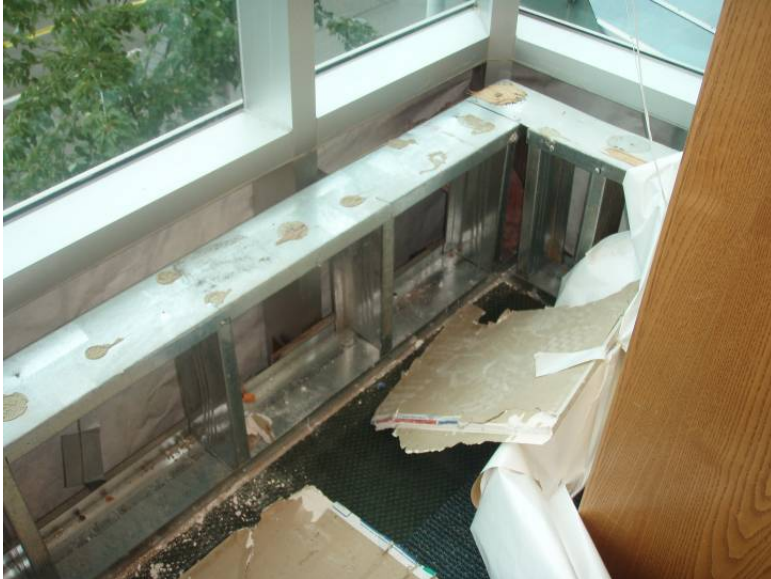
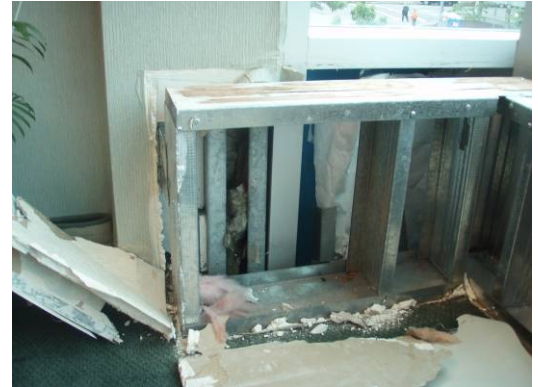
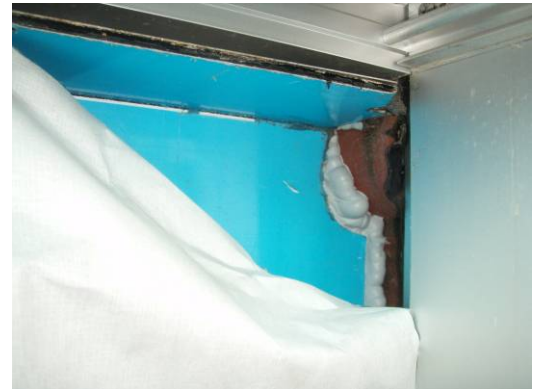
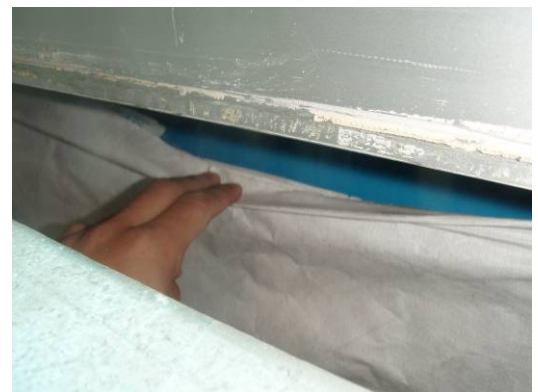
3.1 Interior Opening 2CB – East Curtain Wall Level 2

Location: 2CB, Suite 2201

- Interior gypsum generally appears dry.
- Tyvek is present on the back side of the composite metal panel.
- Sealant is between the composite metal panel and the brick cladding at each end of the assembly.

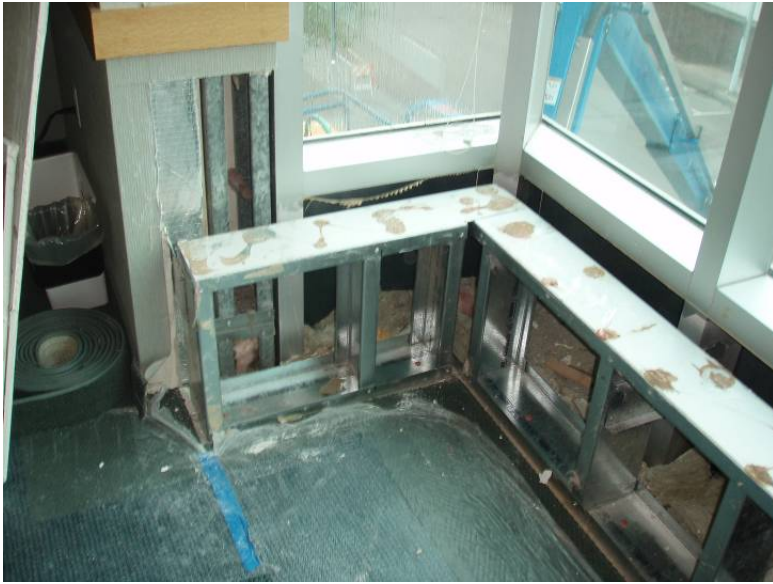
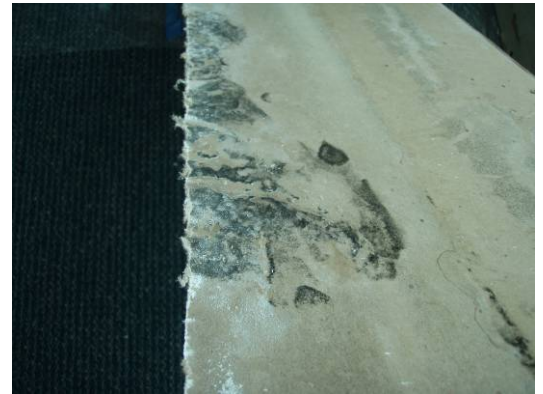
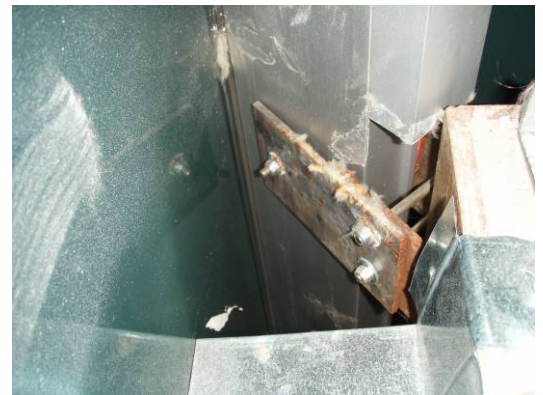
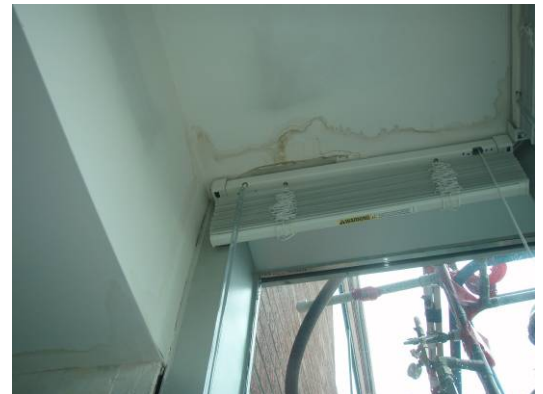
3.2 Interior Opening 3CB – East Curtain Wall Level 3

Location: 3CB, Suite 3201

- Black staining is present on the backside of the interior gypsum at the left jamb.
- Interior gypsum removed from the wall assembly at the sill generally appears dry.
- Mineral wool insulation is installed at the slab edge.
- Metal support brackets at the slab edge are corroded.
- Interior finishes above the left jamb area are heavily stained.

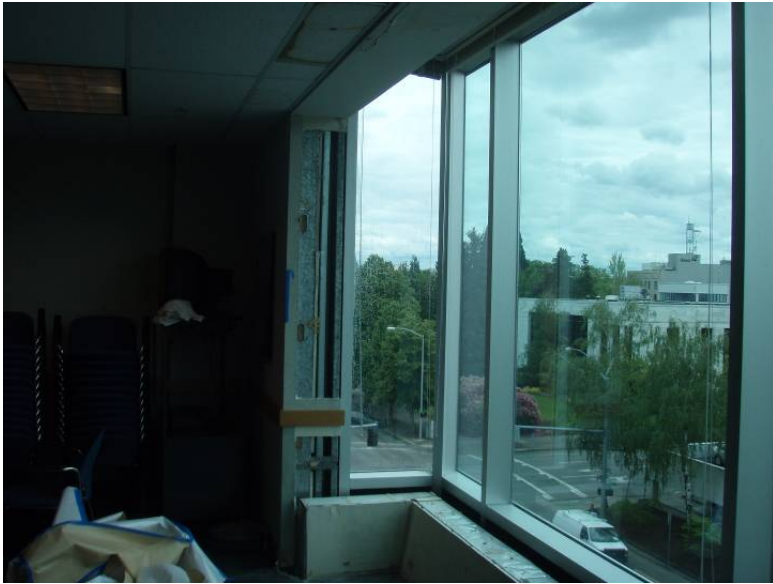
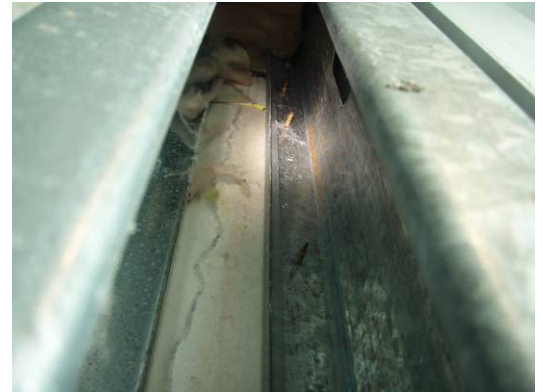
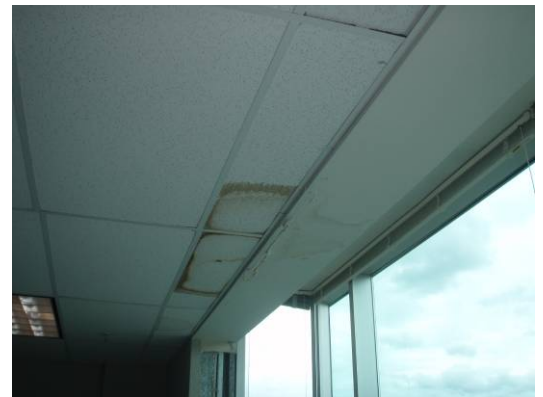
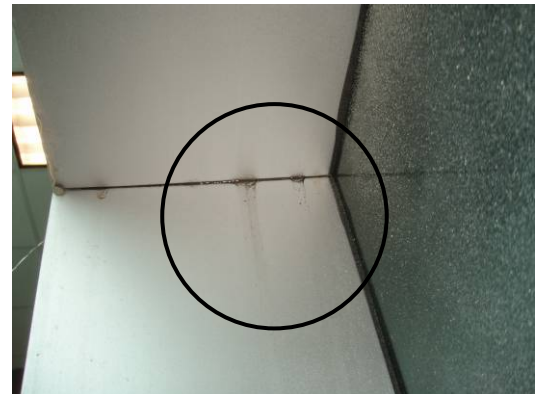
3.3 Interior Opening 4CB – East Curtain Wall Level 4

Location: 4CB, Suite 4231/4211

- Interior gypsum generally appears dry.
- Stains are present on the inboard side of the exterior sheathing at the left jamb. The stain starts at the exposed end of the metal brick support angle.
- Ceiling tiles and interior finishes are heavily stained above the opened areas.
- Water was present prior to testing below the window sill at the East (left) jamb area.

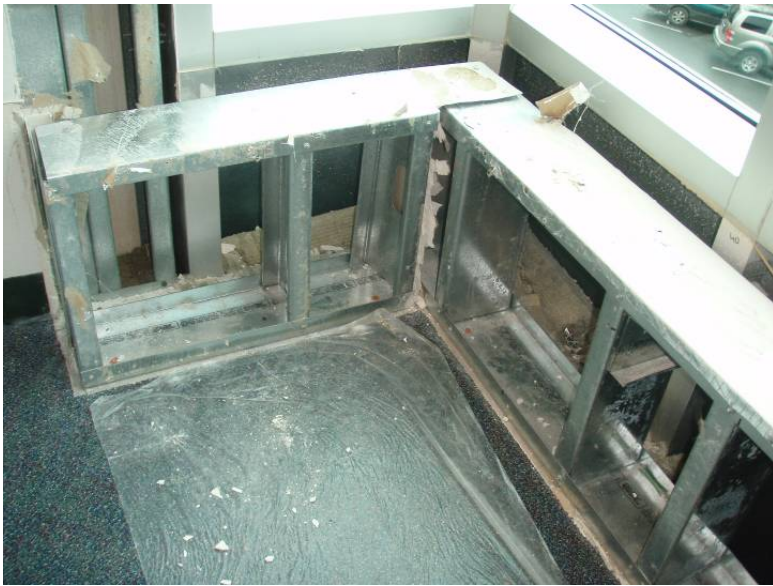
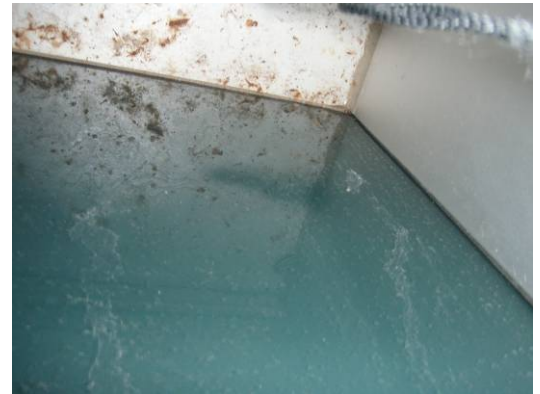
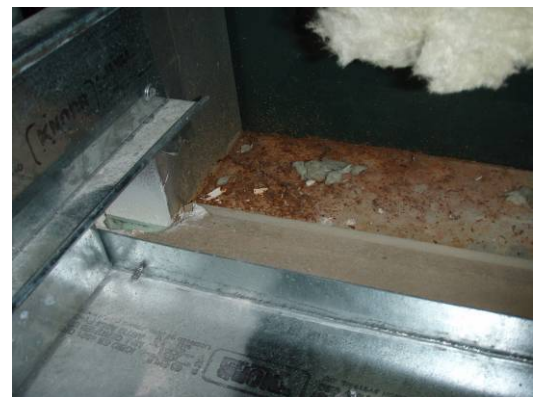
3.4 Interior Opening 3CA – West Curtain Wall Level 3

Location: 3CA, Suite 3120

- Interior gypsum generally appears dry.
- White staining is present on the inboard side of the composite metal panel below the window sill.
- The self adhered membrane at the East end of the curtain wall assembly is not set consistently in the shoulder of the curtain wall.
- Rust is present on top of the head framing member in the ceiling plenum area.

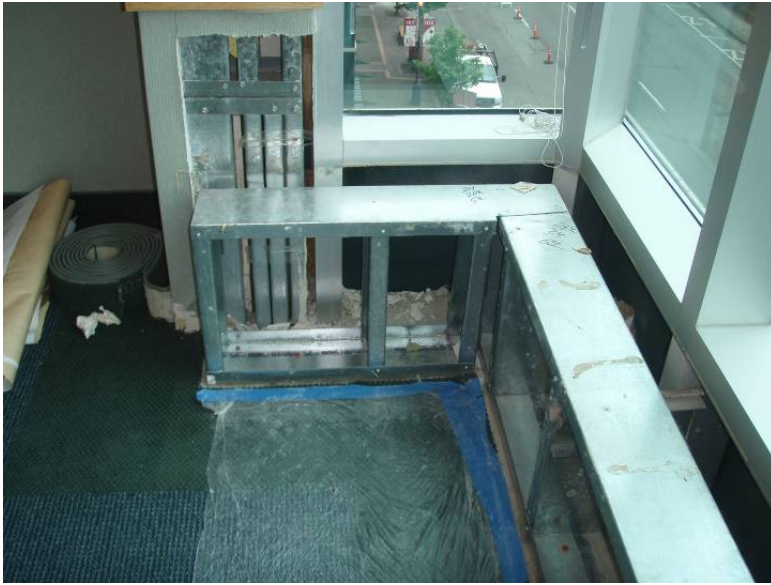
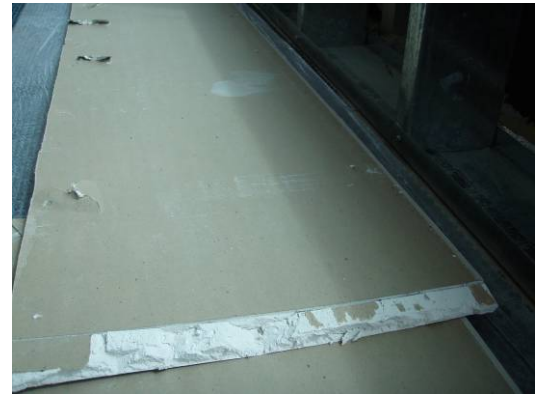
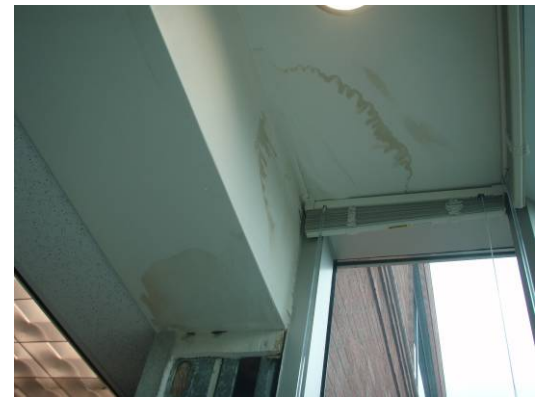
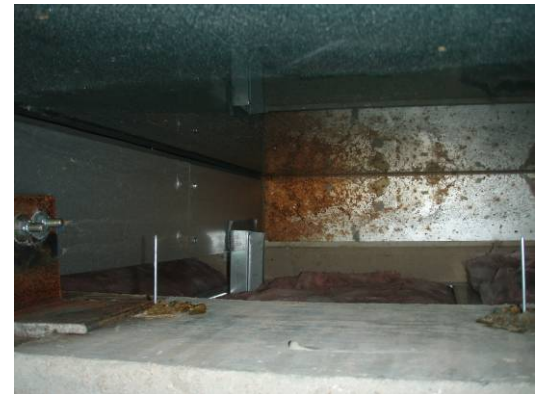
3.5 Interior Opening 4CA – West Curtain Wall Level 4

Location: 4CA, Suite 4101

- Interior gypsum generally appears dry.
- Heavy staining is present on the ceiling finishes above the left jamb area.
- Rust is present on the horizontal frame member of the curtain wall below the slab edge. Staining is present on the vertical frame member above the rust. The curtain wall support bracket at the slab edge is corroded.

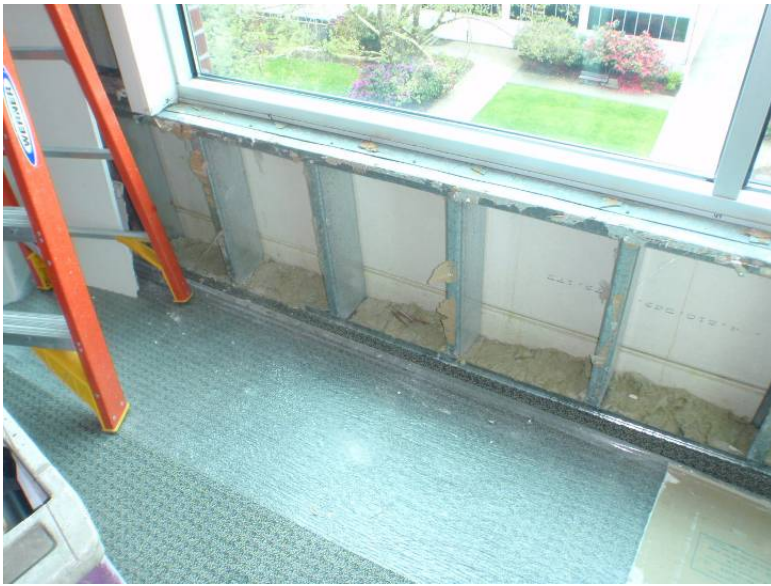
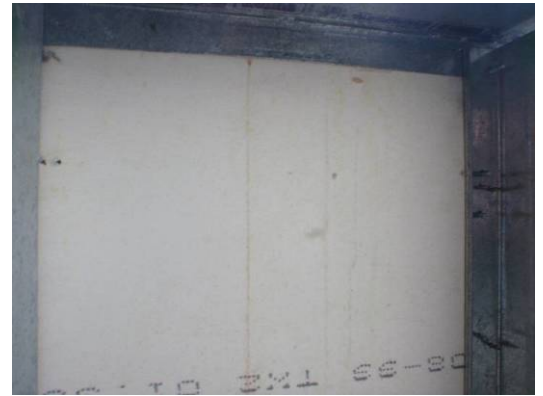
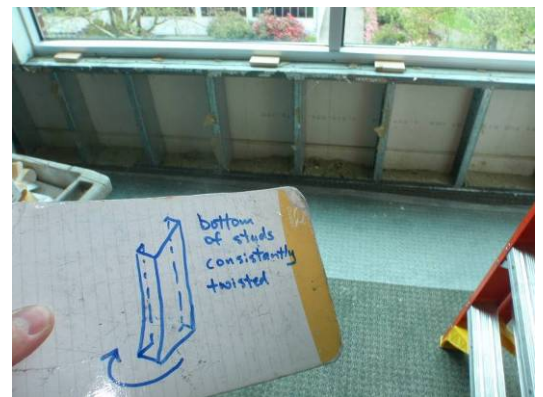
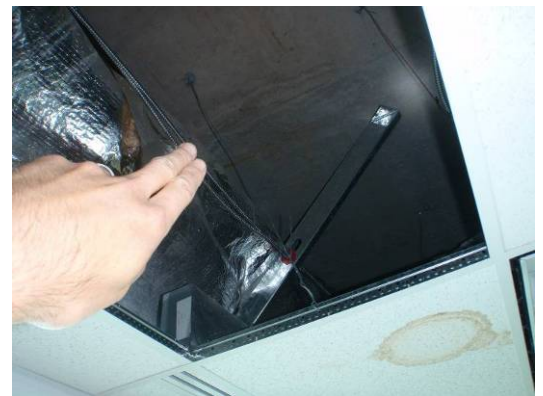
3.6 Interior Opening 5WA – Punched Window

Location: 5WA, Suite 5124

- Interior gypsum generally appears dry.
- Minor stains are present on the back side of the interior gypsum at the left jamb area.
- Pink/brown stains and streaks are present on the interior side of the exterior sheathing below the window sill framing.
- Studs under the sill framing are slightly twisted. The bottom of each stud is turned to the left relative to the top of the stud.
- Stains are present on the underside of the slab above. The end of the stain on the slab is directly above the stained ceiling tile.
- White staining is present on the interior side of the foil backed exterior insulation in the ceiling plenum.
- White staining is present on the vertical studs behind the insulation.

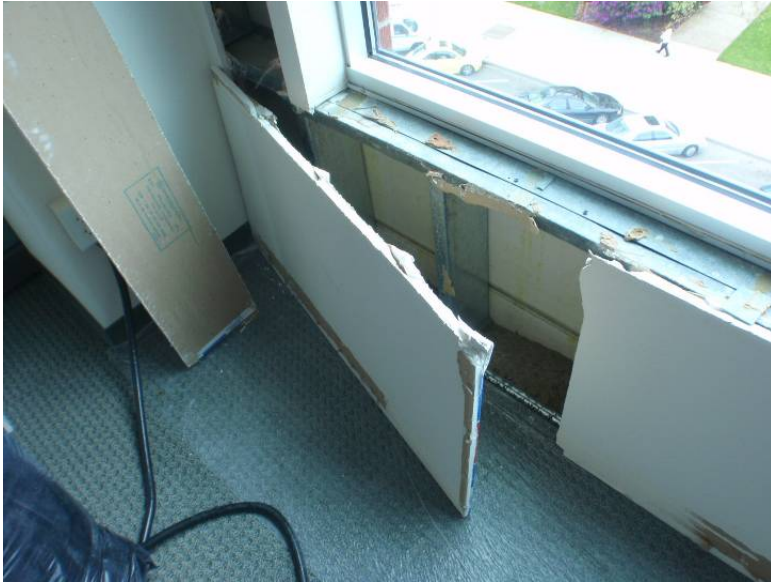
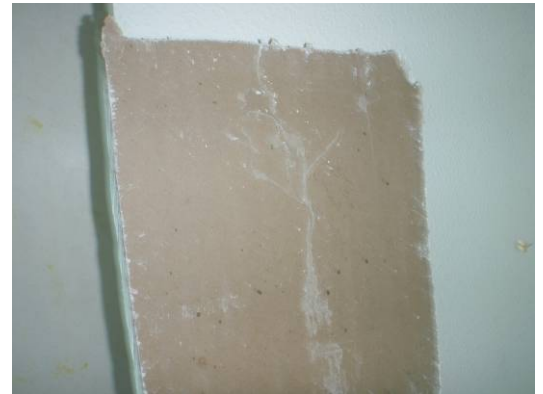
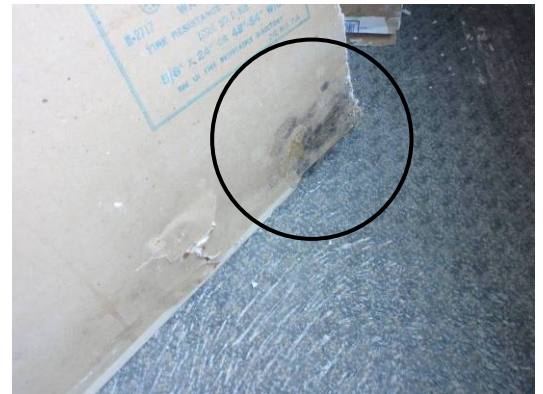
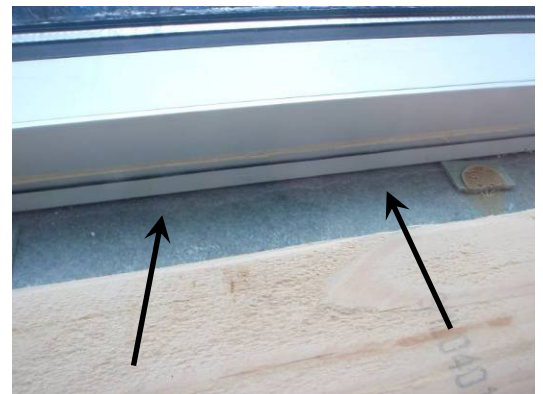
3.7 Interior Opening 5WB – Punched Window

Location: 5WB, Suite 5124

- Interior gypsum generally appears dry.
- White stains are present on the back side of the interior gypsum below the left third of the sill and at the right jamb.
- Black growth and staining are present on the back side of the interior gypsum below the left jamb area adjacent to the floor. The carpet appears dry and is not stained. Rust is present on the curtain wall support bracket at the slab edge next to this area.
- White stains are present under the window pan flashing on top of the sheet metal surround on top of the interior wall/sill framing.
