**Marion County Courthouse Square
555 Court Street NE, Salem Oregon
Remediation Study Final Report
February 07, 2011**

Volume Three of Six

Miller Consulting Engineers, Inc.
Structural Photographic Documentation

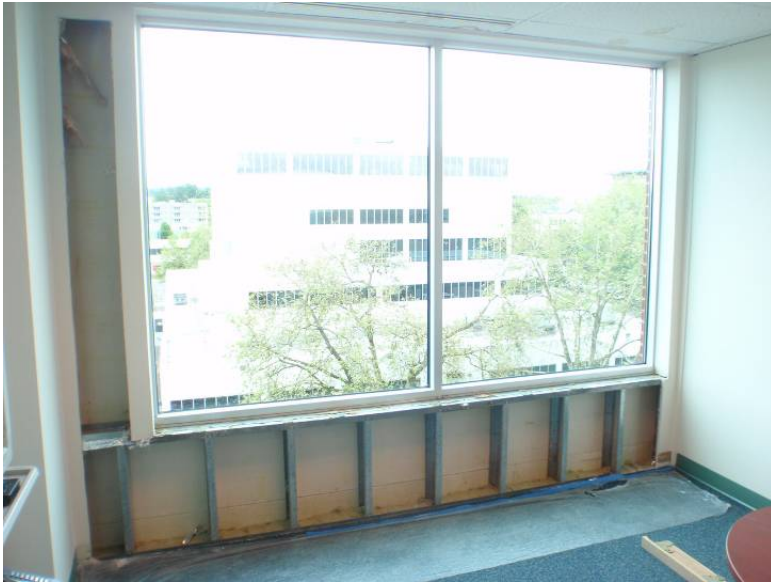
3.8 Interior Opening 5WC – Punched Window

Location: 5WC, Suite 5203

- Interior gypsum generally appears dry.
- White staining is present on the interior side of the foil backed insulation in the ceiling area.
- Studs under the sill framing are slightly twisted. The bottom of each stud is twisted to the right relative to the top of the stud.

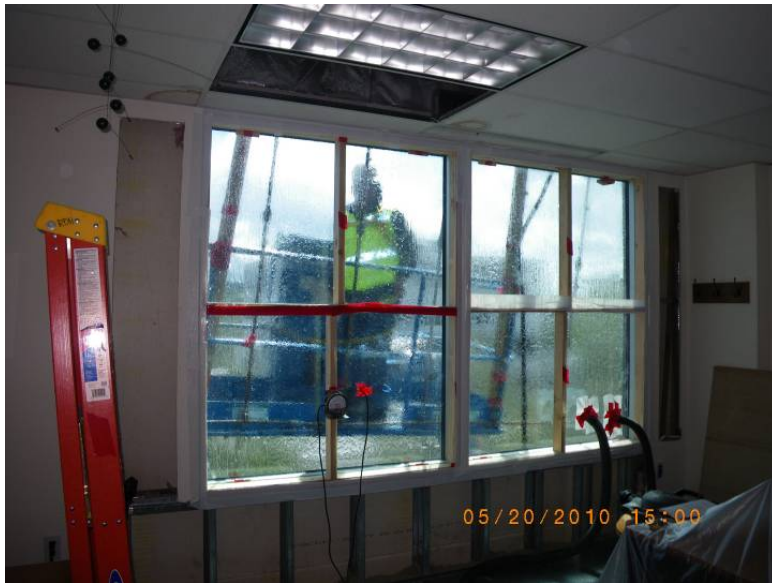
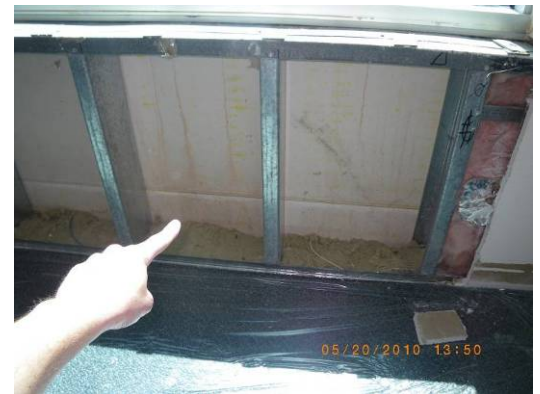
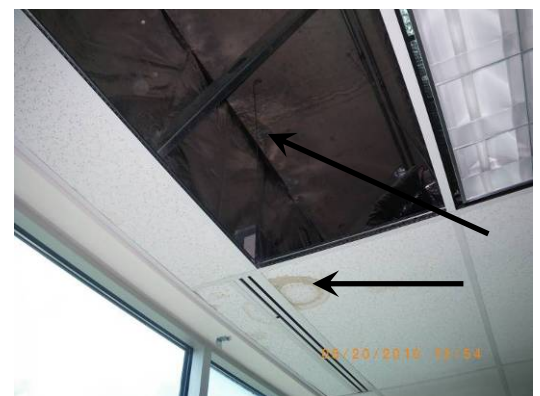
3.9 Interior Opening 5WD – Punched Window

- Interior gypsum generally appears dry.
- Pink/brown stains and streaks are present on the interior side of the exterior sheathing below the window sill framing.
- Stains are present on the underside of slab above. The stains terminate directly above the stained ceiling tile.

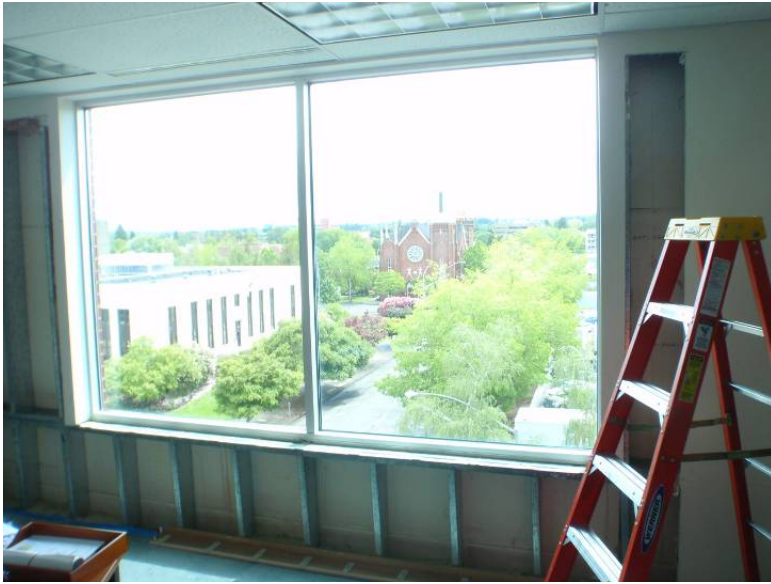
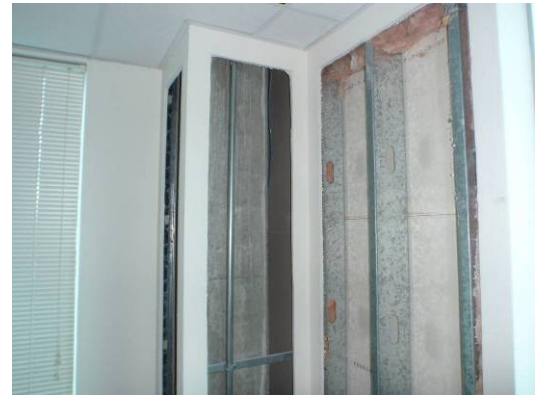
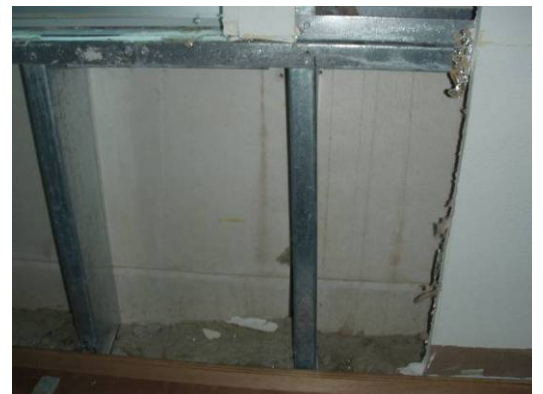
3.10 Interior Opening 5WE – Punched Window

- Interior gypsum generally appears dry.
- White staining is present on the surface of the concrete column.
- Many small horizontal cracks are present on the concrete column.
- Pink/brown stains and streaks are present on the interior side of the exterior sheathing below the window sill framing.

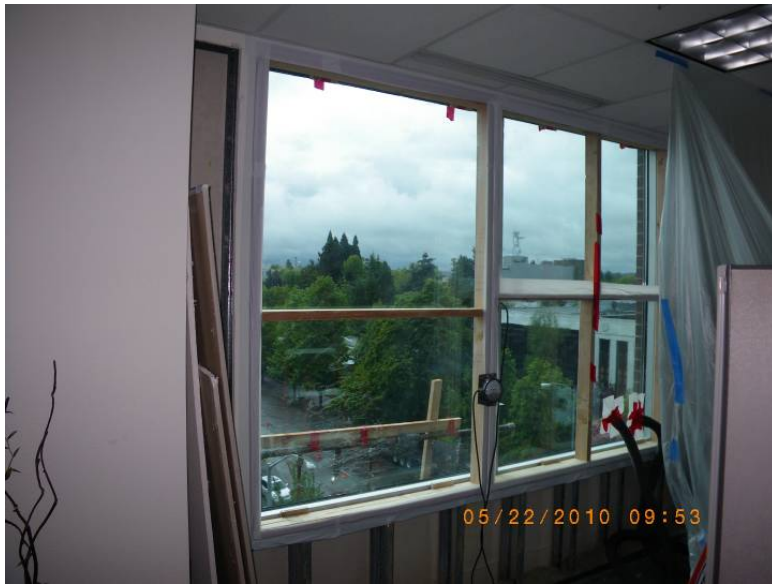
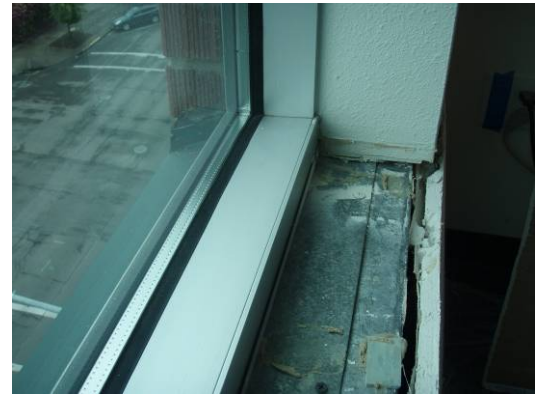
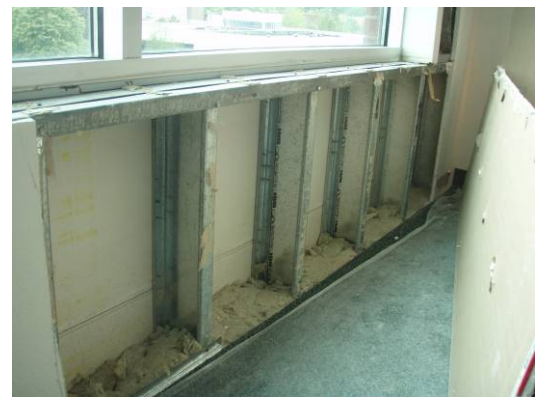
3.11 Interior Opening 5WF – Punched Window

- Interior gypsum generally appears dry.
- Minor pink/brown stains and streaks are present on the interior side of the exterior sheathing below the window sill framing.

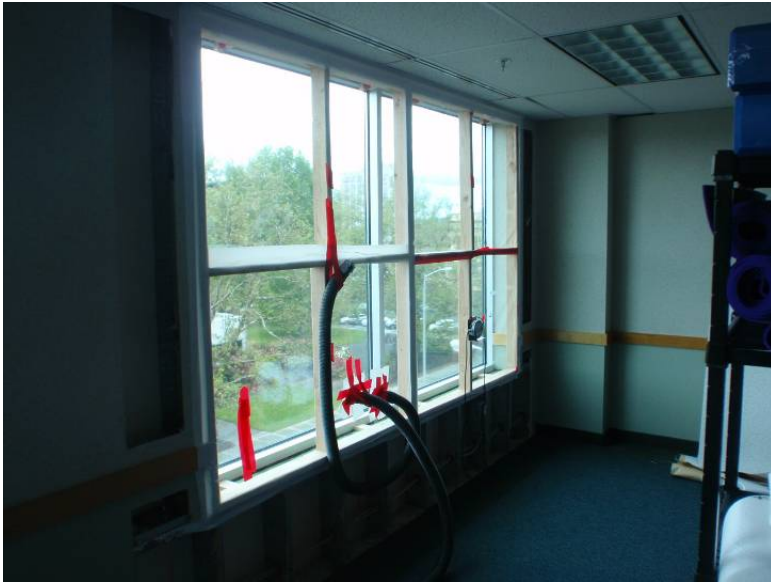
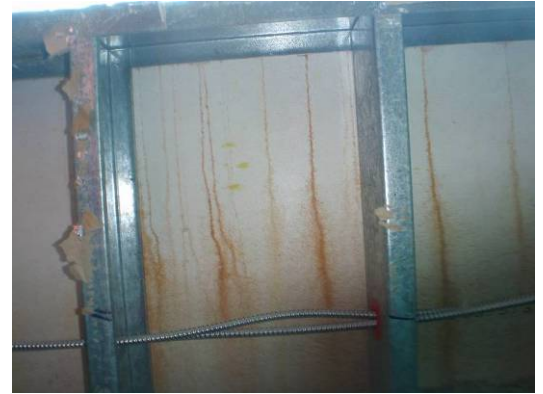
3.12 Interior Opening 4213 – Punched Window

- Interior gypsum generally appears dry.
- Heavy pink/brown stains and streaks are present on the interior side of the exterior sheathing below the window sill framing.
- Minor staining is present on the underside of the wood sill stool.

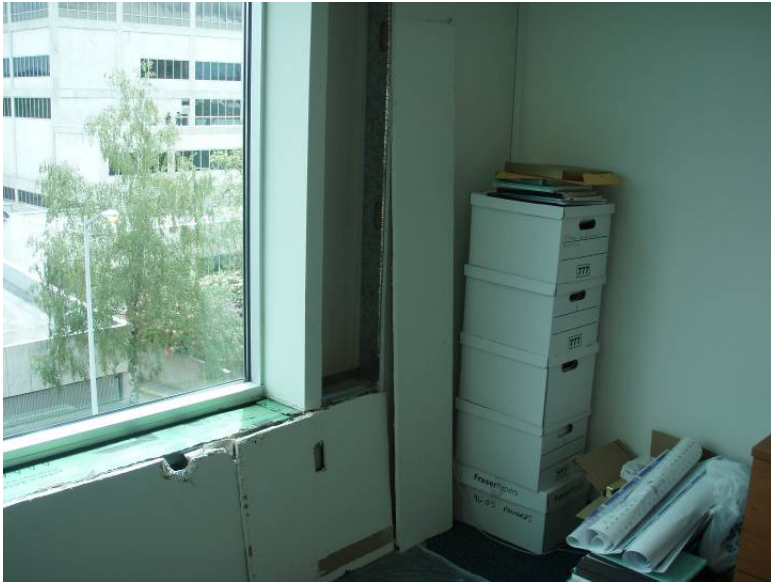
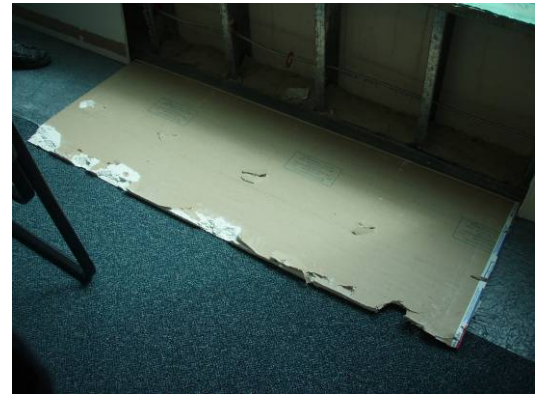
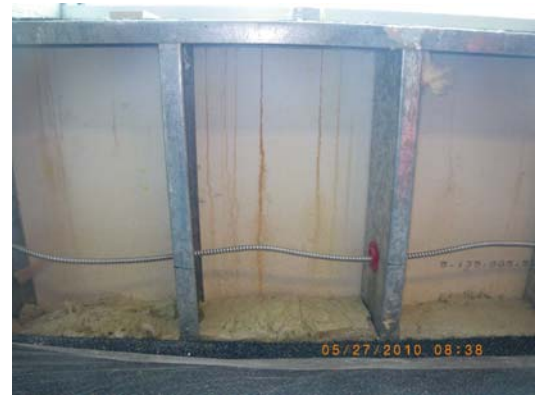
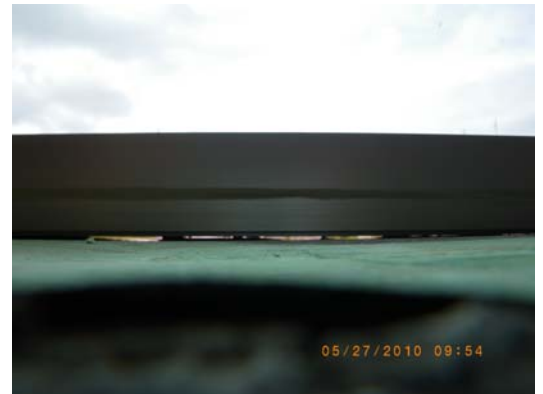
3.13 Interior Opening 4WA – Punched Window

- Interior gypsum generally appears dry.
- Pink/brown stains and streaks are present on the interior side of the exterior sheathing below the window sill framing.
- Brick mortar is present in the Perm-A-Barrier membrane lap at the right jamb and sill.
- The Perm-A-Barrier membrane is unsupported where it transitions from the horizontal sill framing to the vertical wall framing in the brick cavity.
- Studs under the sill framing are slightly twisted. The bottom of each stud is twisted to the right relative to the top of the stud.
- Daylight is visible between the window sill frame and the brick veneer 16" to 32" from the right jamb.

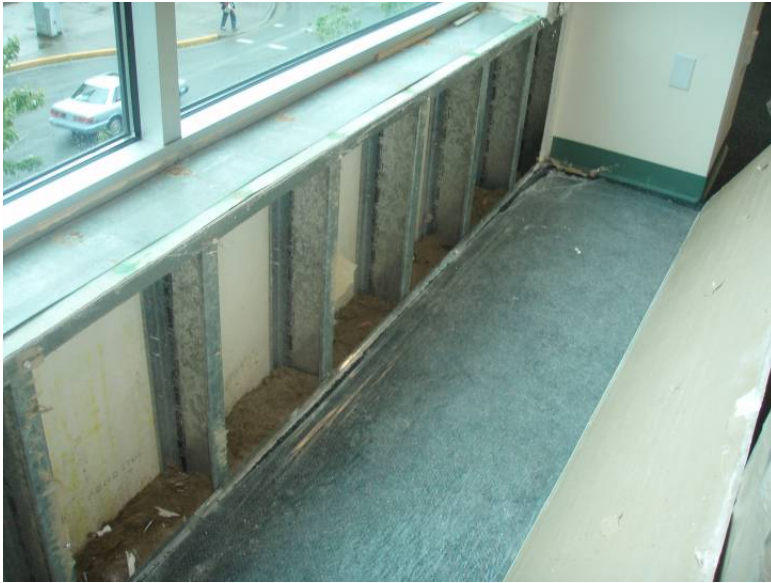
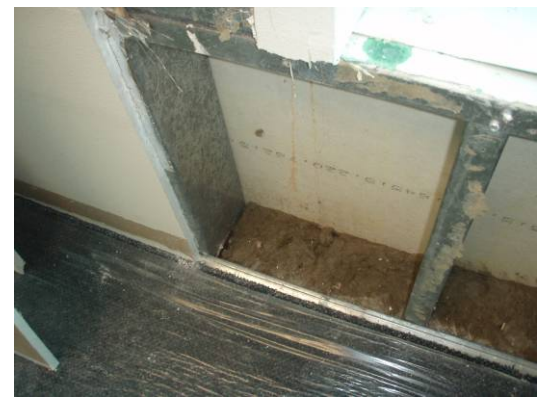
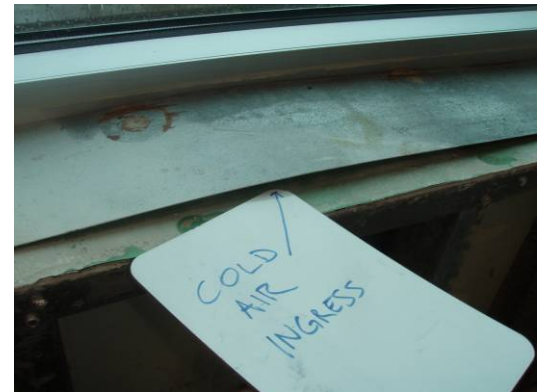
3.14 Interior Opening 3WA – Punched Window

- Interior gypsum generally appears dry.
- Staining is present on the bottom side of the wood sill stool
- Pink/brown stains and streaks are present on the interior side of the exterior sheathing below the window sill framing at the left jamb.
- On all punched openings, a piece of sheet metal covers the gap between the interior wall sill framing and the window frame which is installed on top of the brick cladding. The sheet metal is not sealed to either the interior wall framing or the window frame. Air moves freely through the brick cavity past the sheet metal to the interior space.

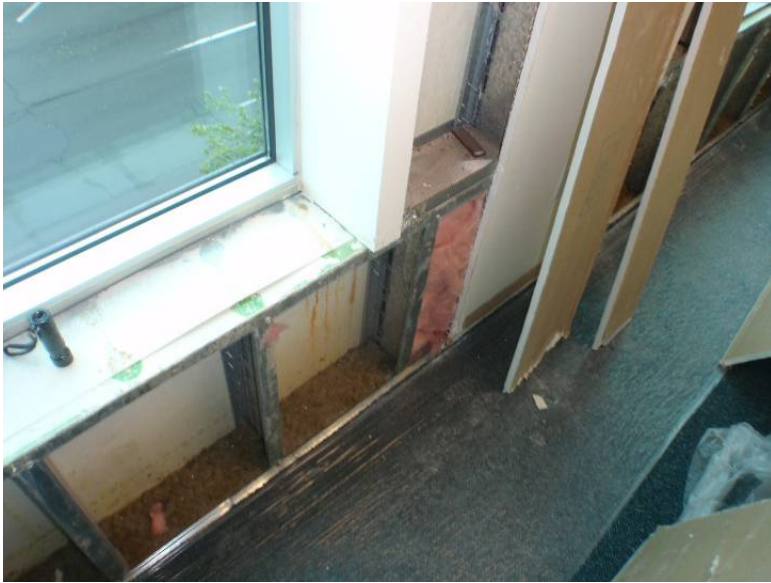
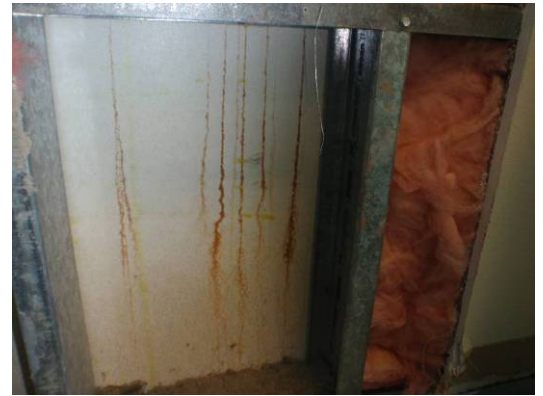
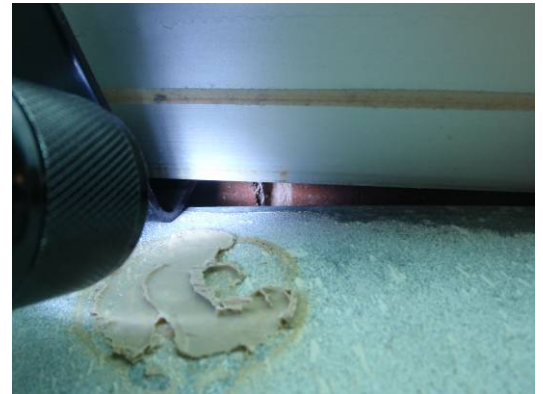
3.15 Interior Opening 3WB – Punched Window

- Interior gypsum generally appears dry.
- Pink/brown stains and streaks are present on the interior side of the exterior sheathing below the window sill framing and at each jamb area.
- The brick cladding is visible below the window sill frame.

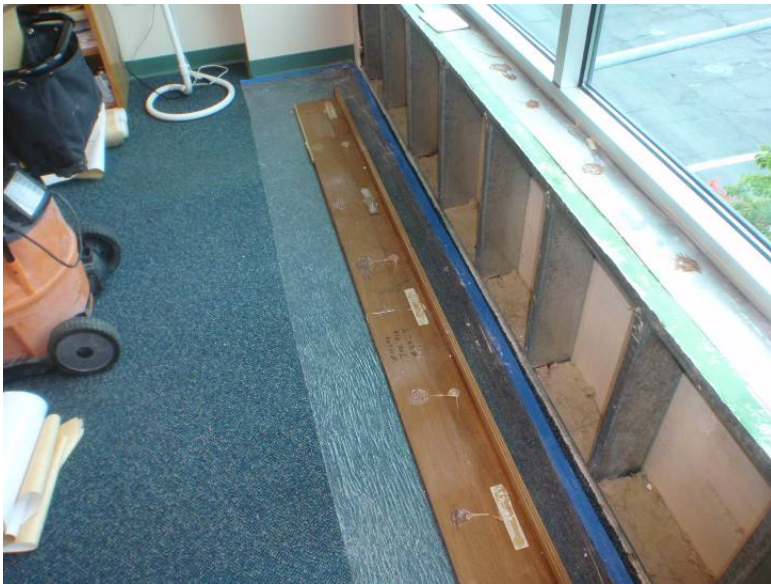
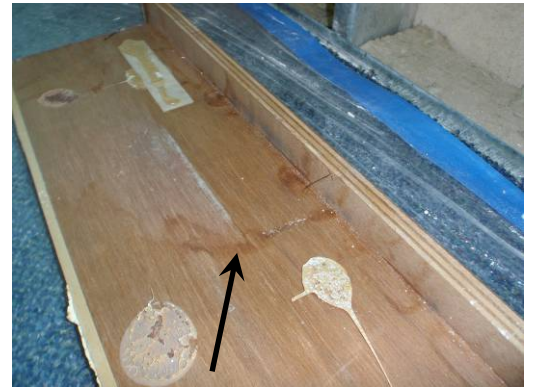
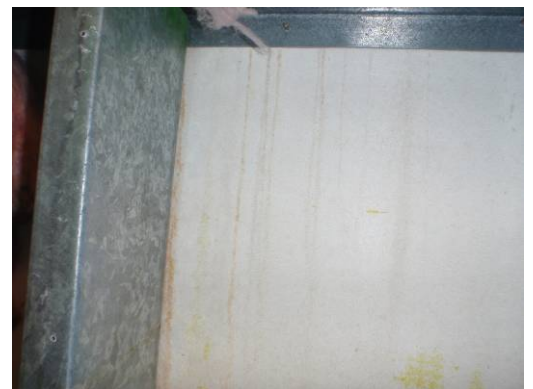
3.16 Interior Opening 3WC – Punched Window

- Interior gypsum generally appears dry.
- Staining is present on the bottom side of the wood sill stool
- Pink/brown stains and streaks are present on the interior side of the exterior sheathing below the window sill framing.

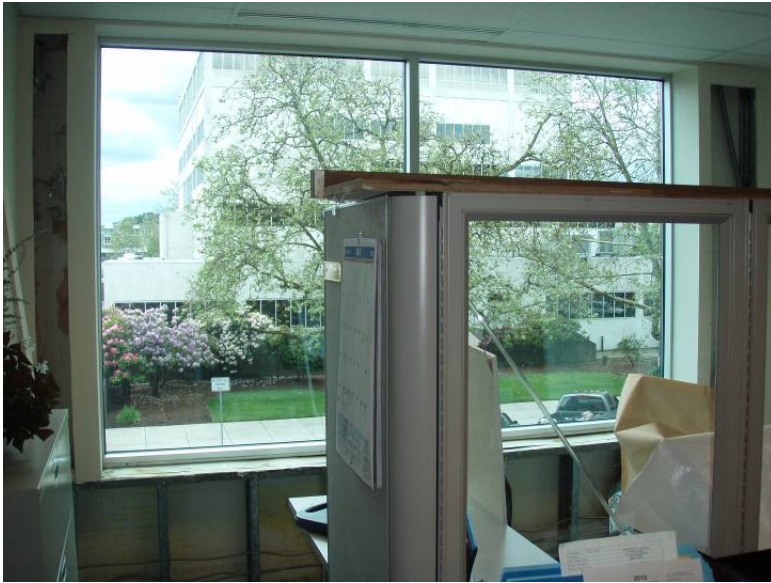
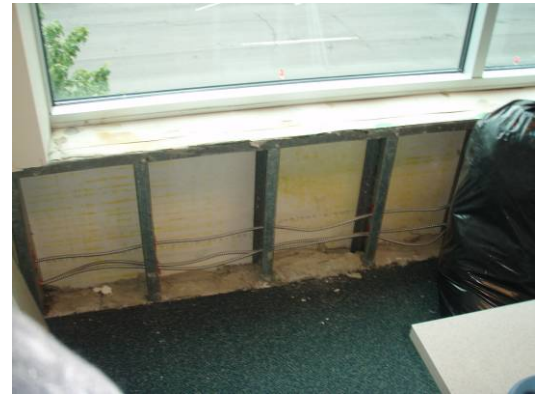
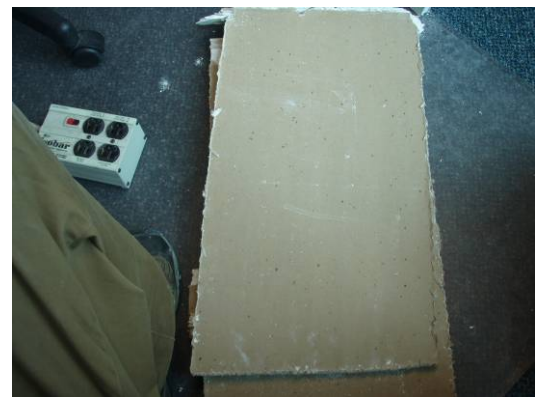
3.17 Interior Opening 2WA – Punched Window

→ Interior gypsum generally appears dry.

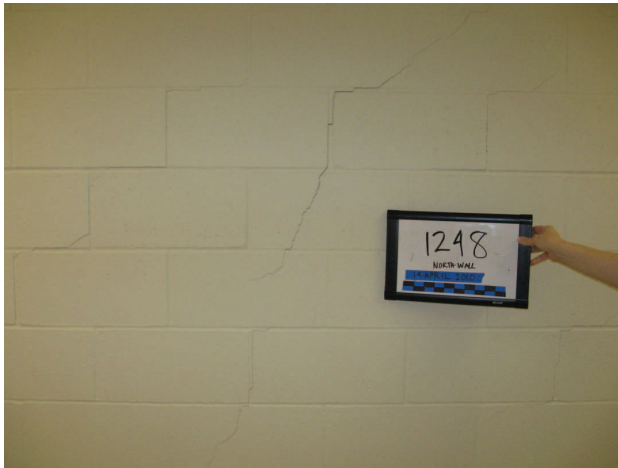
Top left and right : Cracks in masonry block walls

Bottom left: Wall crack can be seen above chair and below sign.

Bottom right: Ceiling grid has shafted and buckled.

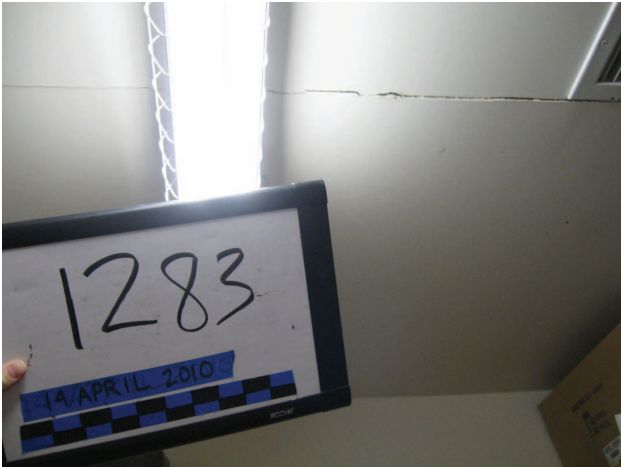
Top left: Ceiling crack in a utility space.

Top right: ceiling crack in the ground floor lobby.

Bottom left: Ceiling grid buckling at window head.

Bottom right: Racked door is binding at electrical room.

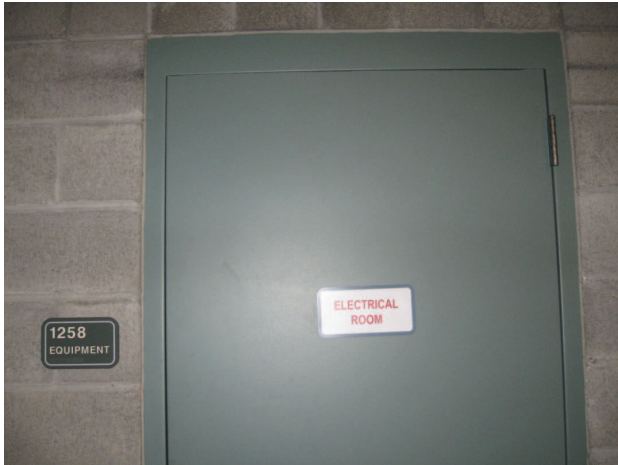
Top left: Racked electrical room door.

Top right: Wall damage at window jamb.

Bottom left: Wall damage at window jamb.

Bottom right: Cracked terrazzo floor at main lobby.

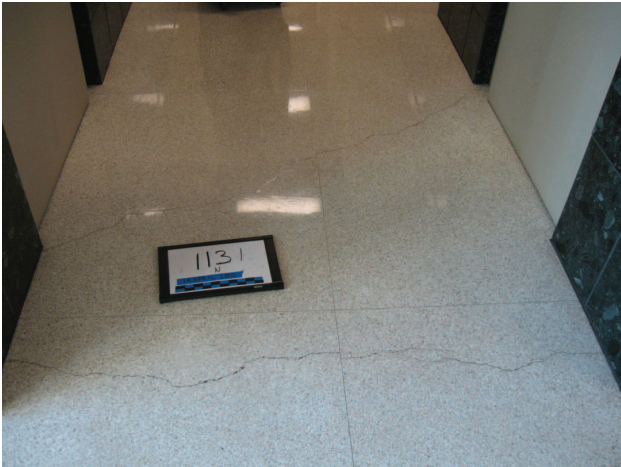
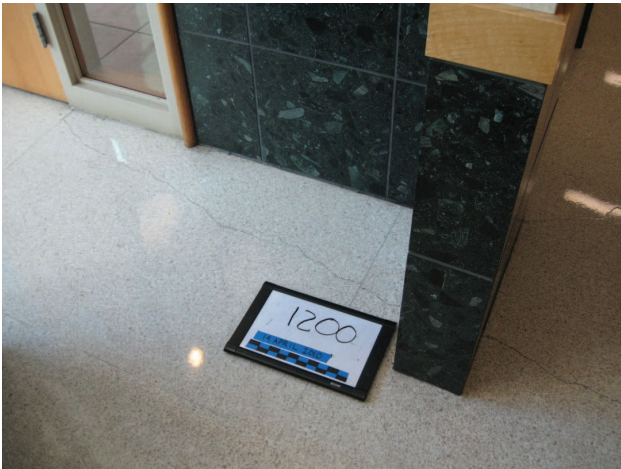
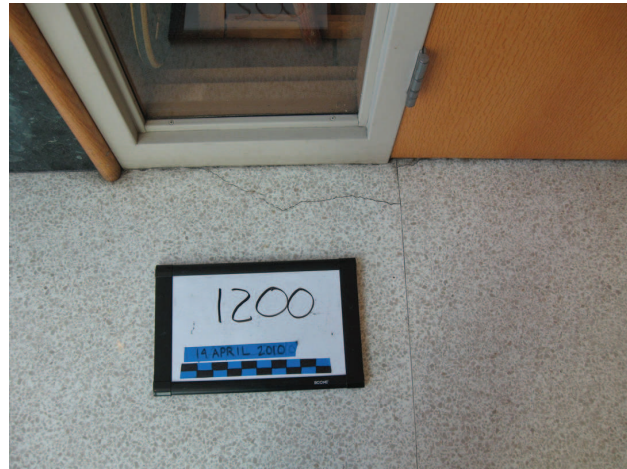
Top left and right: Cracked terrazzo floor at main lobby.

Bottom left and right: Cracked terrazzo floor at main lobby.

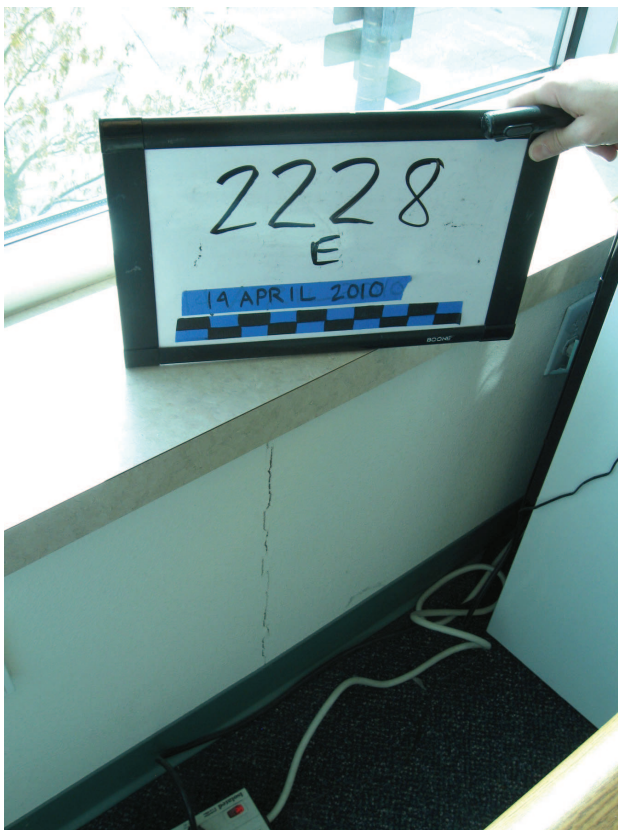
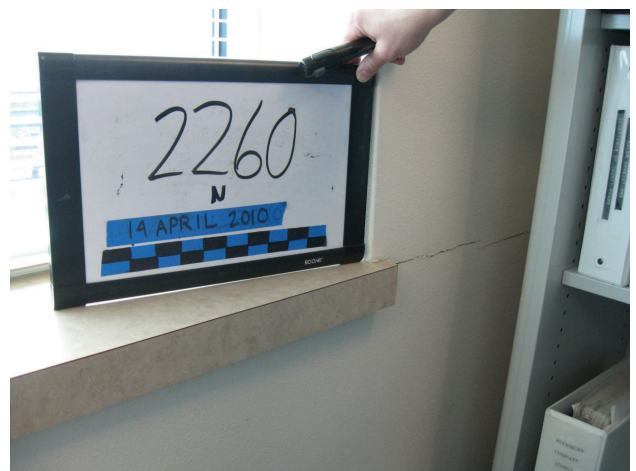
Top left and right: Small cracks are visible at some wall intersections.

Bottom left: Wall crack at exterior wall.

Bottom right: Horizontal wall crack at window sill.

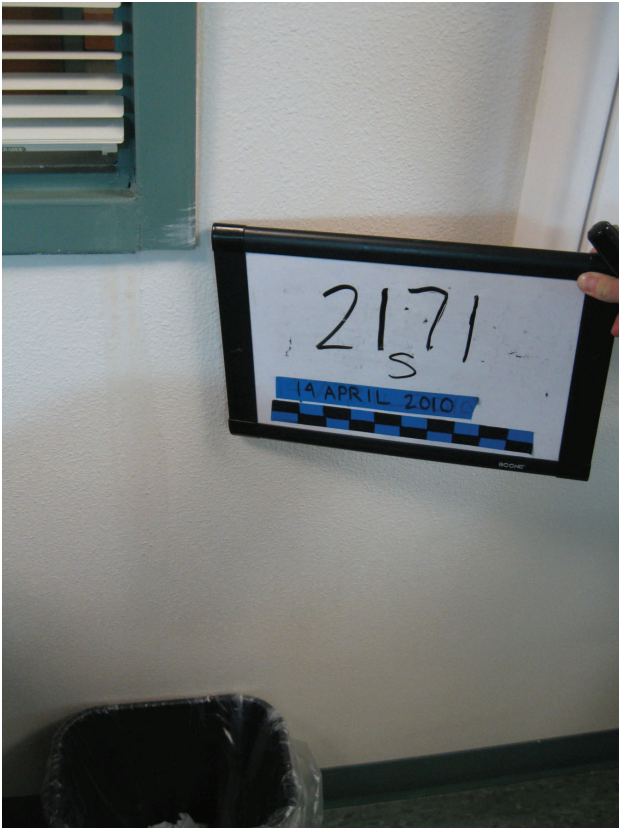
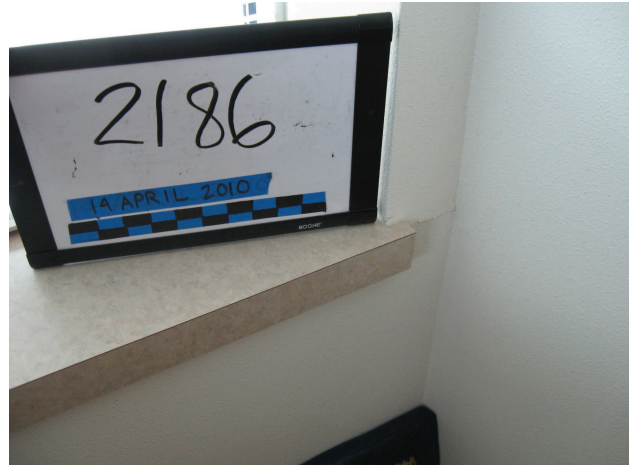
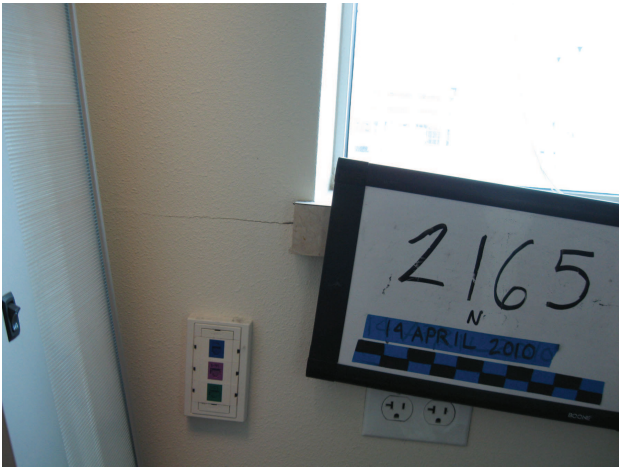
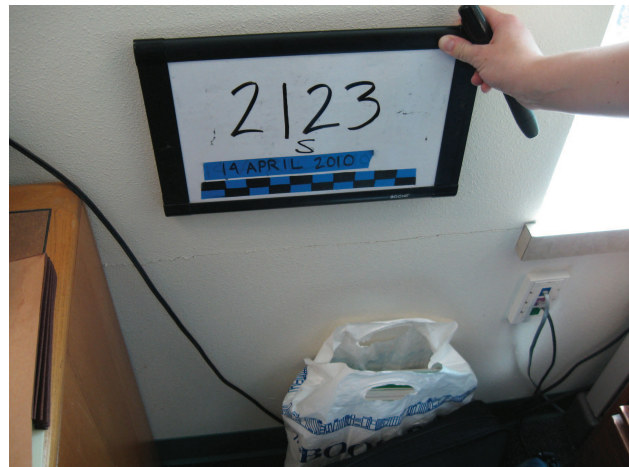
Top left: Wall crack with repair attempt.

Top right, bottom left and right: Horizontal wall crack at window sill.

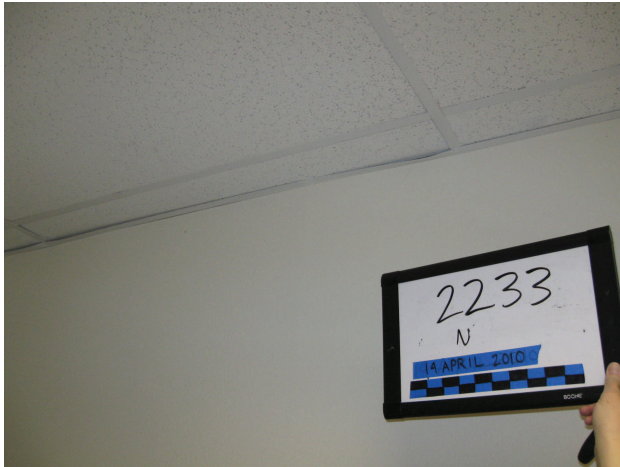
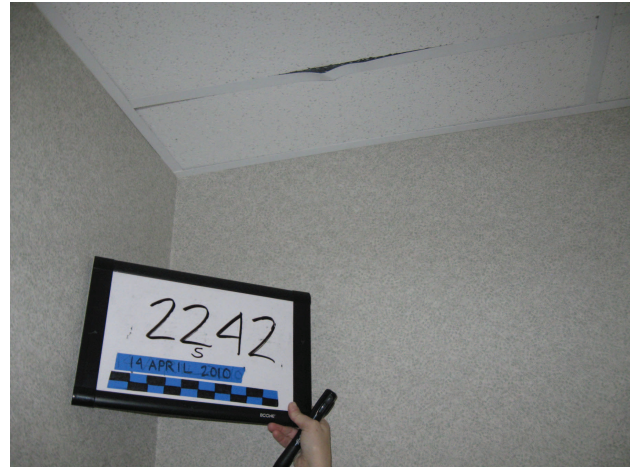
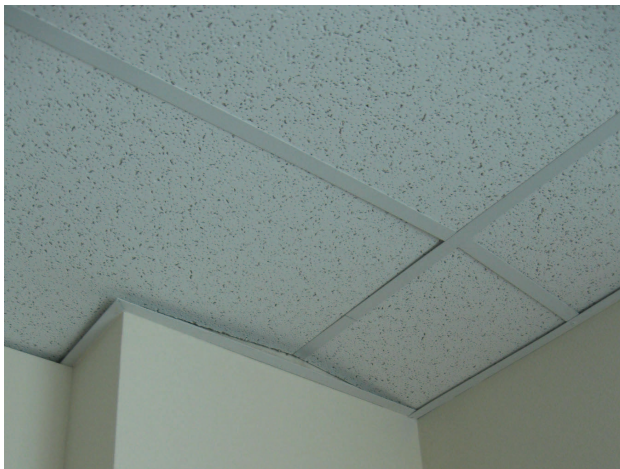
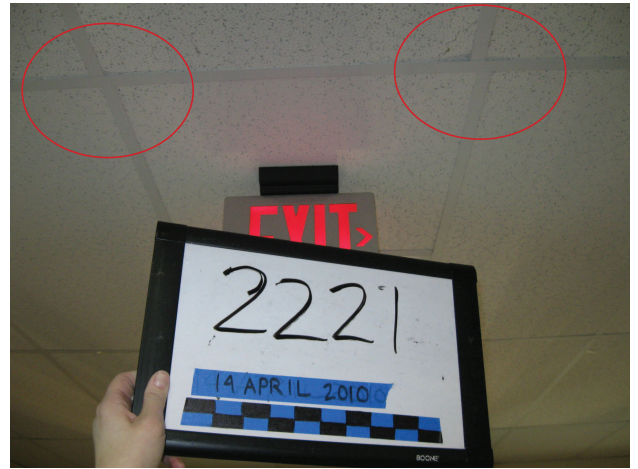
Top left, bottom left: Ceiling grid buckling at system perimeters.

Top right: Buckled ceiling grid.

Bottom right: Shifted ceiling grid can be seen at top of photo.

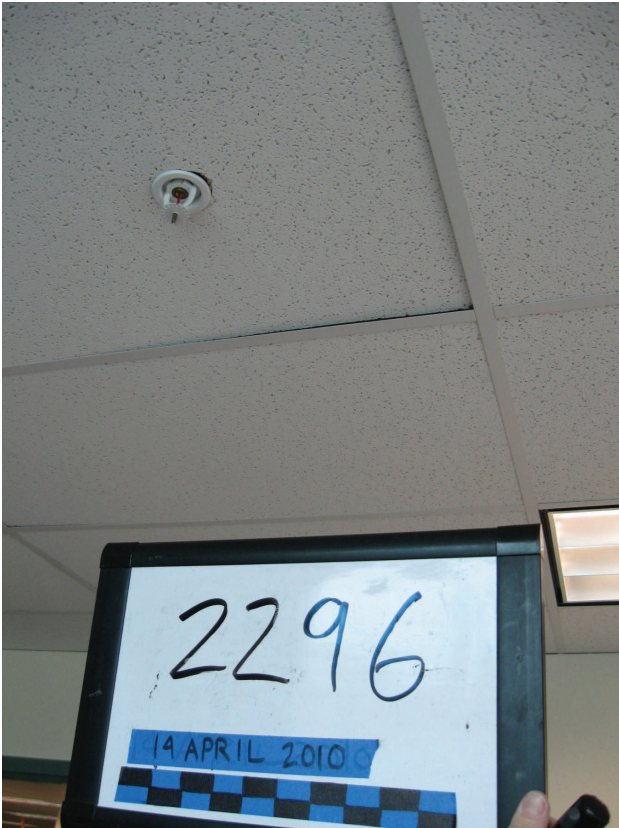
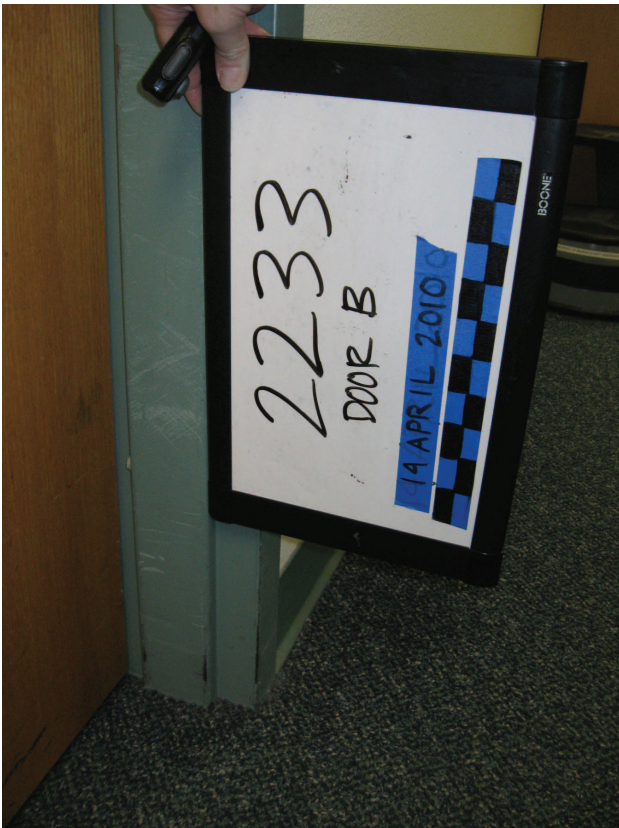
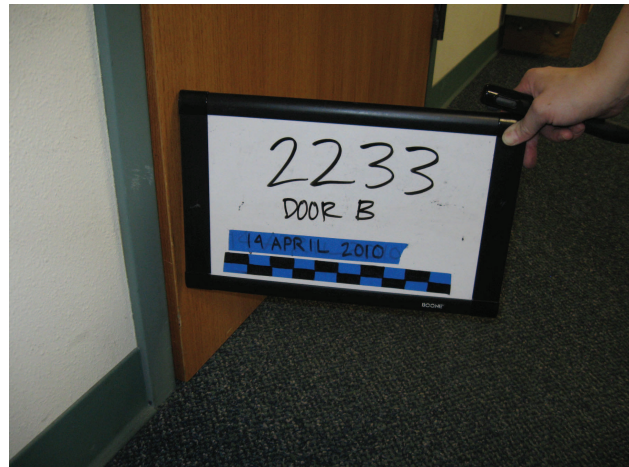
Top left and right: Buckled ceiling system.

Bottom left and right: Building movement can be seen by twisting door frames. This causes hardware to bind.

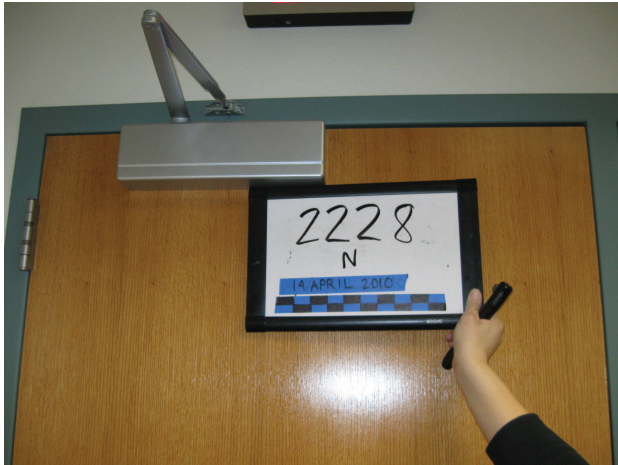
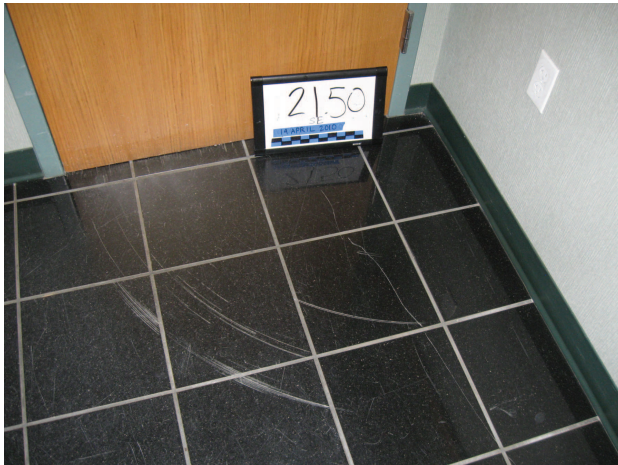
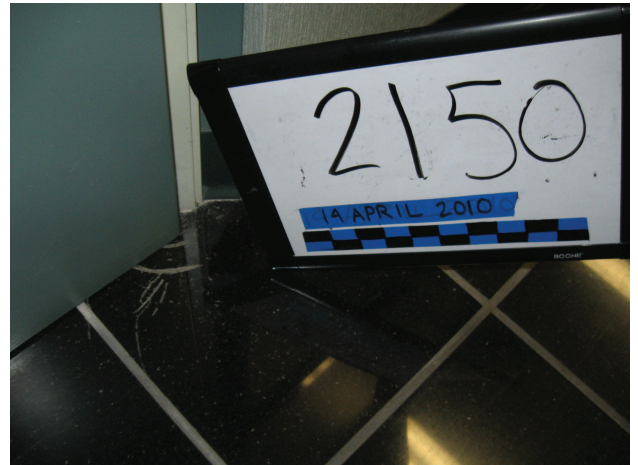
Top left: Racked door frame.

Top right: Racked door frame at elevator lobby fire doors causes them to rub. This may prevent proper function.

Bottom left and right: Building movement is causing some doors to damage floor finishes.

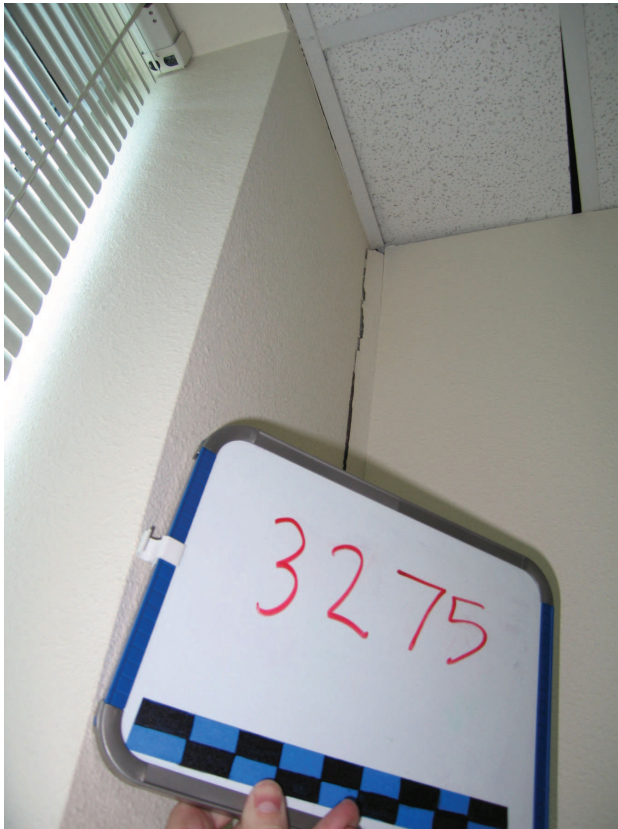
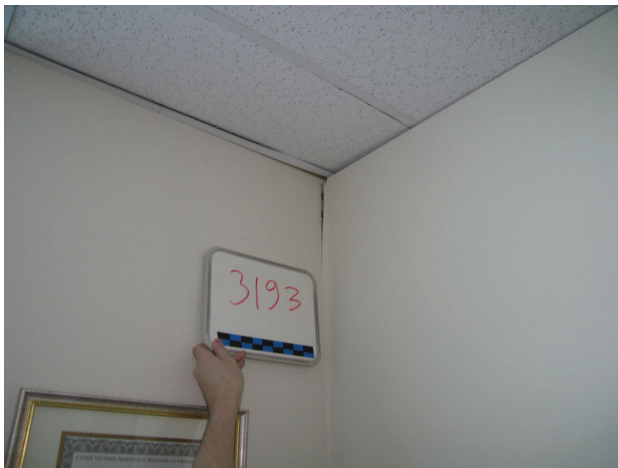
All photos: Cracks at wall intersections is more severe at the Third Floor compared to the Second Floor.

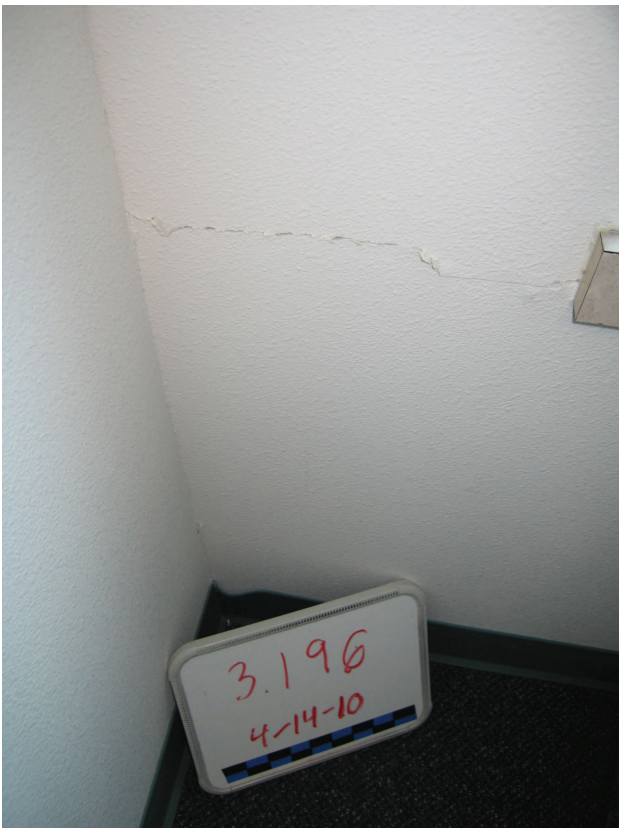
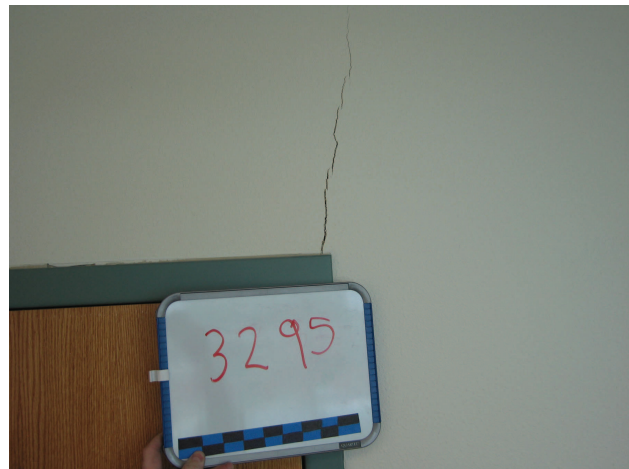
Top left: Wall crack at building column.

Top right and bottom left: horizontal wall crack at window sills.

Bottom right: Wall crack at door frame.

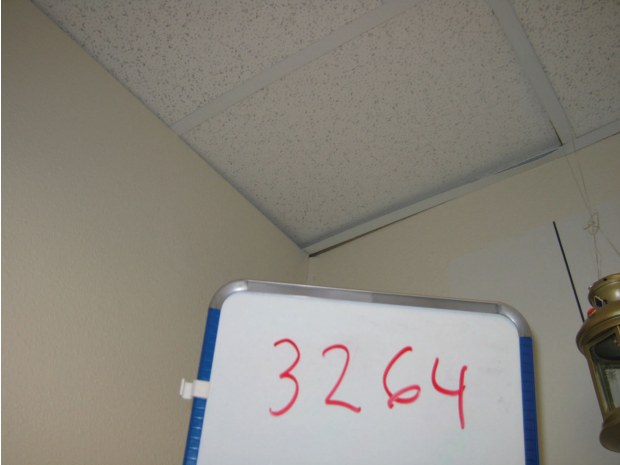
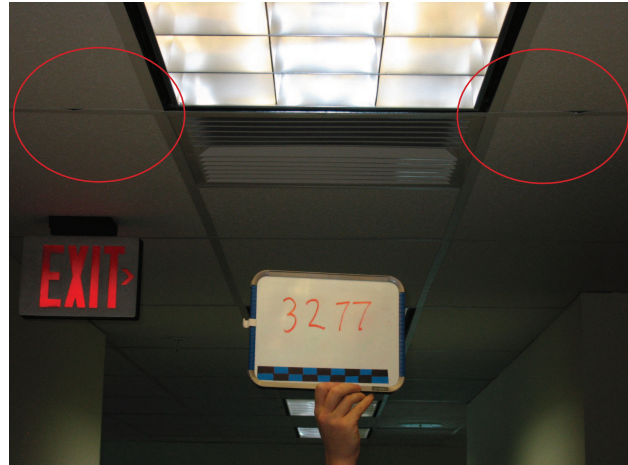
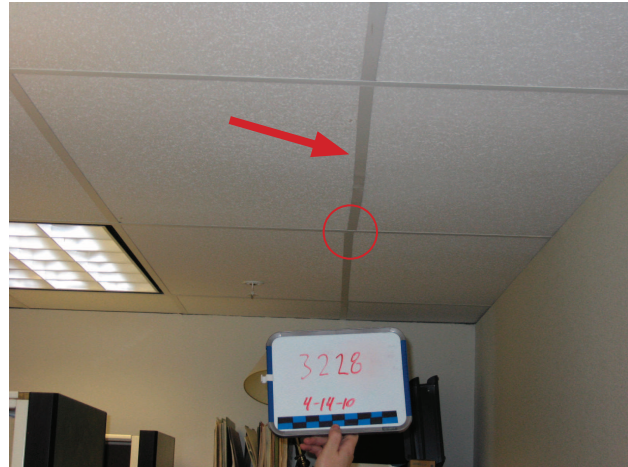
Top left: Buckled ceiling grid and ceiling tile.

Top right: Ceiling grid is buckled on each side of the light fixture.

Bottom right: Shifting ceiling grid caused by building movement.

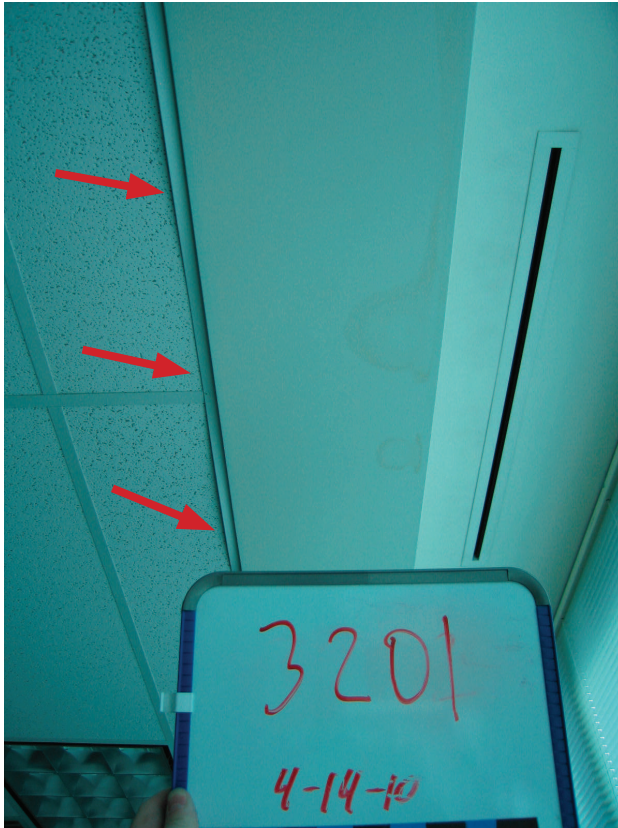
Top left and right: Buckled and shifted ceiling grids.

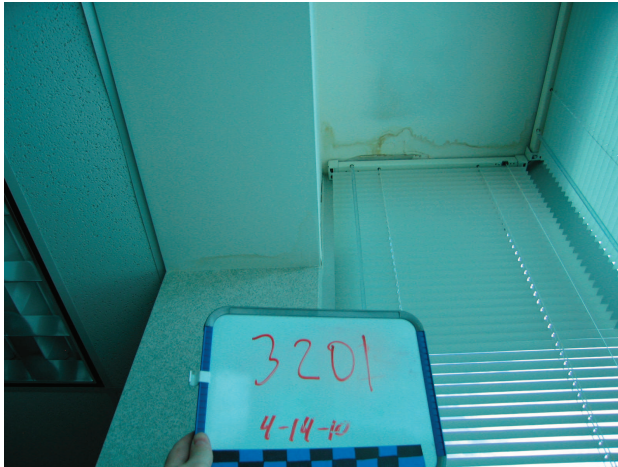
Bottom left: Damage caused by water infiltration.

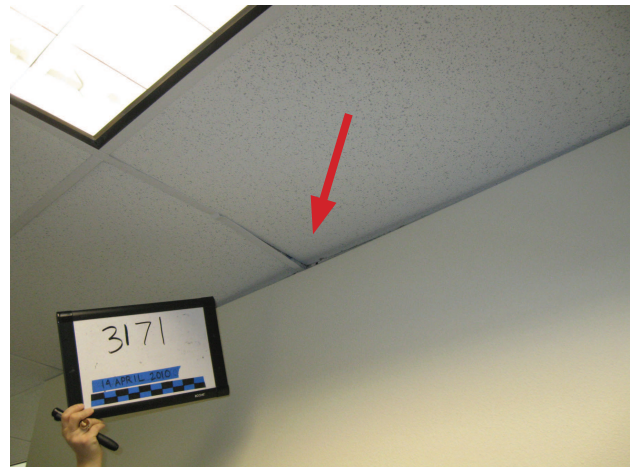
Bottom right: Buckled ceiling grid.

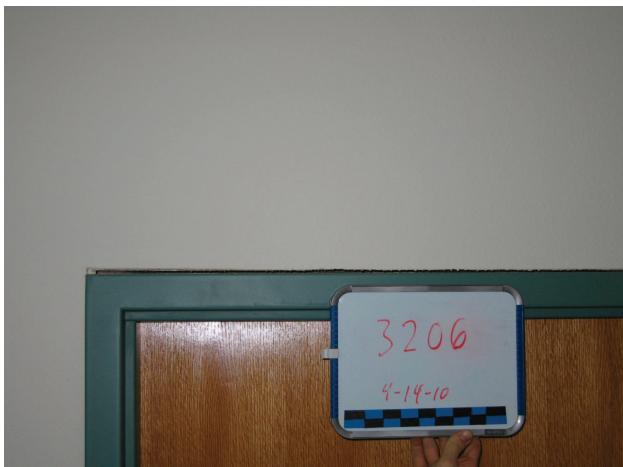
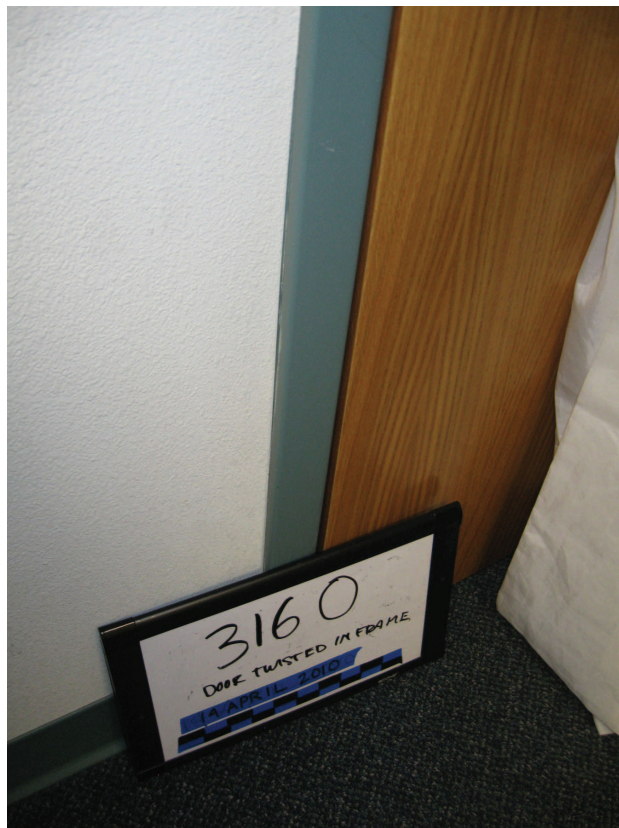
Top left and right: Racked door frames causing twisted and binding doors.

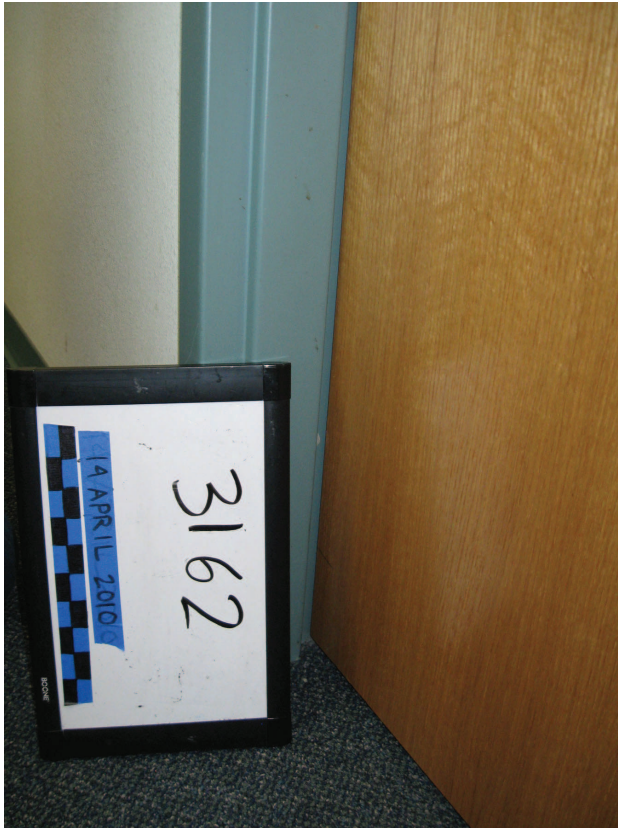
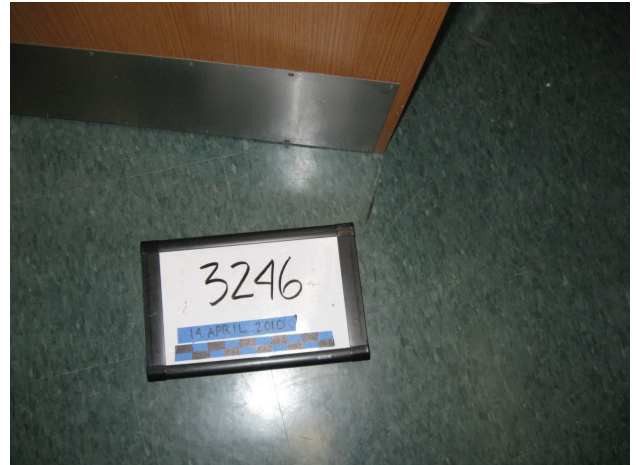
Top left and right: Building movement is causing doors to function improperly.

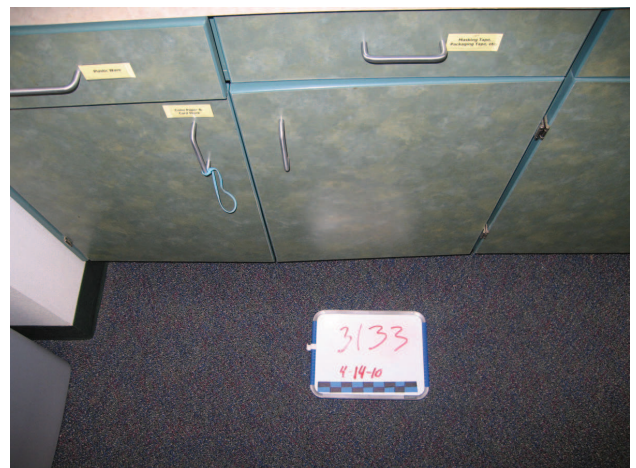
Bottom left and right: Building movement has caused casework and cabinetry functionality issues.

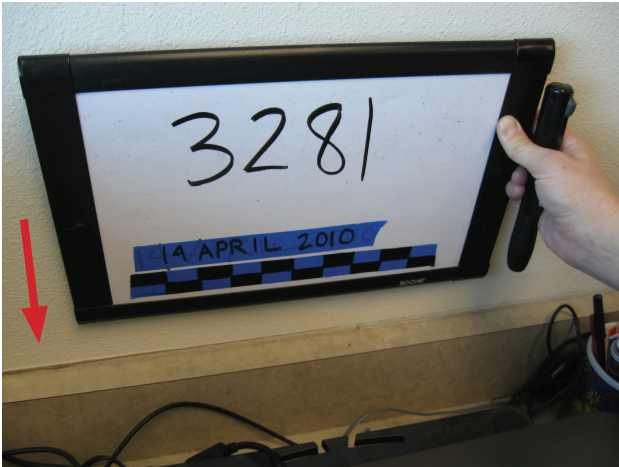
Top left and right: Casework and cabinet functionality to due building movement.
