**Marion County Courthouse Square
555 Court Street NE, Salem Oregon
Remediation Study Final Report
February 07, 2011**

Volume Three of Six

Miller Consulting Engineers, Inc.
Structural Photographic Documentation

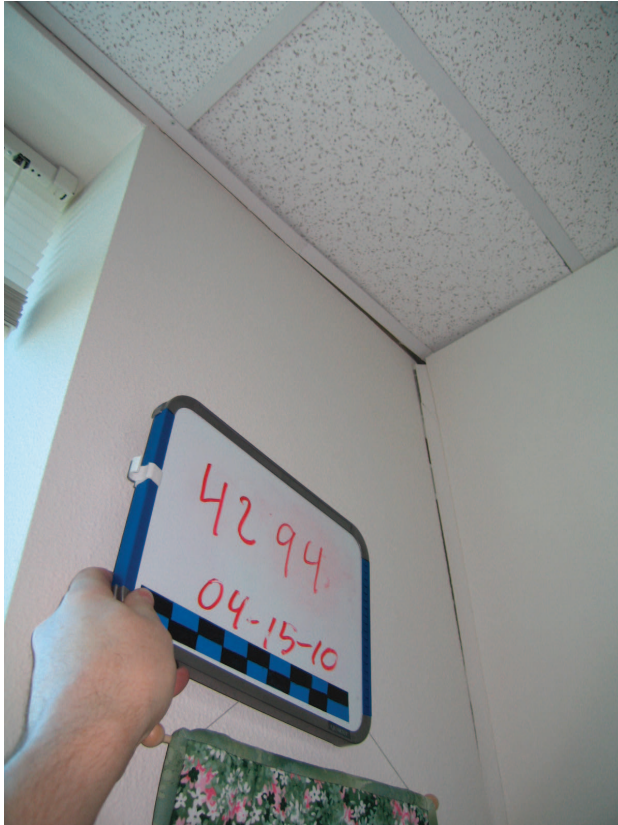
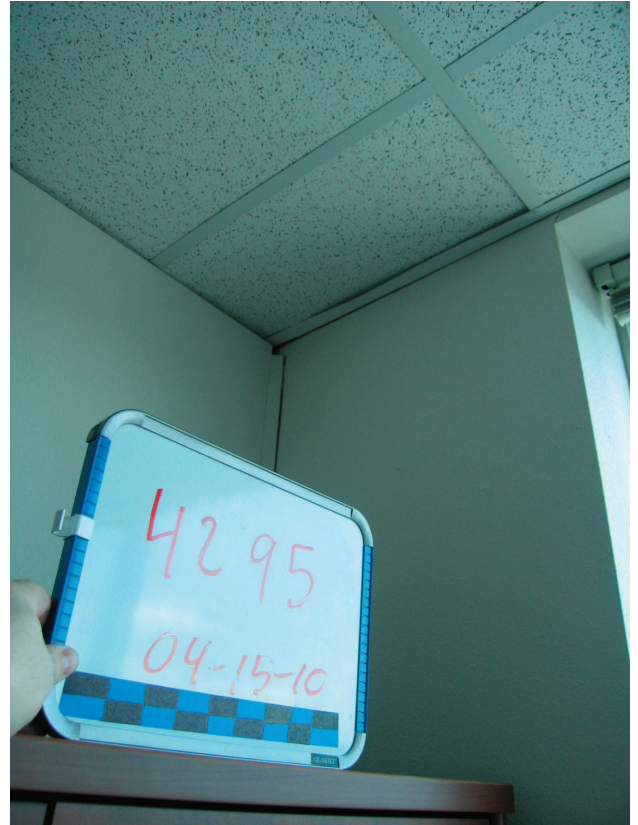
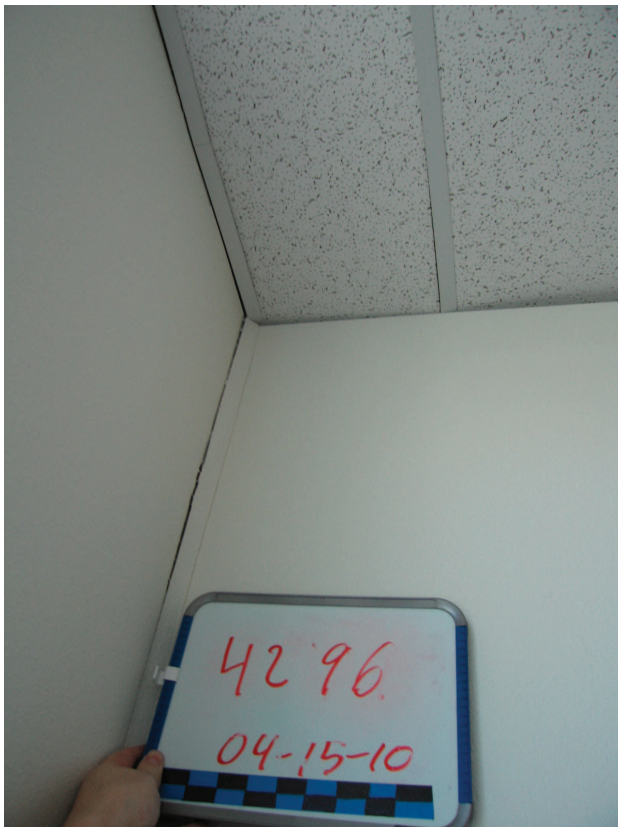
Opposite page: Cracks at wall intersections is more severe when compared to the second or third floor.

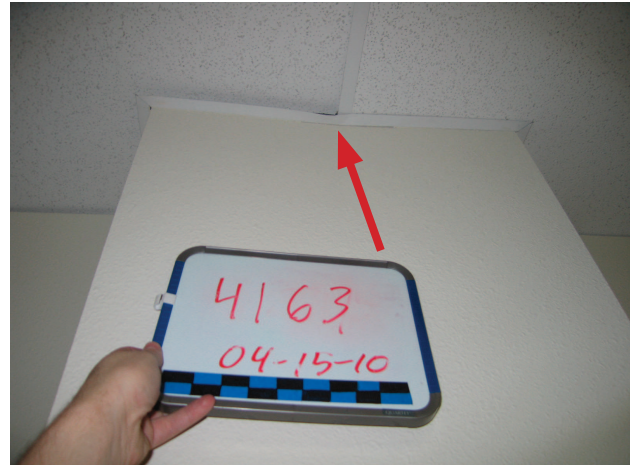
Bottom left and right: Compression stress on the ceiling grid system.

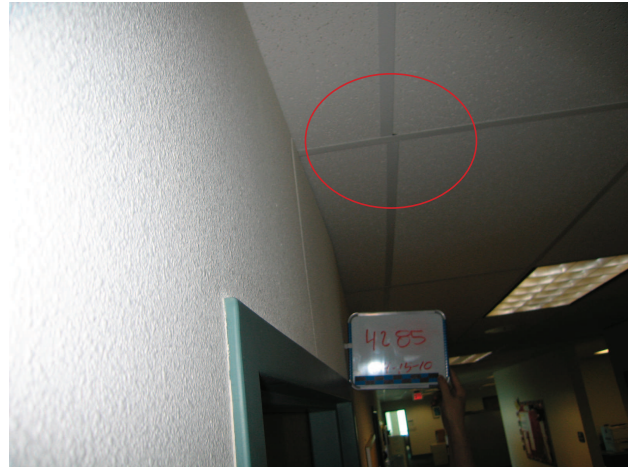
Top left and right: Ceiling grid system has shifted due to building movement.

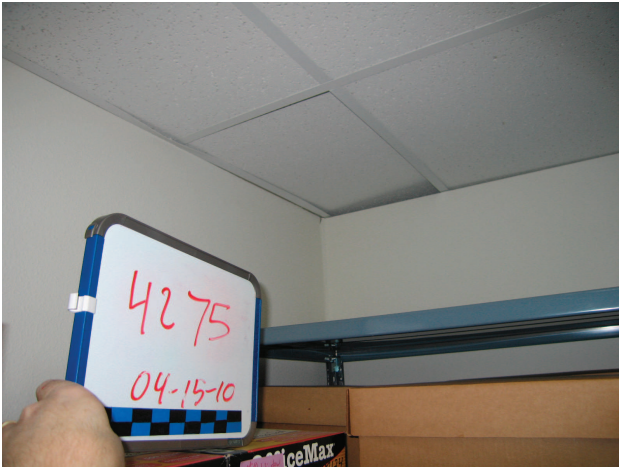
Bottom left and right: Ceiling grid and panels have buckled due to building movement.

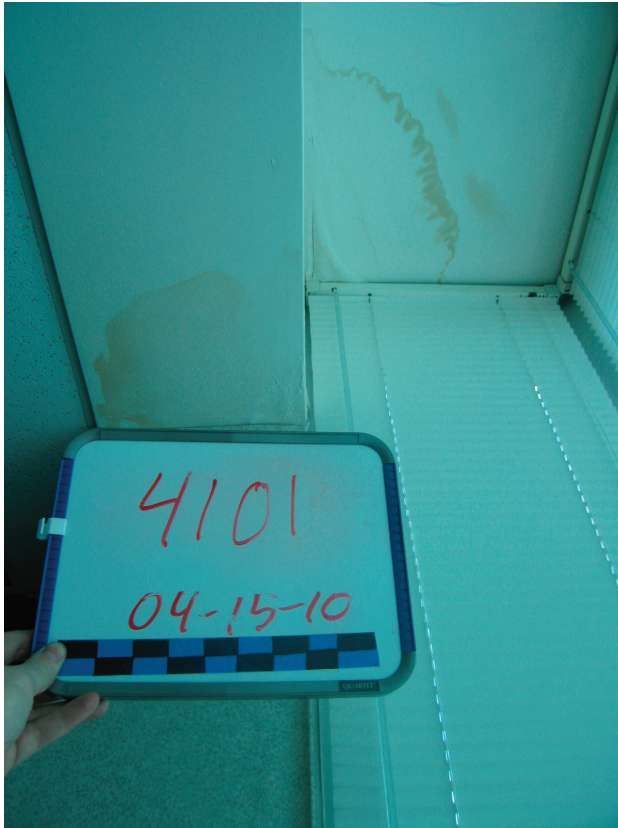
All photos: Damage due to water infiltration is evident at numerous window locations.

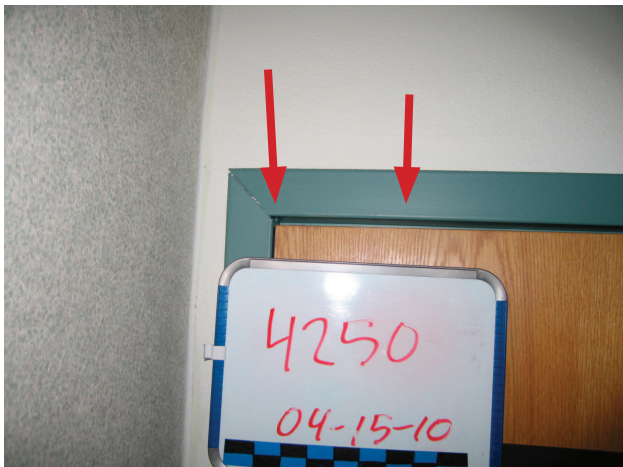
All photos: Building movement has caused racked frames resulting in binding doors and other damage.

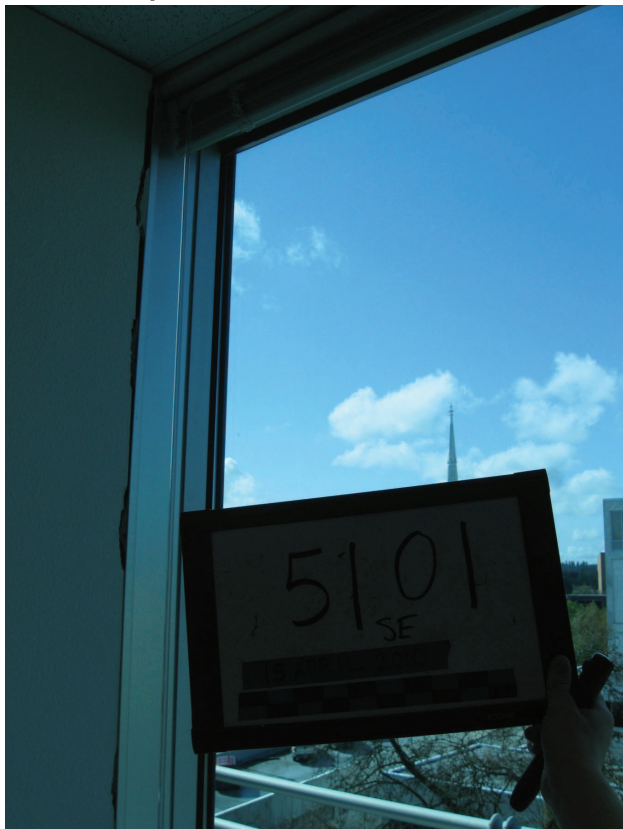
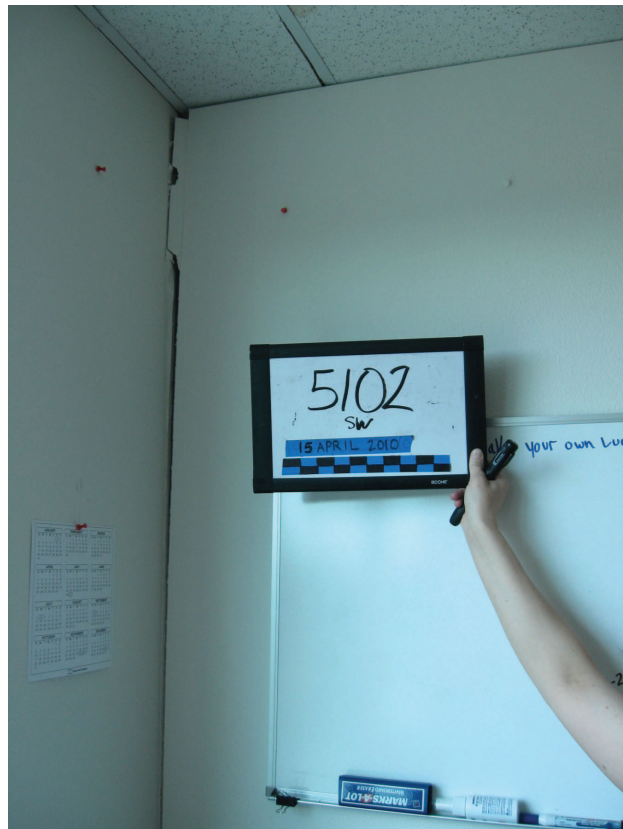
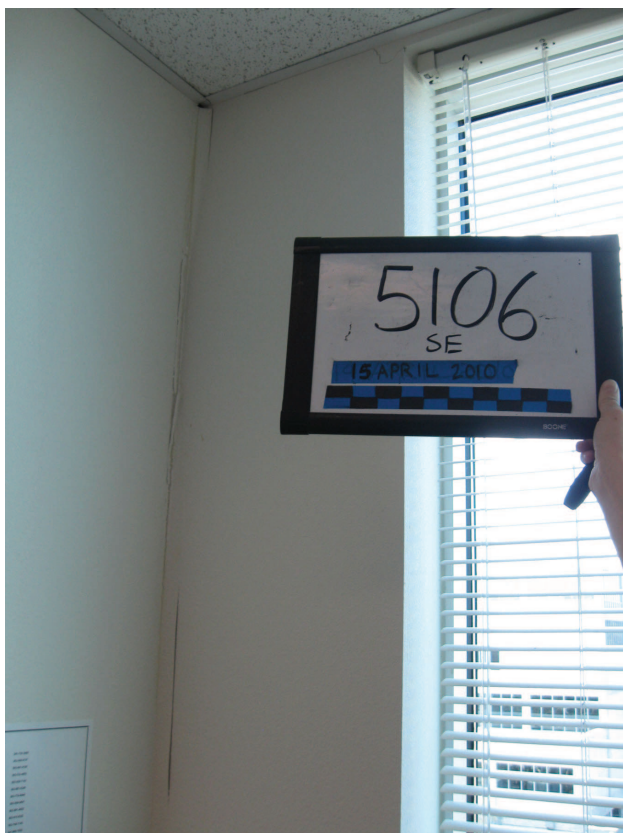
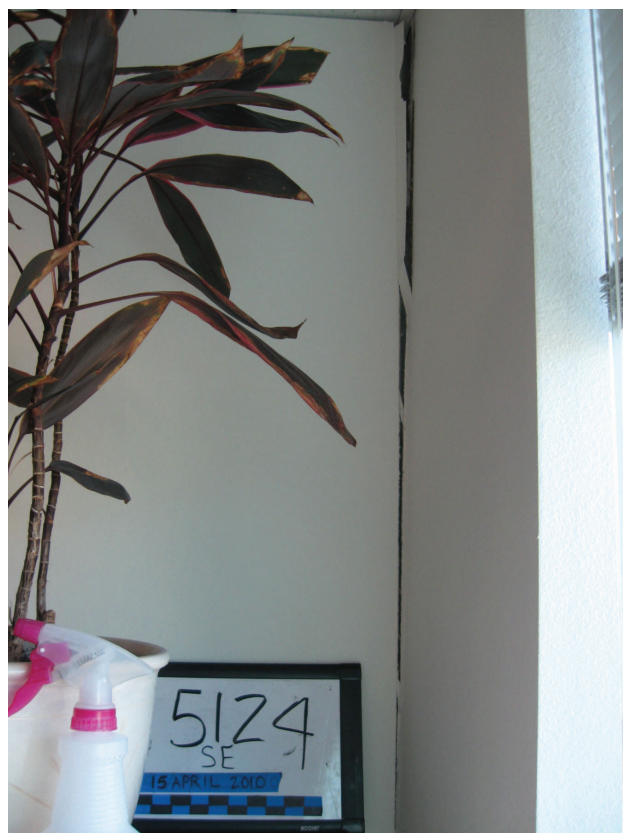
Opposite page: Cracks at wall intersections is most severe at the fifth floor.

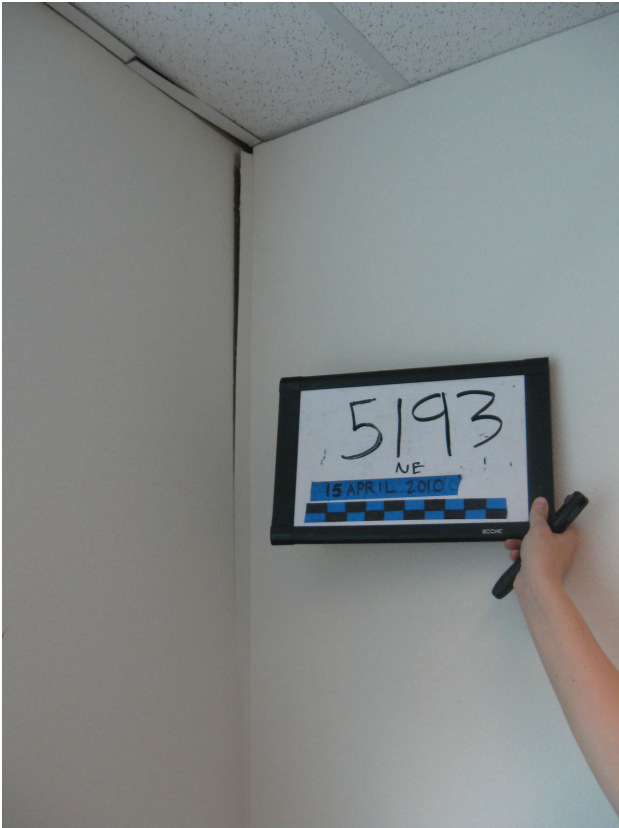
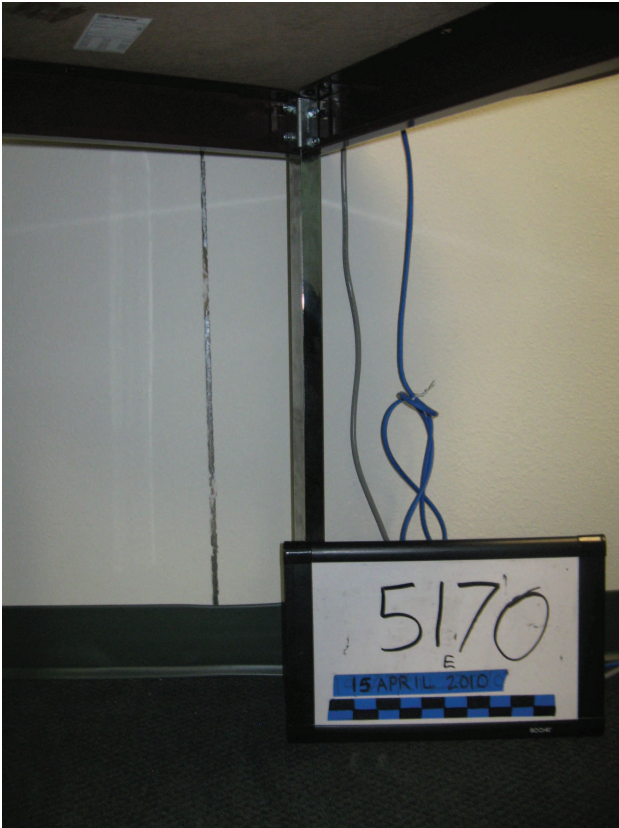
All photos: Wall cracks at door frame.

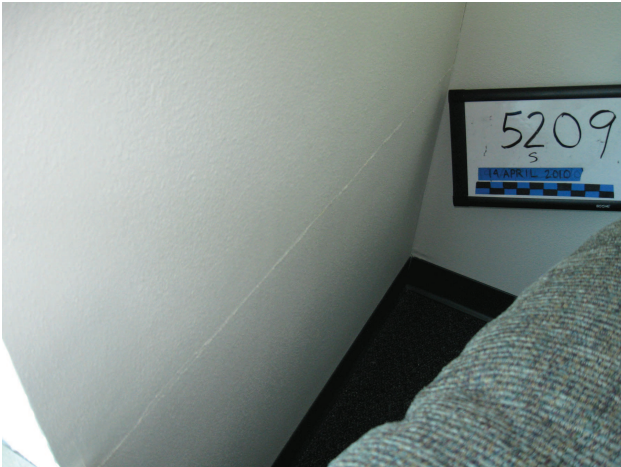
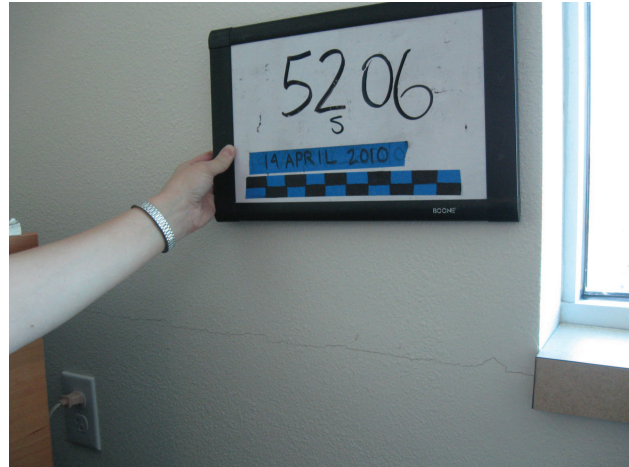
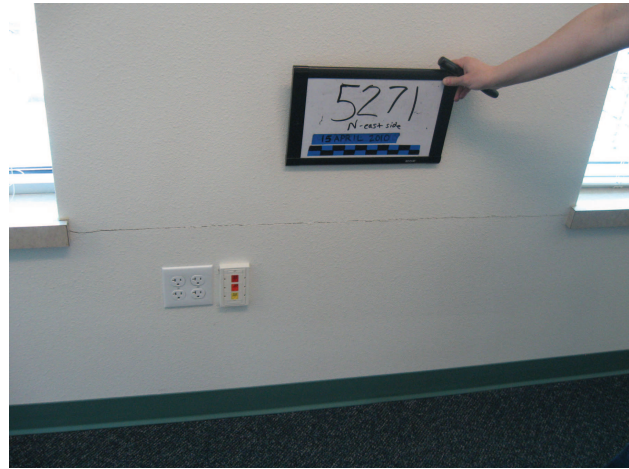
All photos: Horizontal wall crack occurs at nearly all window sills on the Fifth Floor.

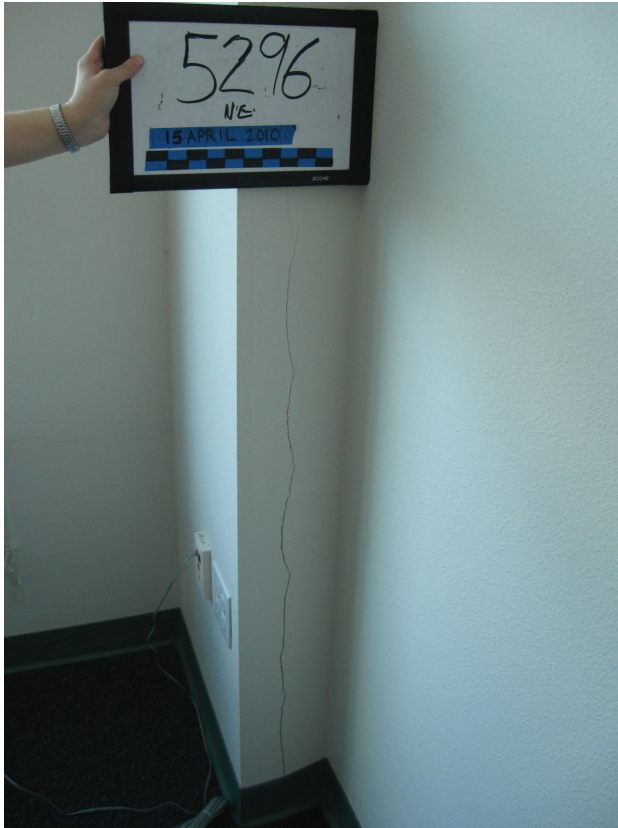
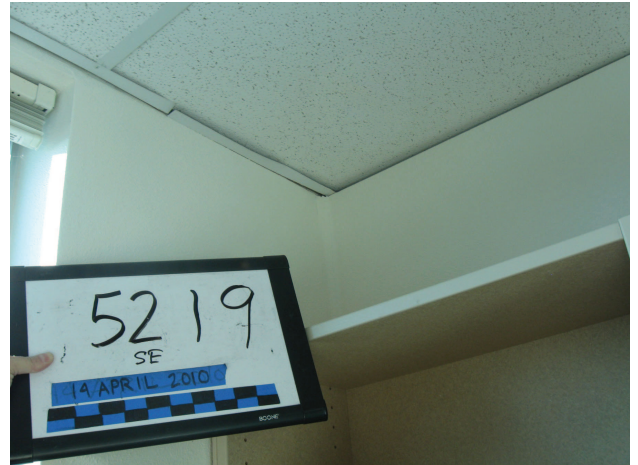
Top left: Building movement resulting in crushed walls.

Top right, bottom left and right: Buckled ceiling grid and panels.

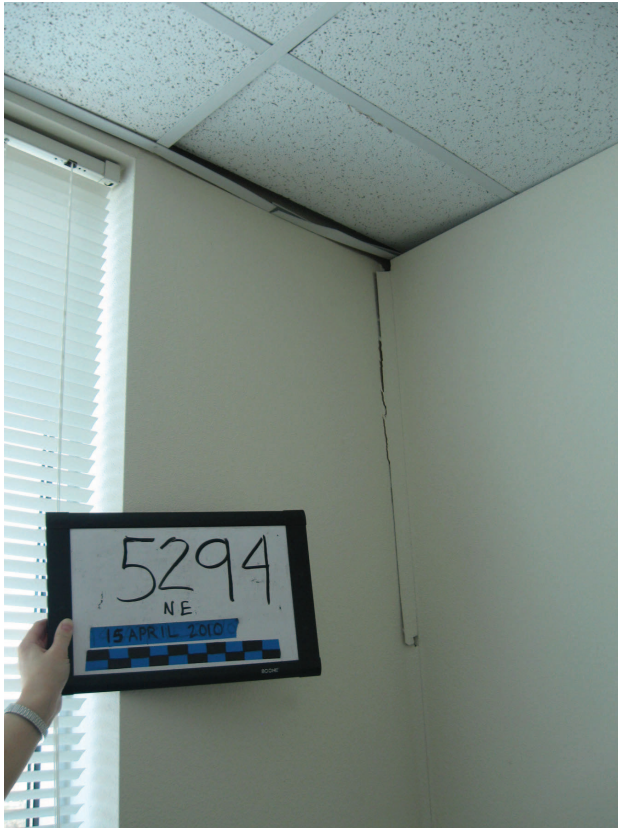
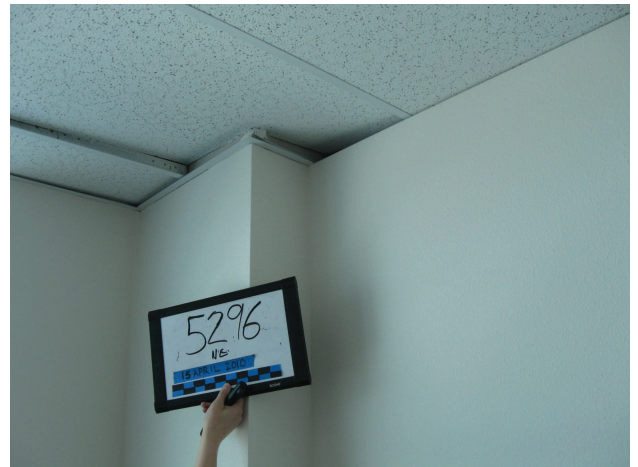
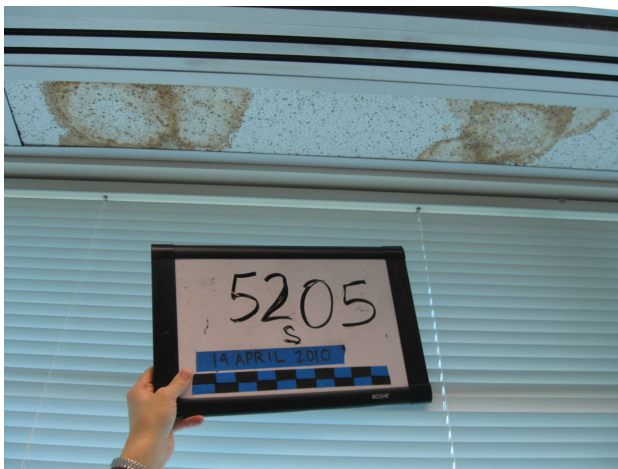
Top left and right: Significant building damage due to building movement.

Bottom left and right: Damage due to water infiltration.

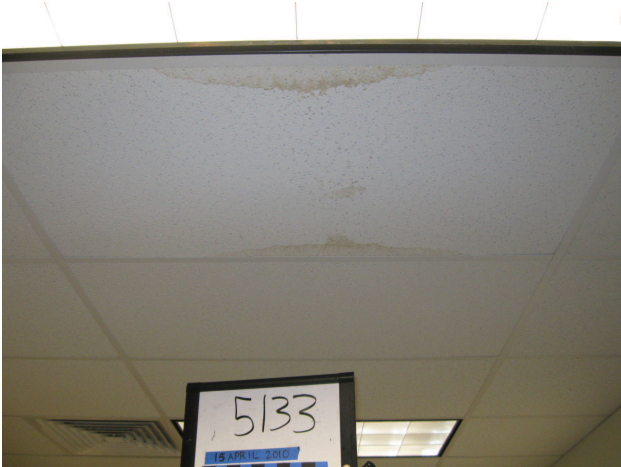
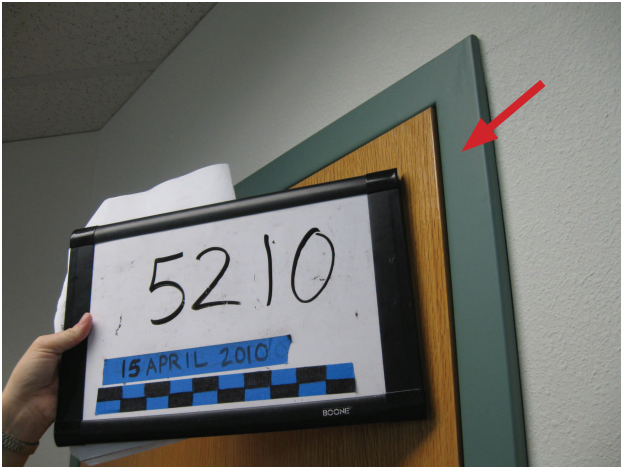
Top left and right: Damage due to water infiltration.

Bottom left and right: Racked door frames causing doors to bind.

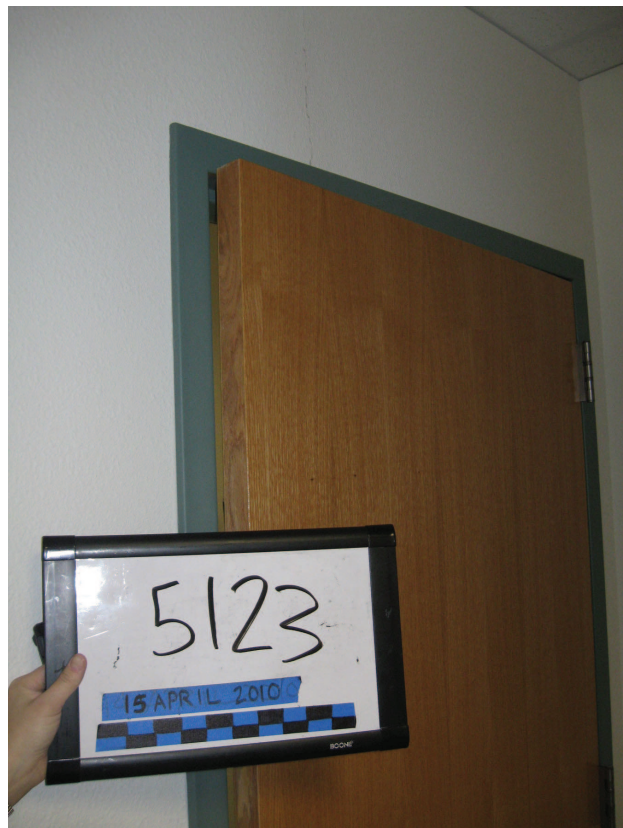
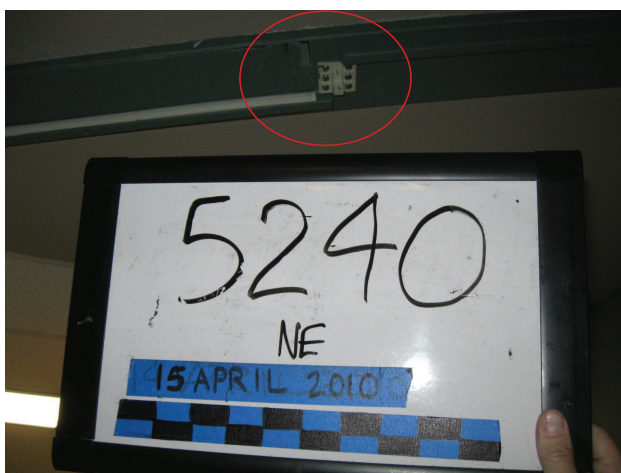
Top left and right, bottom left: Building movement has caused door frames to rack. In some instances, doors can not close completely.

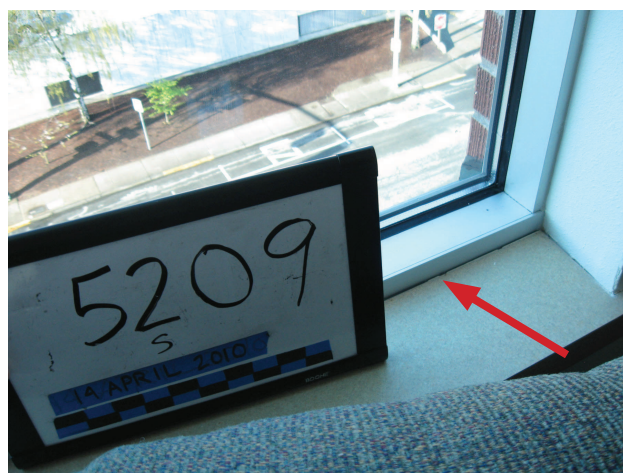
Bottom Right: Building movement has resulted in other damage such as separately window sills.

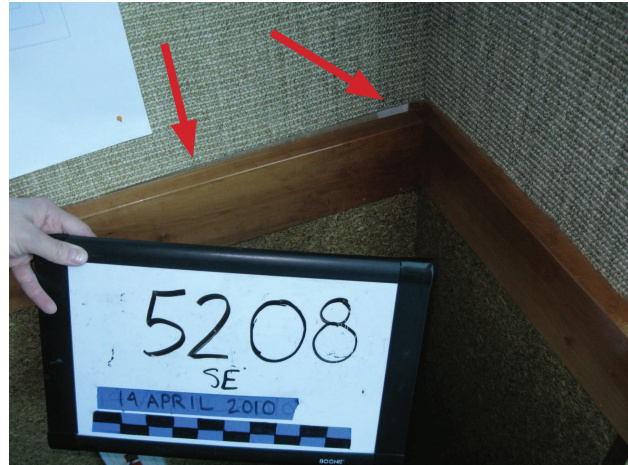
Top right: Building movement has caused rigid finishes to separate from walls.

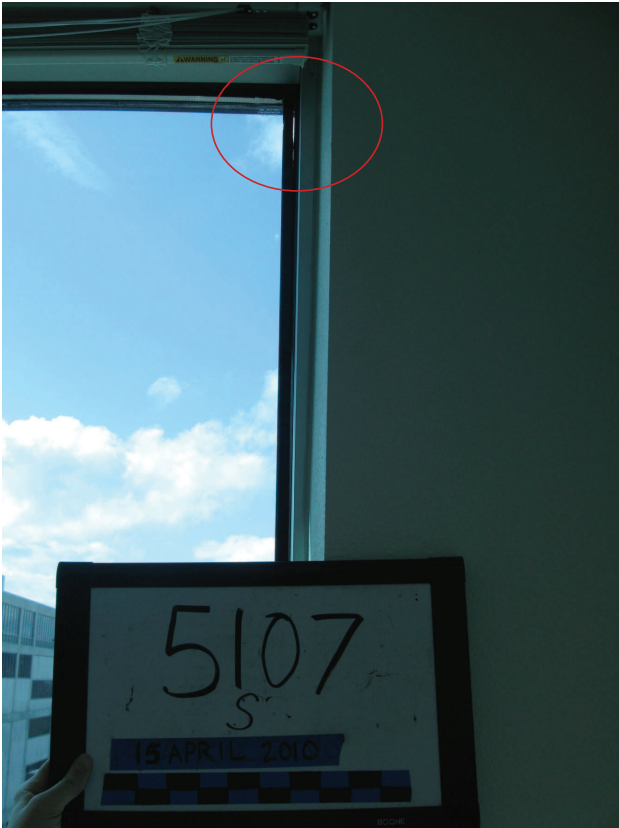
Bottom left: Building movement has caused exterior window frames to rack. In this extreme example, the window frame is separating from the glass. This is noticeable by a sliver of daylight between the glass and window frame.

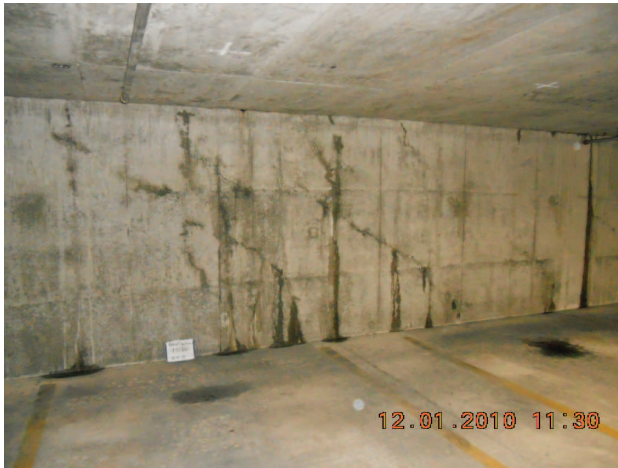
NE portion of Bus Mall foundation wall.

All photos: Parallel cracks point toward the middle of the wall.

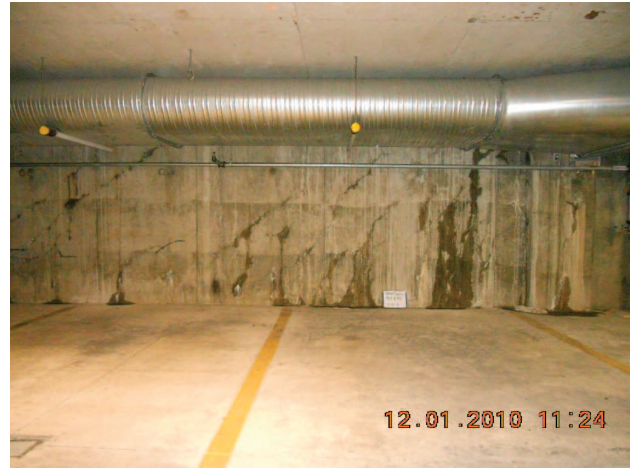
SE portion of Bus Mall foundation wall.

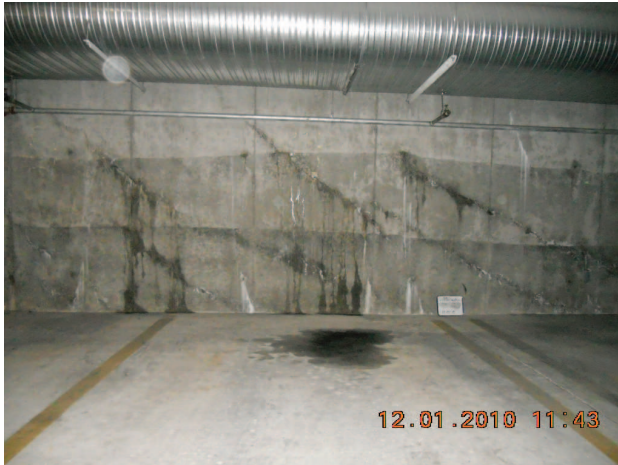
SW portion of Bus Mall foundation wall.

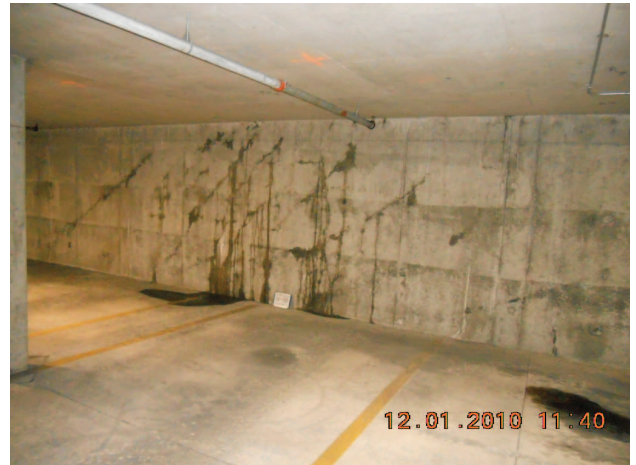
NW Portion of Bus Mall foundation wall.

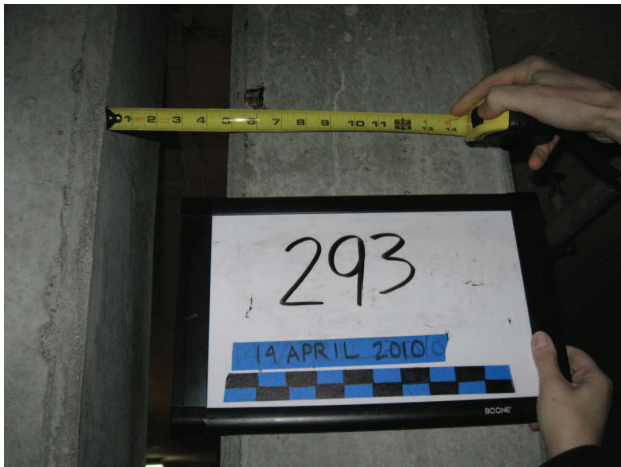
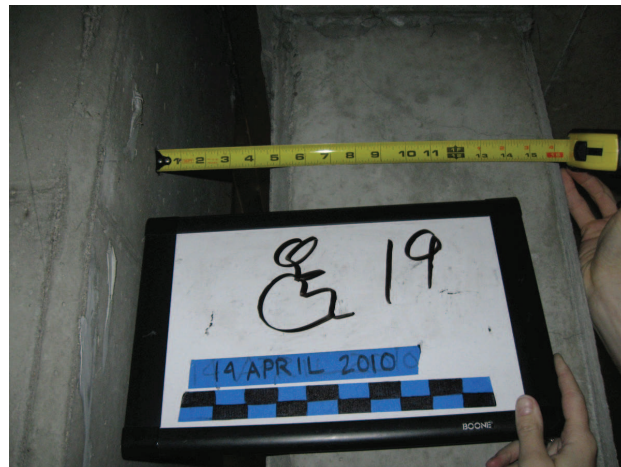
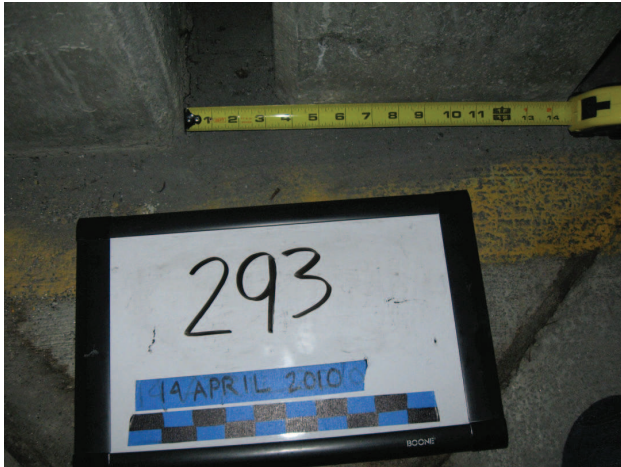
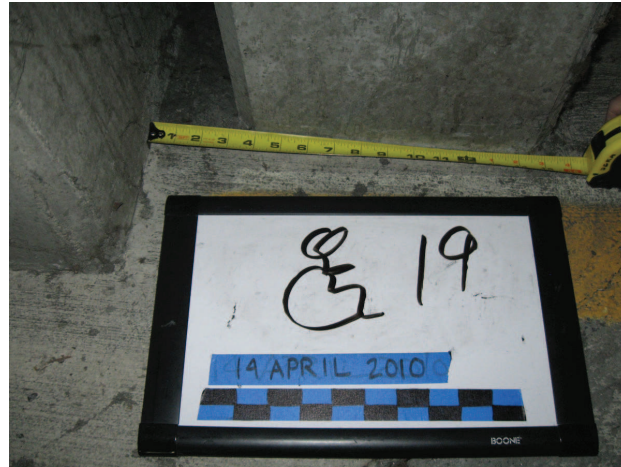
All photos: Columns can be measured to determine how much they lean.

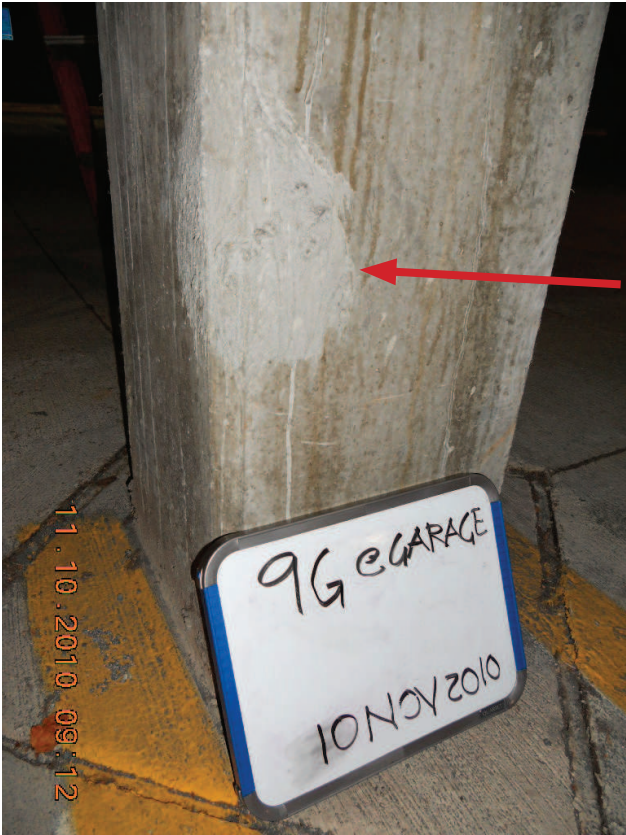
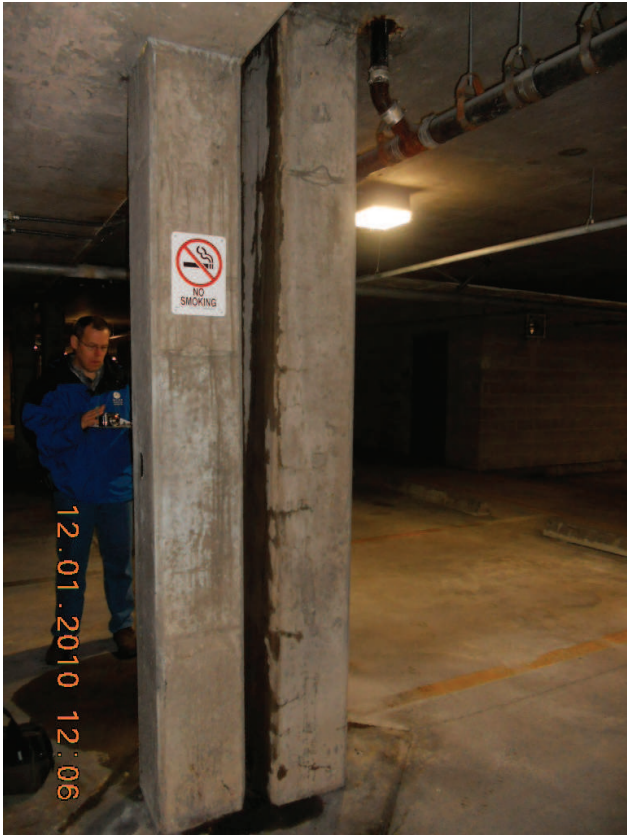
Top left and right: North Block column at grid M-1. Water infiltration is noticeable in the December photo.

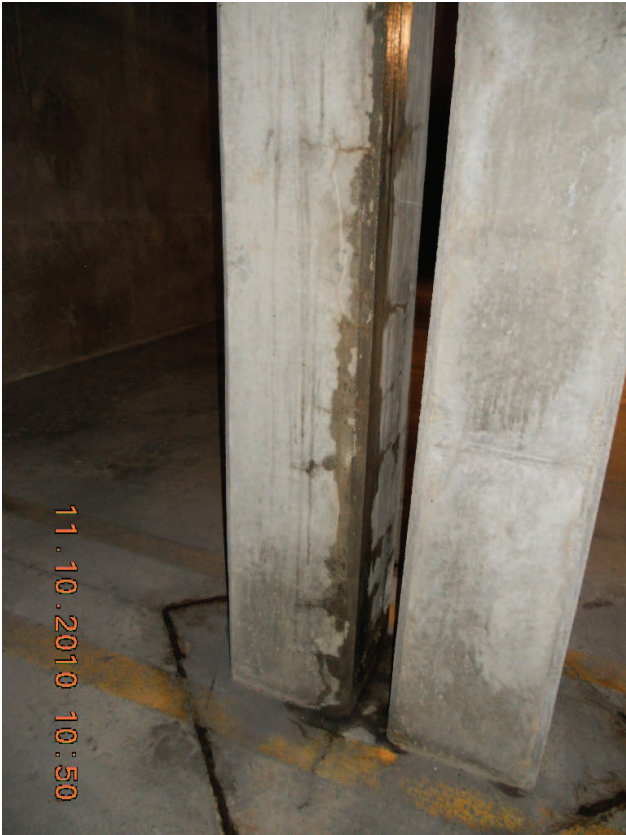
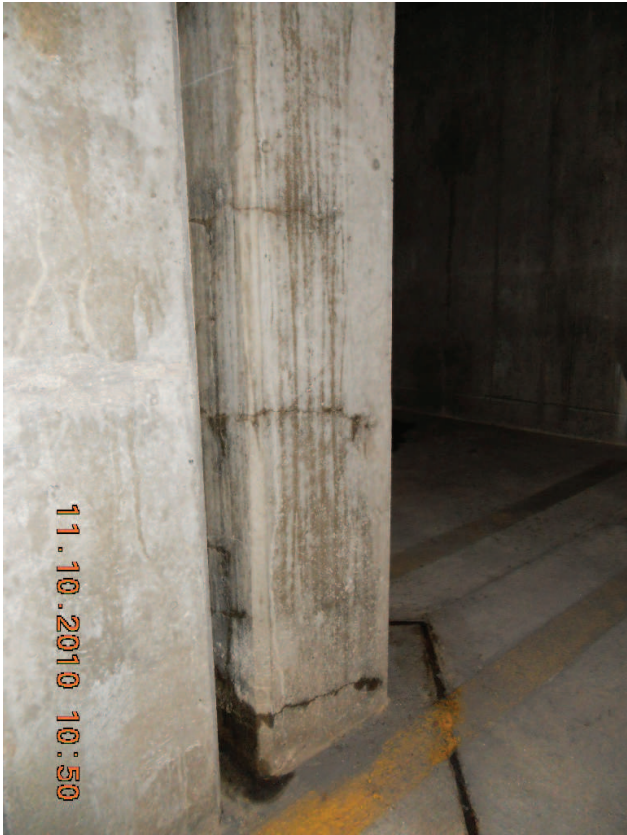
Bottom left and right: Columns damaged and repaired during construction.

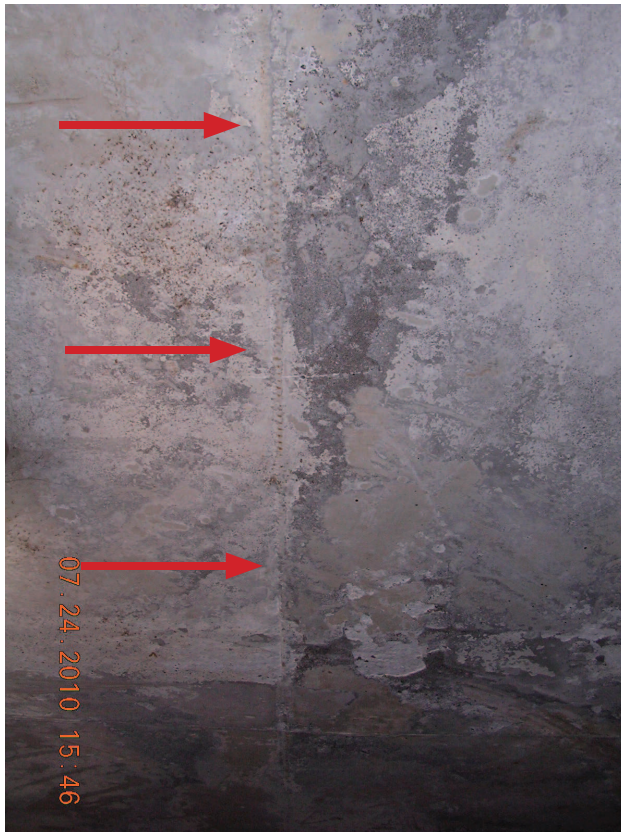
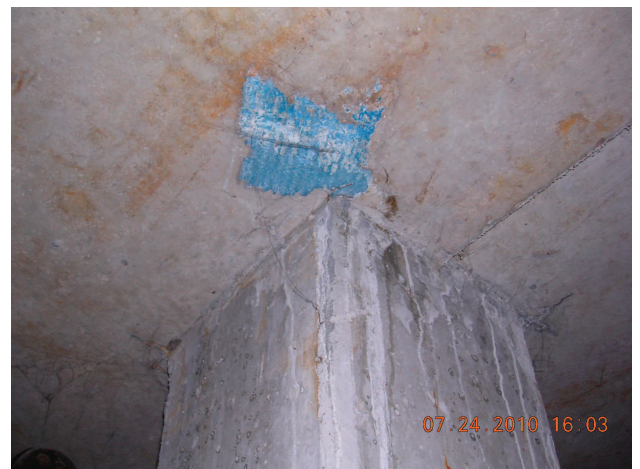
Top right, bottom left and right: Water infiltration has highlighted cracks in columns due to the shortening of the Bus Mall slab.

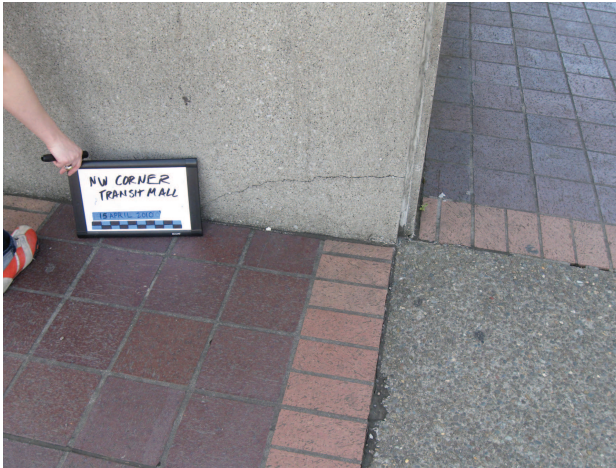
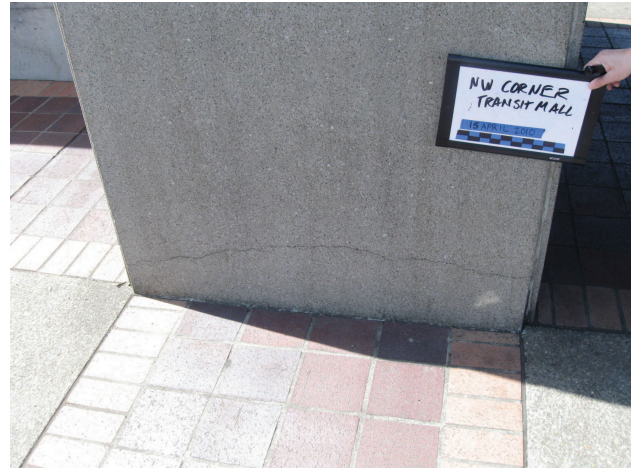
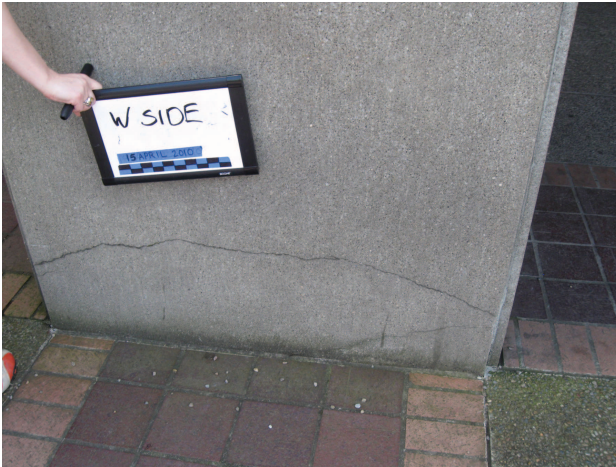
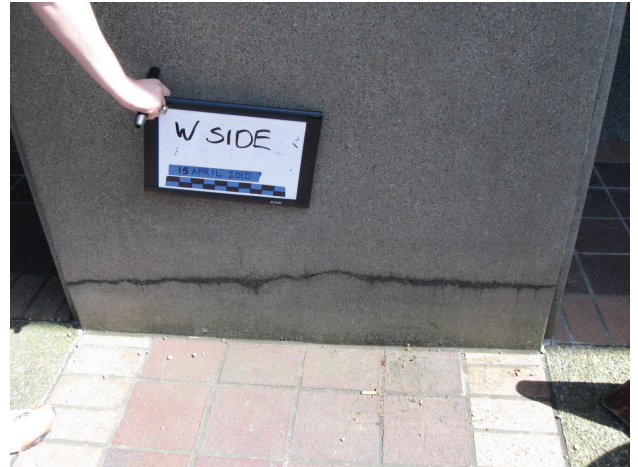
All photos: Movement of the Bus Mall slab has resulted in cracks of the pre-cast concrete column bases.

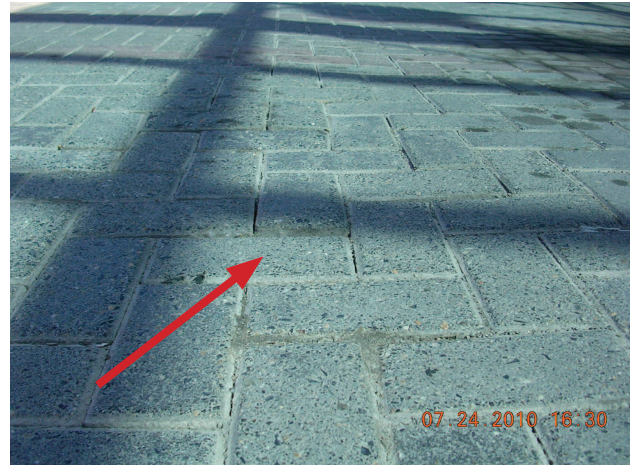
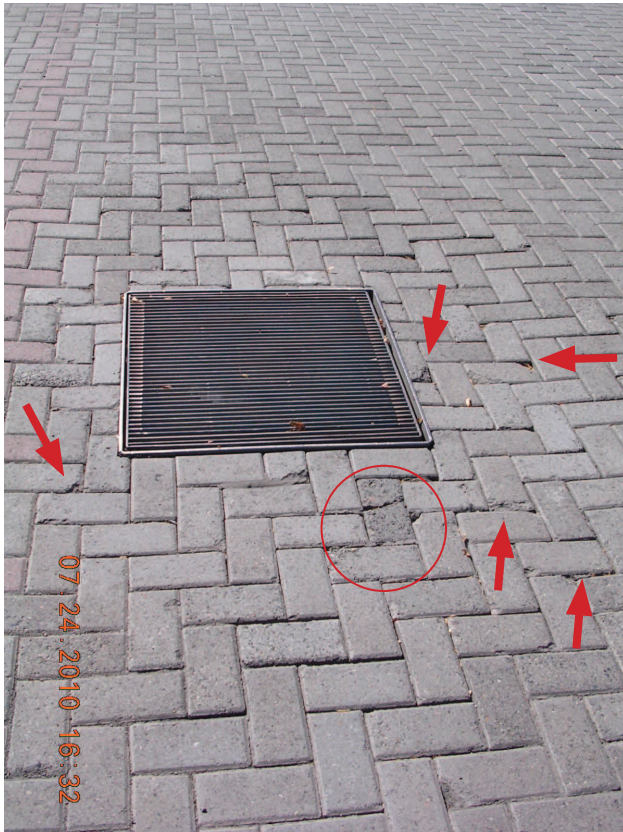
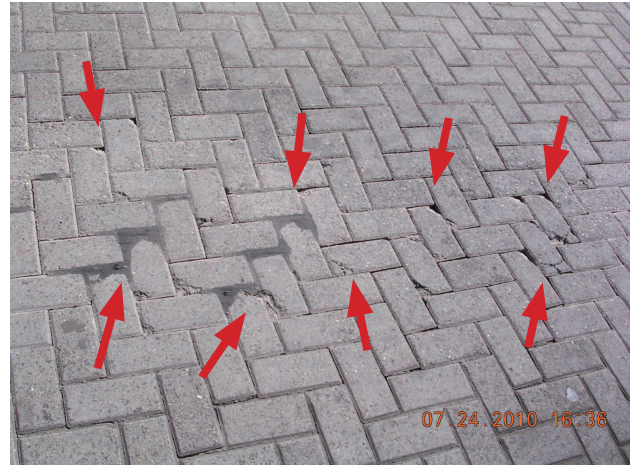
Top right, bottom left and right: Subsurface conditions at the Bus Mall are causing pavers to heave and move resulting in damaged pavers.

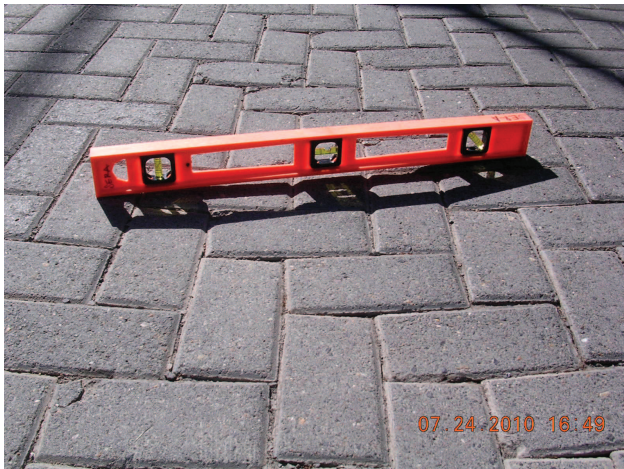
Top left: Subsurface movement produces dips which could lead to ponding of water.

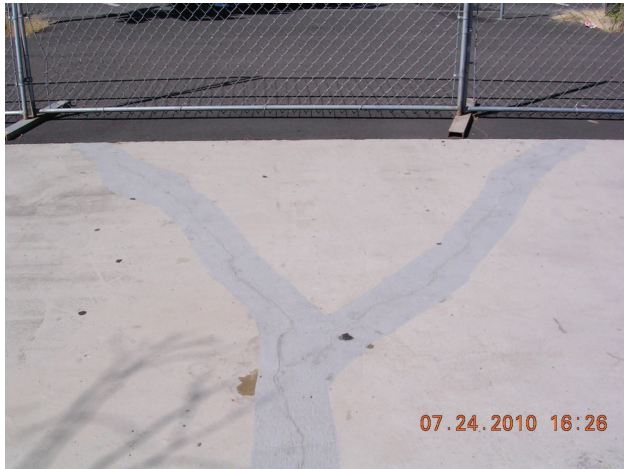
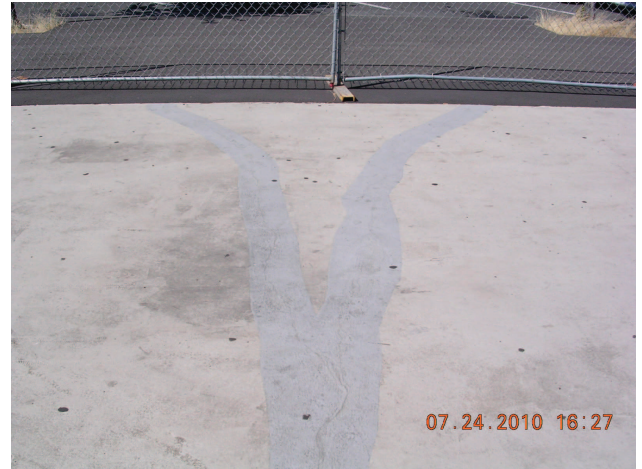
All photos: Cracks at the North Block slab.

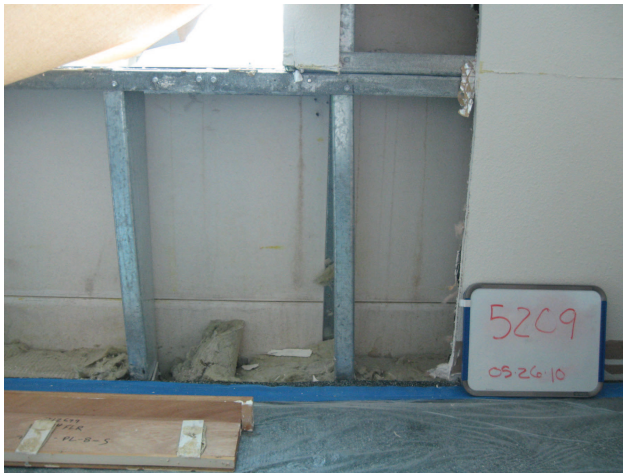
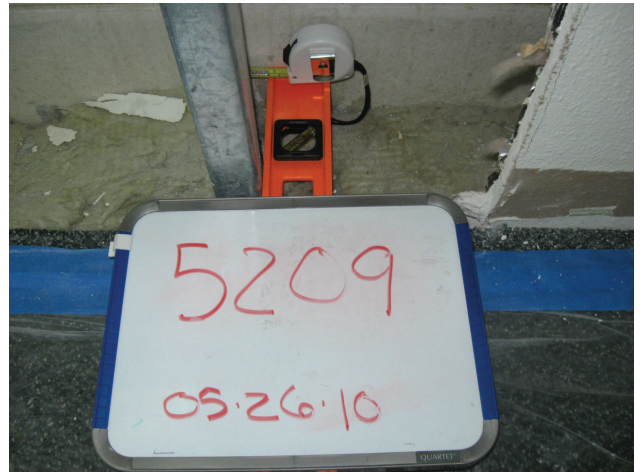
Top left and right, bottom right: Twisting of studs is greatest at the Fifth Floor and at the outer most east and west ends of the north and south walls. Twisting of studs is believed to be caused by floor slab shrinking and shortening.

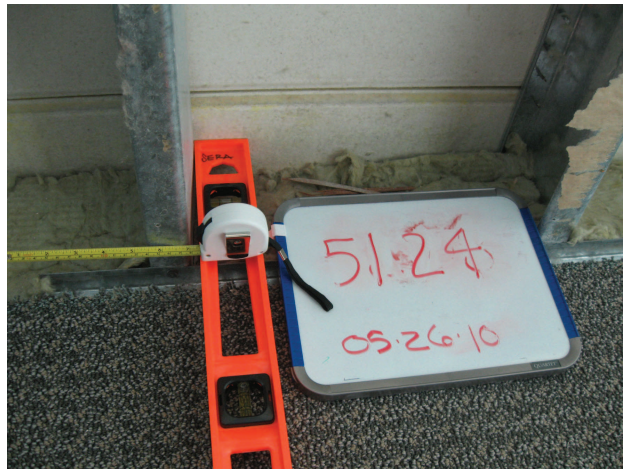
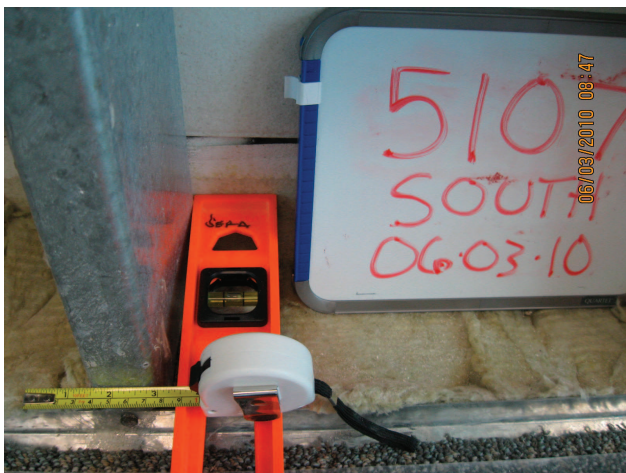
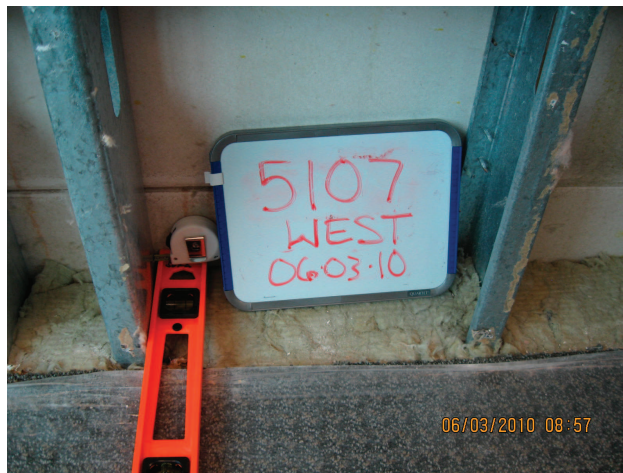
Top right, bottom left and right: Twisting studs due to floor slab shrinkage and shortening.

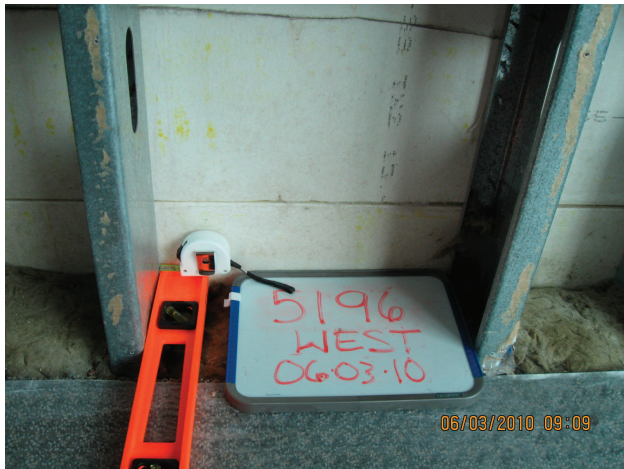
Top left: Twisting of studs is less severe on the east and west walls.

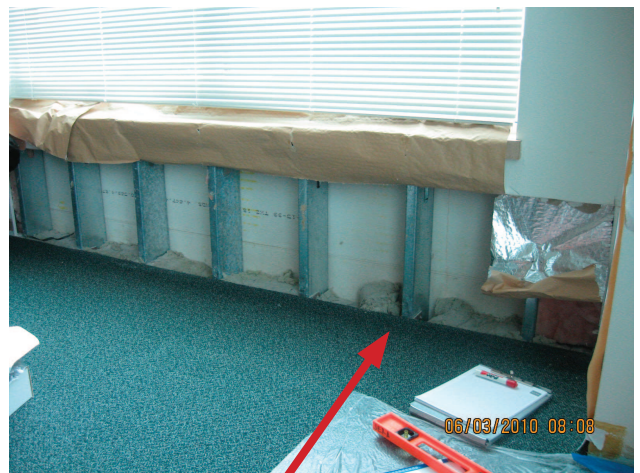
Bottom right: This stud has experienced significant twisting.

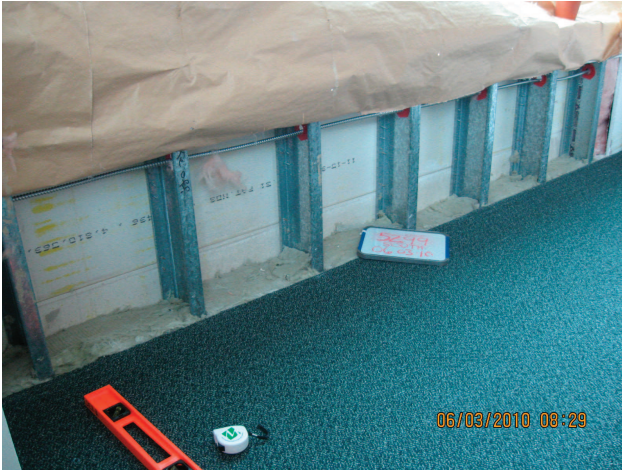
Top left: All observed studs exhibited some degree of twisting. The sign is mislabeled ; it is the north wall of 5299.
