**Marion County Courthouse Square
555 Court Street NE, Salem Oregon
Remediation Study Final Report
February 07, 2011**

Volume Three of Six

Miller Consulting Engineers, Inc.
Structural Photographic Documentation

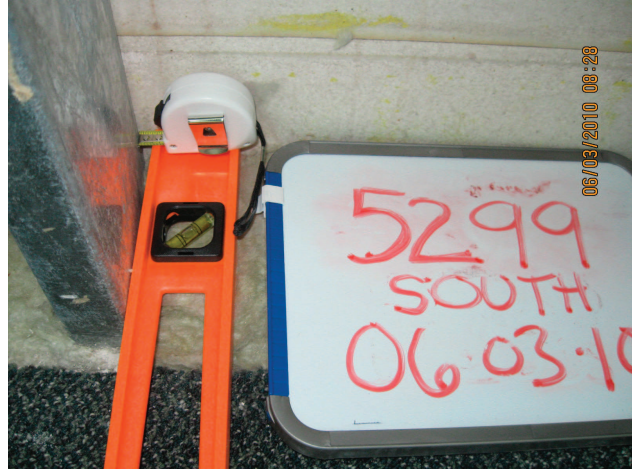
Top right: Twisted metal studs. The sign is mislabeled; it is the east wall of 5299.

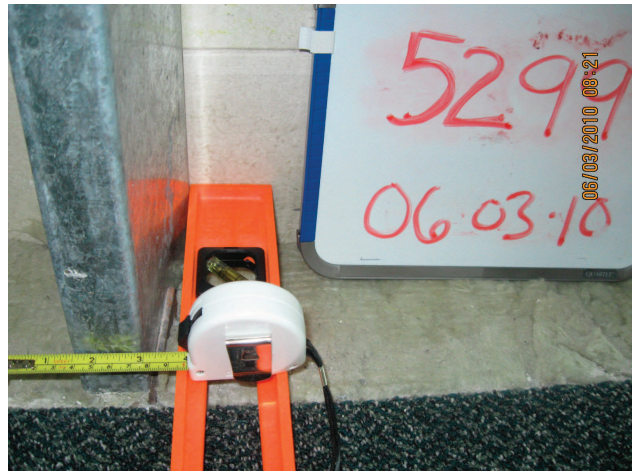
Bottom left and right: Twisted studs.

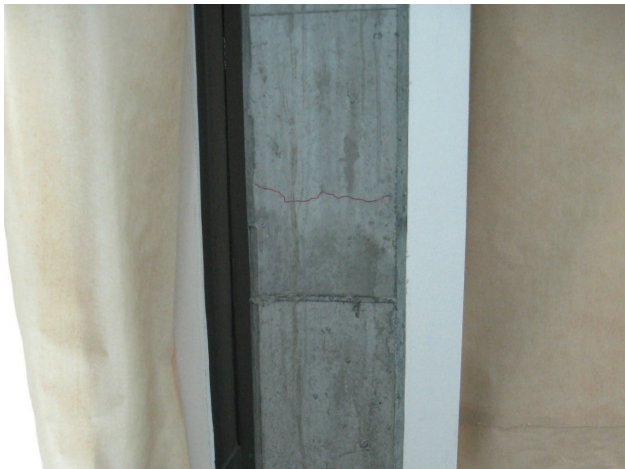
Top left and right: Cracks at column 0-13 at the Fifth Floor are highlighted. The crack pattern is similar to leaning columns at the Bus Mall.

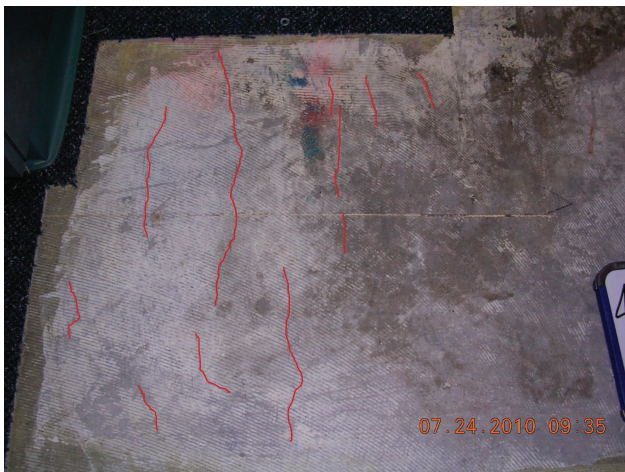
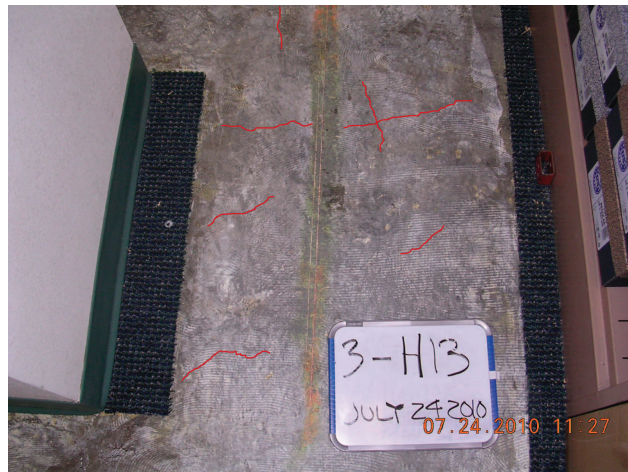
Bottom left and right: Parallel floor cracks discovered during building punching shear investigation. Note: cracks have been traced for ease of viewing.

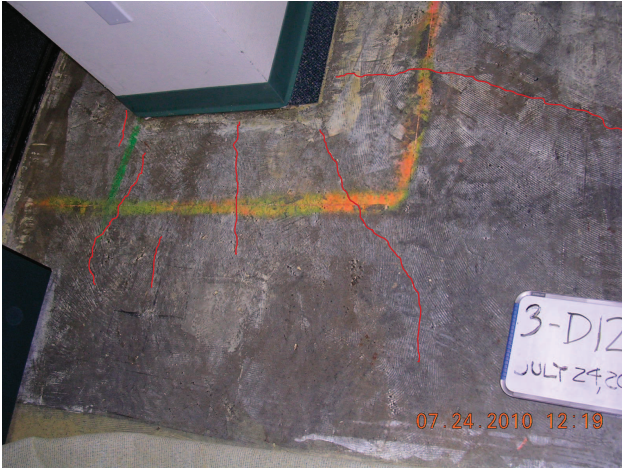
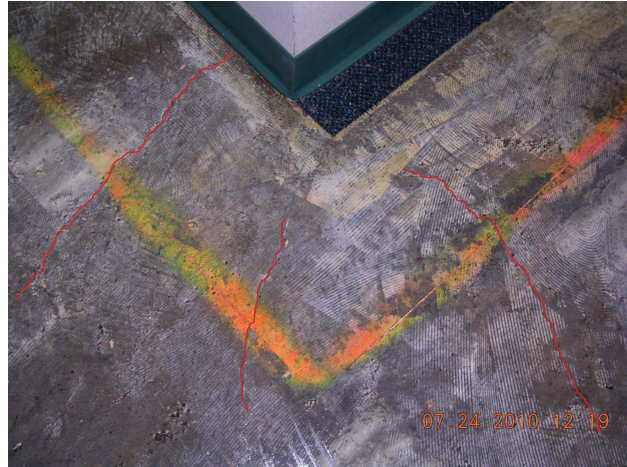
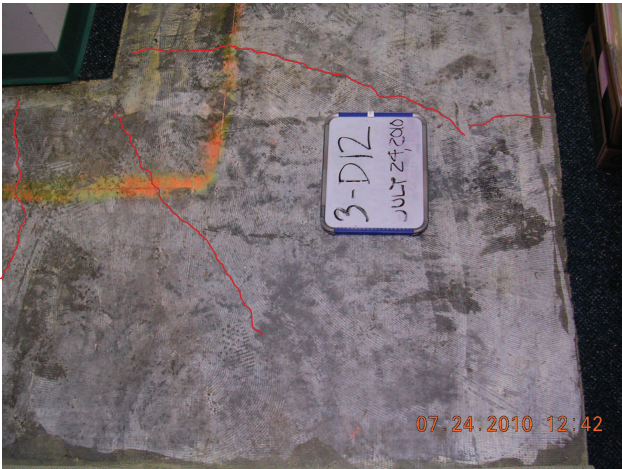
Top left and right, bottom left: Punching shear failure is evident by the presence of radiation cracks from the column.

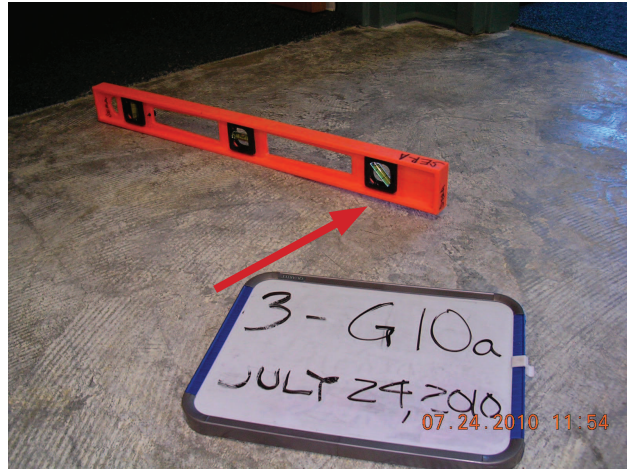
Bottom right: Bump in the floor indicates installation quality during construction. This is noticeable at the gap between the floor and level.

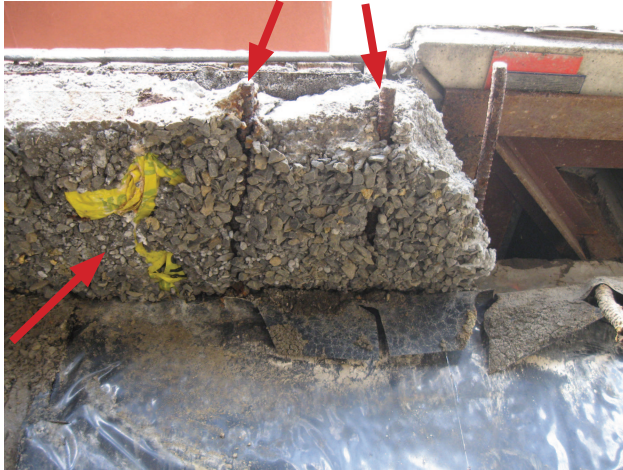
Top left and right: Reinforcing bars not installed properly. Debris is evident in the casting bed during construction.

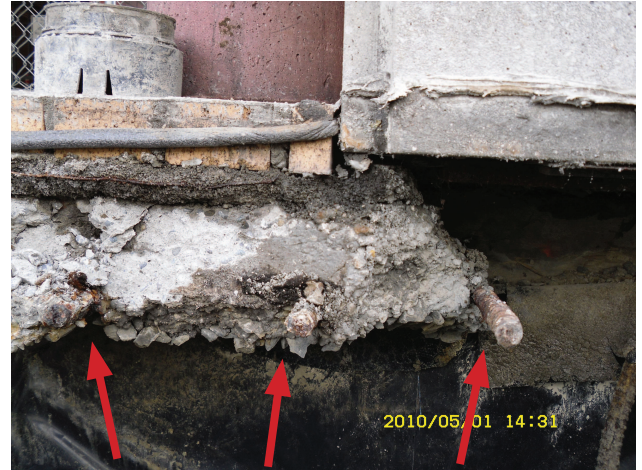
Bottom right: Joint between building and Bus Mall slab. Slab shortening ripped apart installed rubber water proofing.

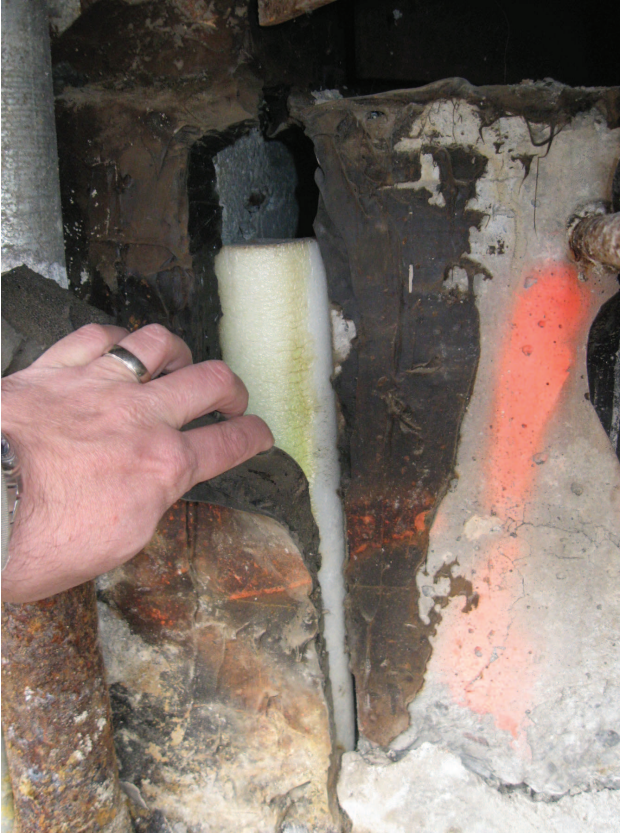
Top left: Joint between building and Bus Mall slab. Slab shortening exacerbated and compounded water infiltration issues from poor design detailing.

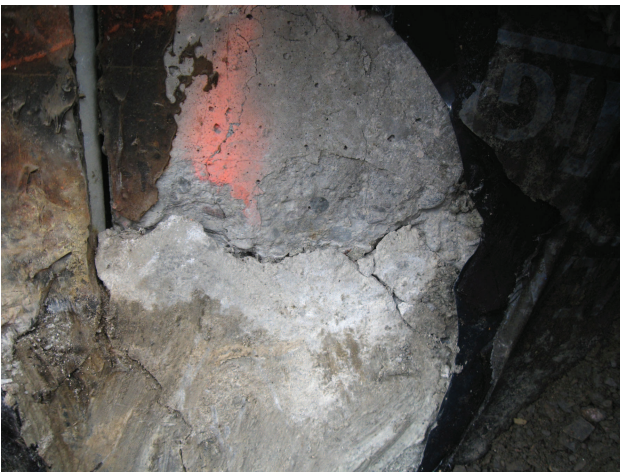
Top right, bottom left: Slab shortening and horizontal movement was not properly accounted for and detailed. This is evident by sheared waterproofing and cracks at the foundation wall/slab interface. The column at this location on the interior is significantly damaged.

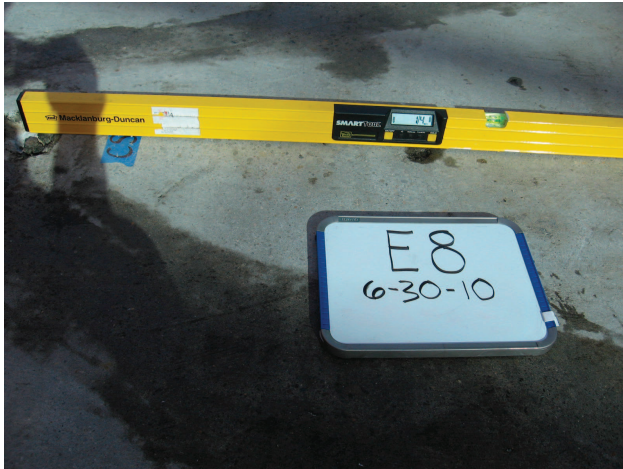
Top left: Location E-8 has a perceptible crown, sloping down and away from the unrepaired hole at a rate of 1/4 inch per foot.

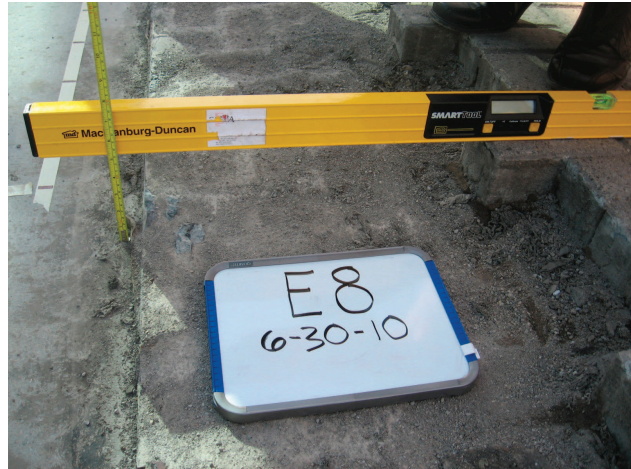
Bottom left and right: Thickness of the waterproof/ paver assembly varies from approximately 4-7 inches. Note: Cracks have been traced for ease of viewing.
