**Marion County Courthouse Square  
555 Court Street NE, Salem Oregon  
Remediation Study Final Report  
February 07, 2011**

**Volume Four of Six**

Marion County  
Courthouse Square Structural Remediation  
Project Summary  
June 09, 2010

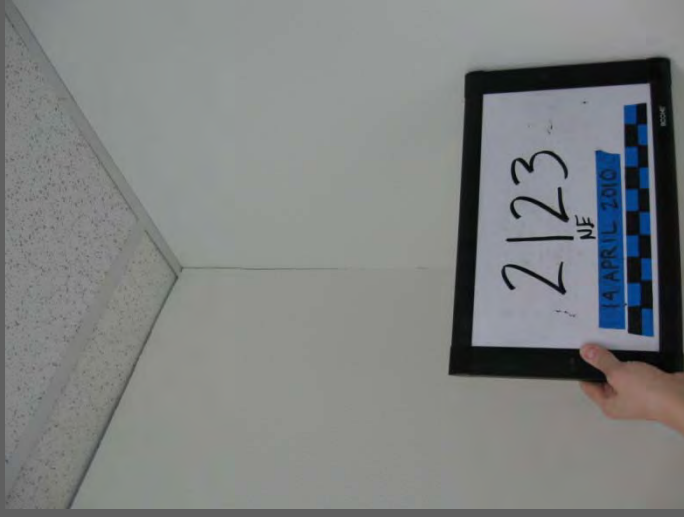
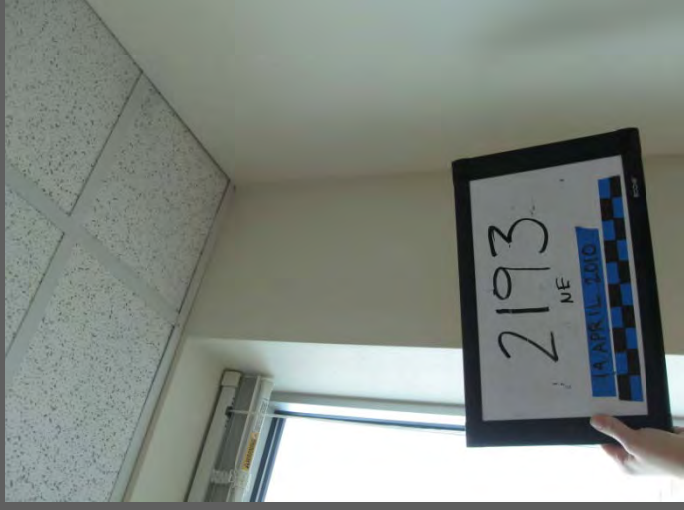
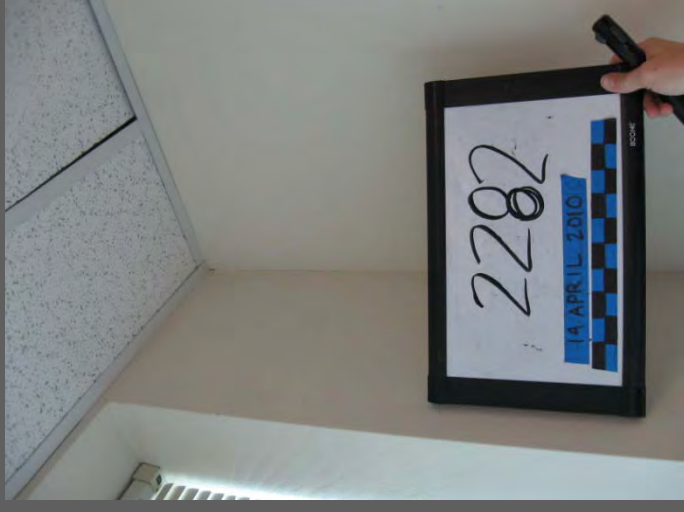
### Interior finishes- Walls

- Wall cracking is prevalent throughout the building
  - Progressively more frequent
  - Progressively more numerous

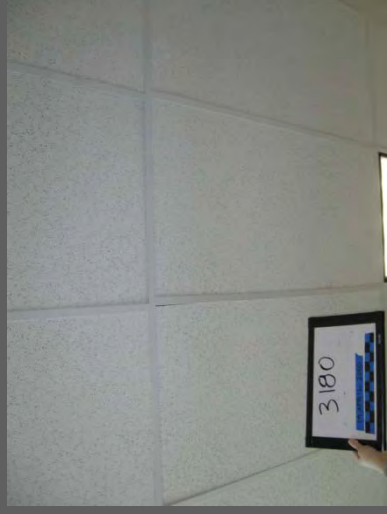
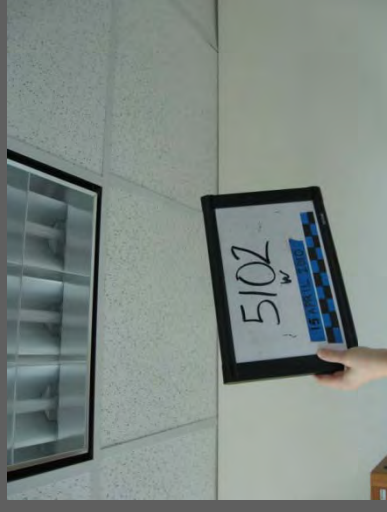
### Interior finishes- Ceilings

- Ceiling misalignment is prevalent through the building
  - Misalignment is extremely pervasive with a few buckled ceiling grids
  - Acoustic tiles have sustained damage
  - Nearly all perimeter grids have been damaged

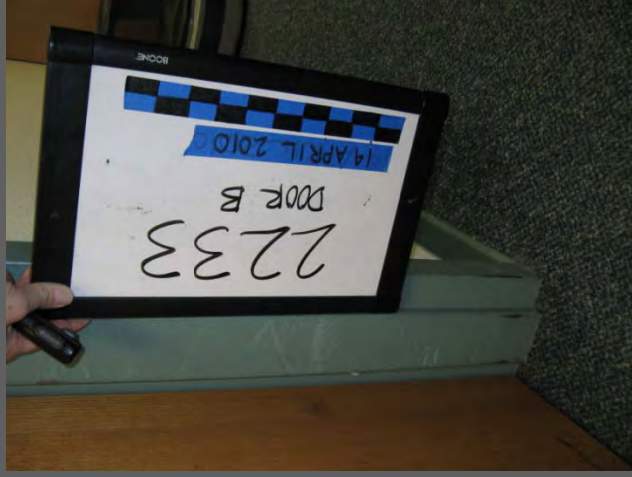
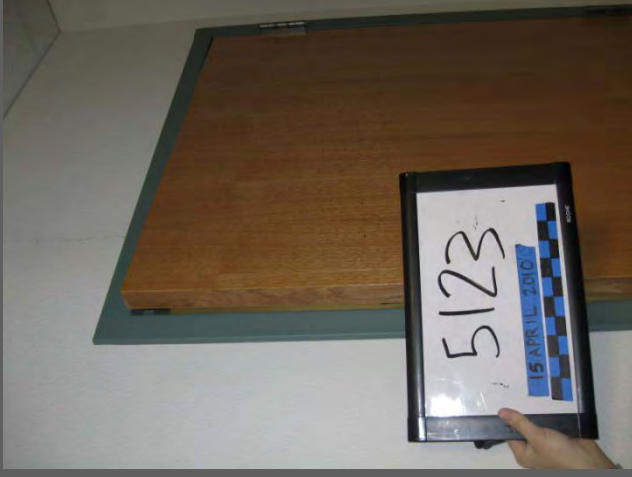
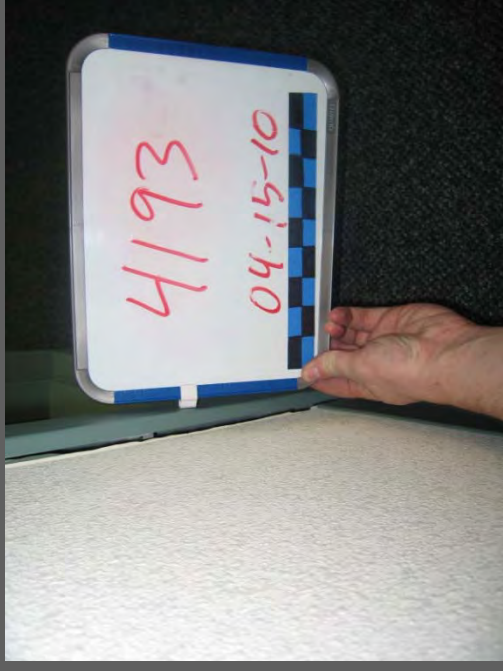
### Interior finishes- Doors

- Building movement has caused door issues
  - Fire Life Safety doors have been impacted
  - Doors have been modified to fit conditions
  - Many doors are not square within the frame or are warped

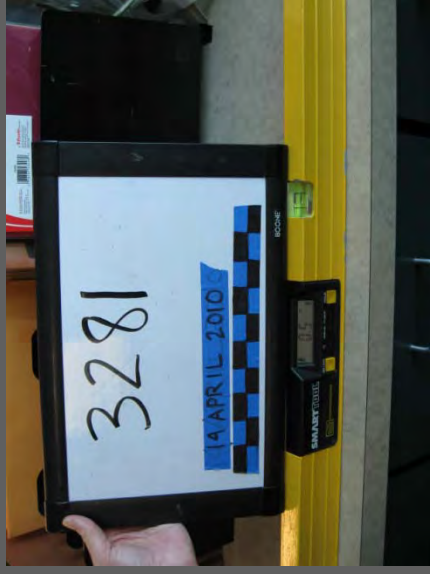
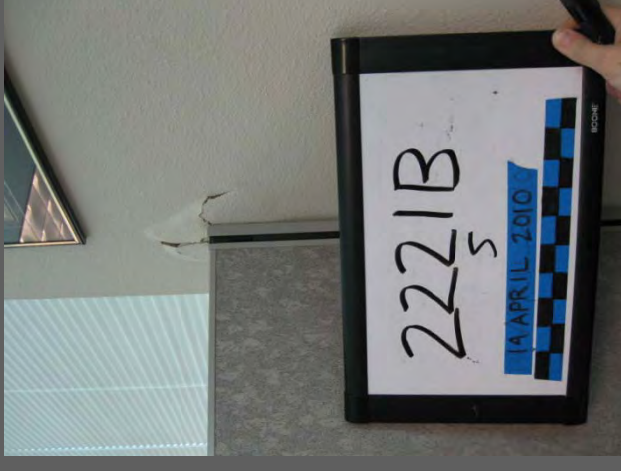
### Interior finishes- Cabinetry, Casework and Furniture

- Deflection in the floor slabs have caused other damage throughout the building
  - Anchored systems furniture are damaging walls
  - Cabinetry and casework are not level causing function issues
  - Counter top backslashes are detaching from the walls
  - Employee desks are not level

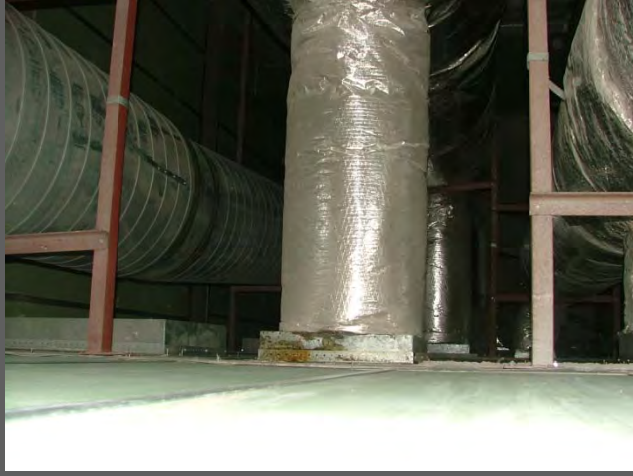
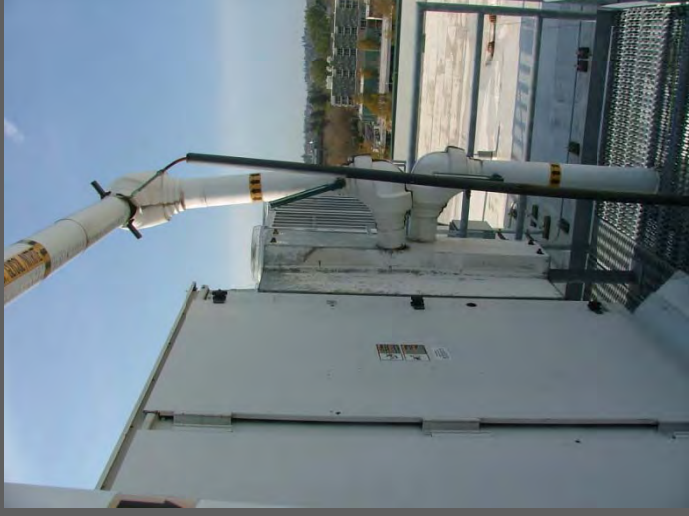
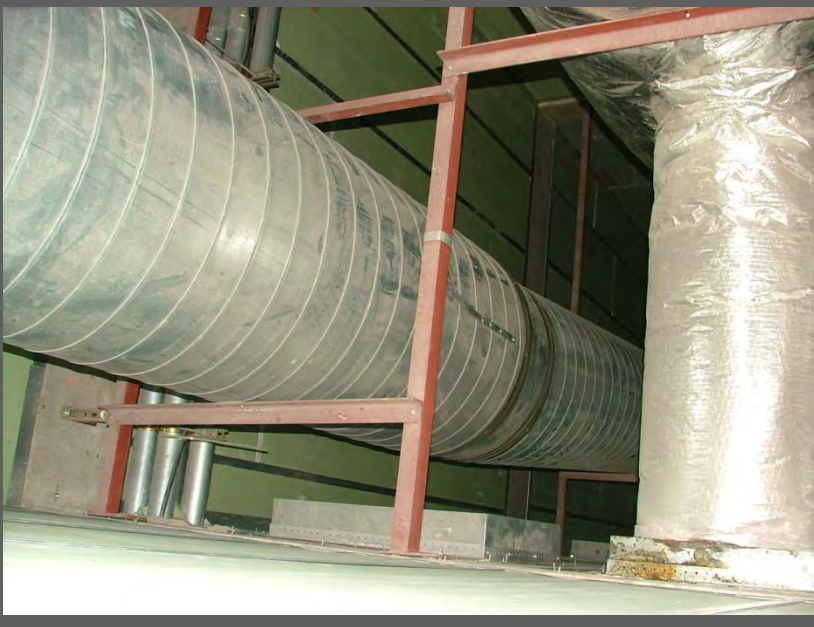
### Building equipment

- Areas visually observed include:
  - Main duct risers (east and west shafts)
  - Ductwork, sprinkler piping, electrical equipment above ceiling at worst deflection
  - Basement fan rooms and duct connections
  - Gas pipe riser at the street meter and at the 5<sup>th</sup> Floor
  - Roof top equipment

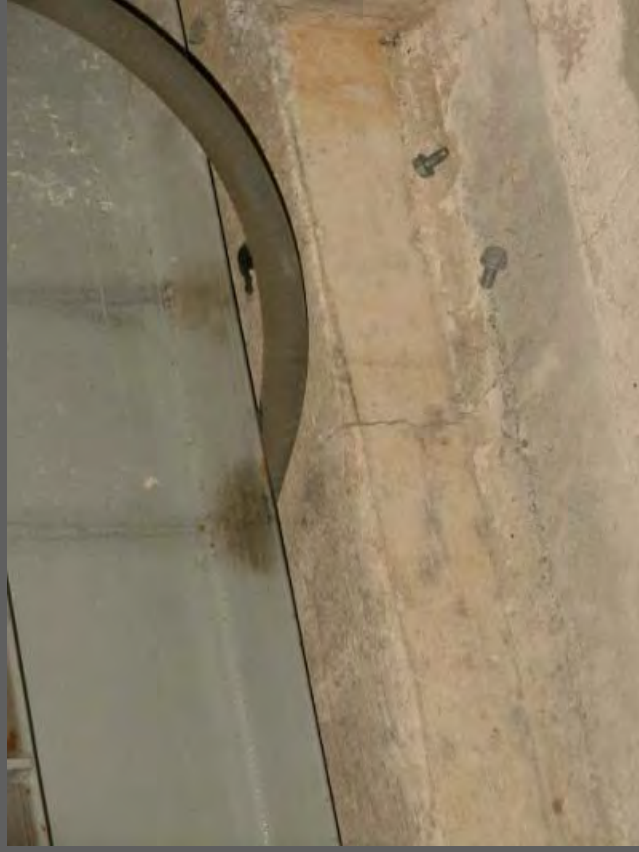
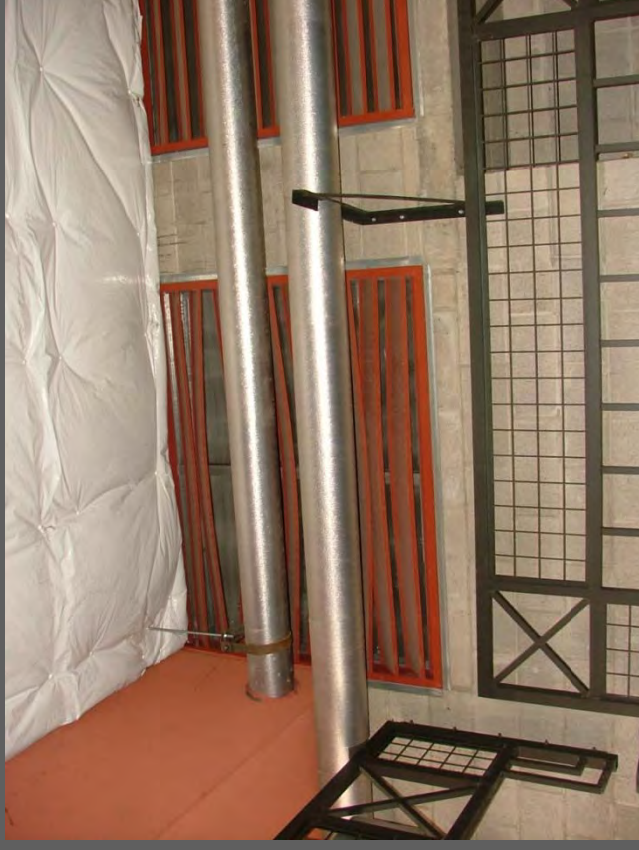
### Building equipment

- Equipment damaged related to building movement include:
  - Intake louver at parking garage ramp
  - Fan room wall cracks in the Basement
  - Fan housekeeping pad cracked

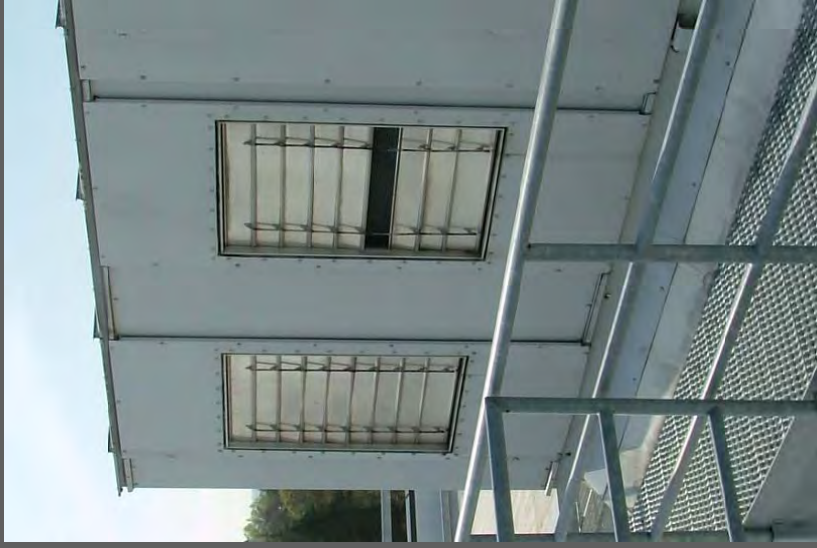
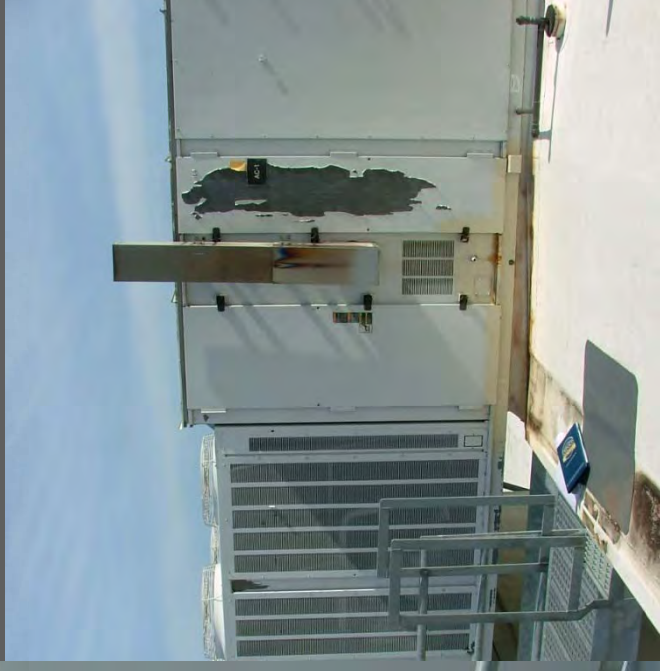
- A note of special concern
  - Fire/ smoke damper access panels should be installed at west shaft
  - Equipment wear and tear

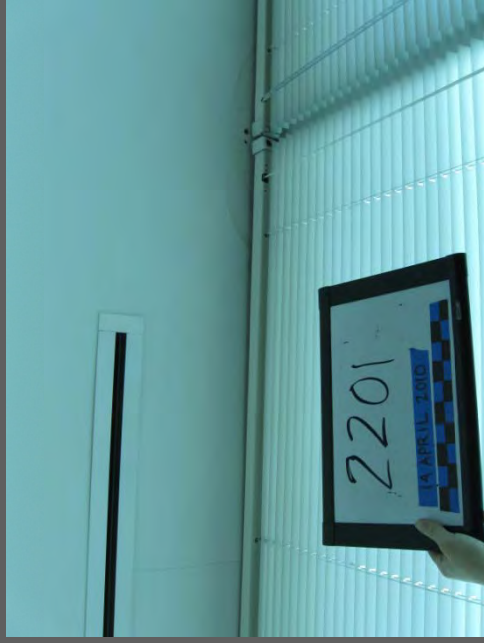
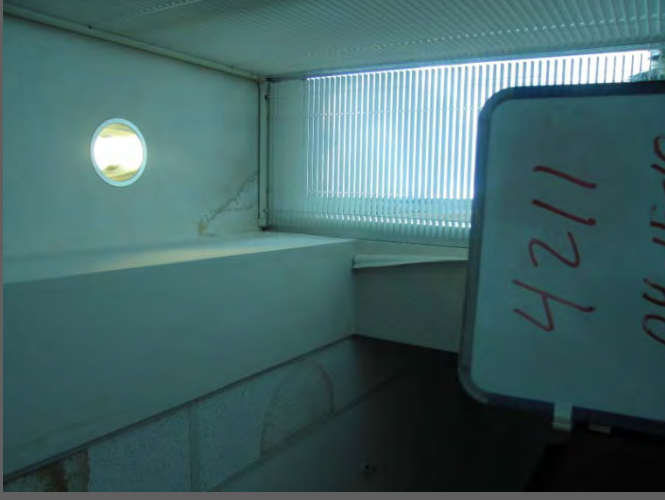
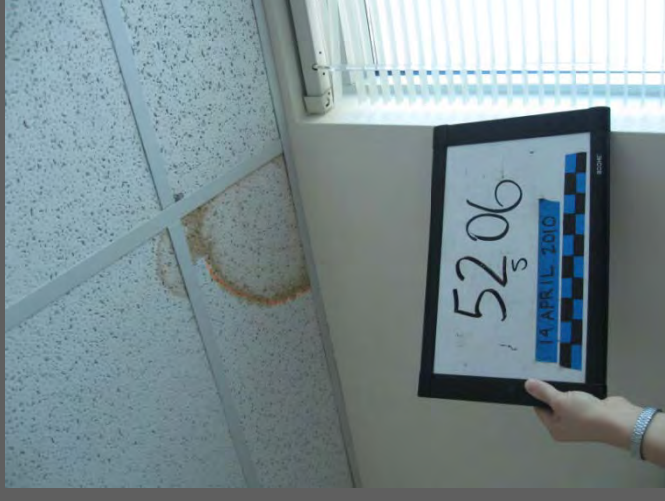
### Building Envelope and Waterproofing

- Interior damage from water infiltration includes:
  - Ceiling and soffit staining
  - Window frame staining
  - Water infiltration at the foundation walls

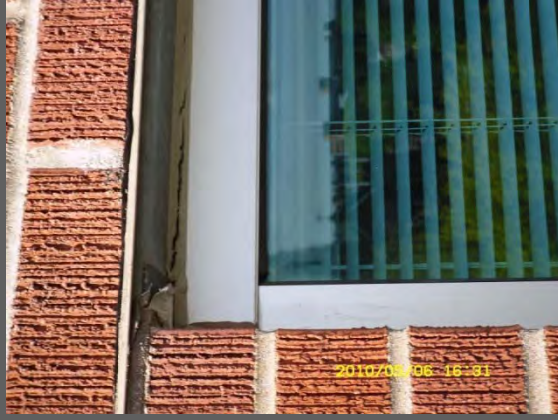
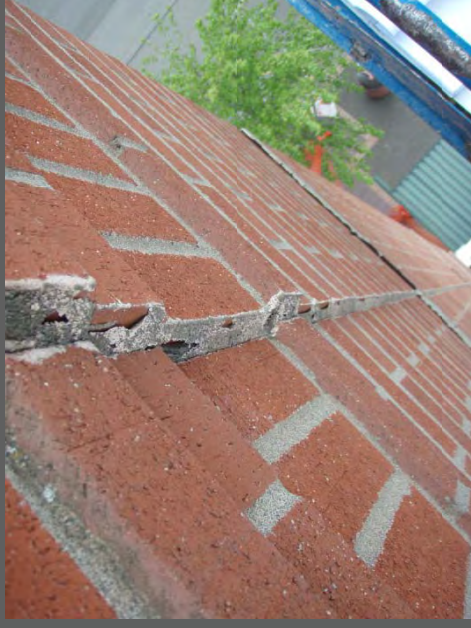
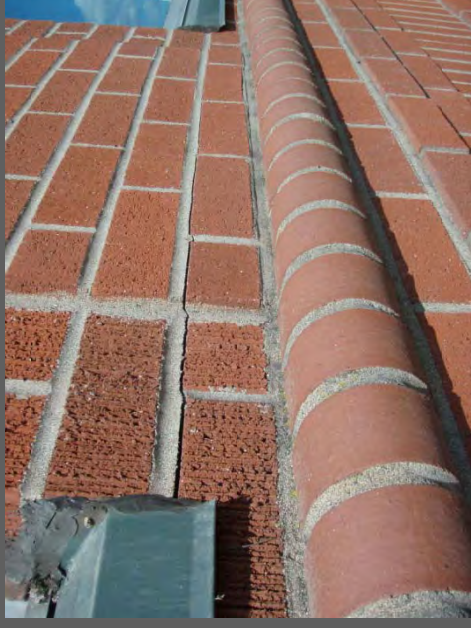
- Exterior Observation found:
  - Water infiltration issues at the curtain walls including failed window units
  - Window frames out of alignment
  - Brick control and expansion joints not uniform
  - Window sealant at the end of it's useful life
  - Cracks in the brick facade

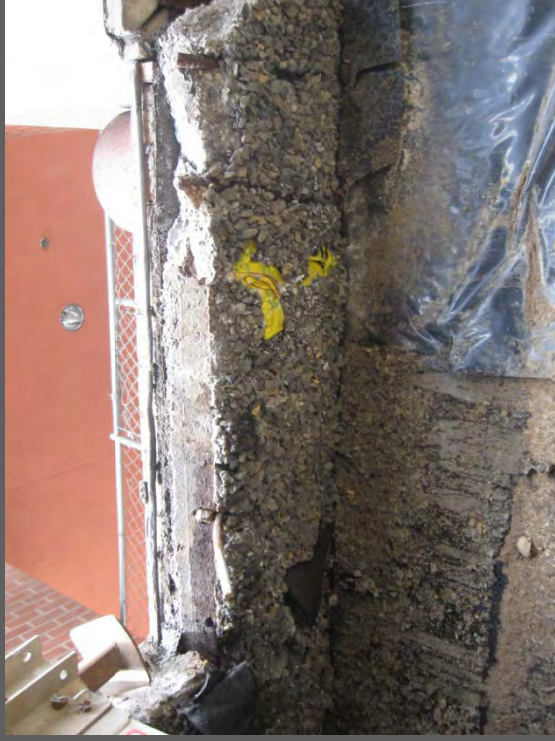
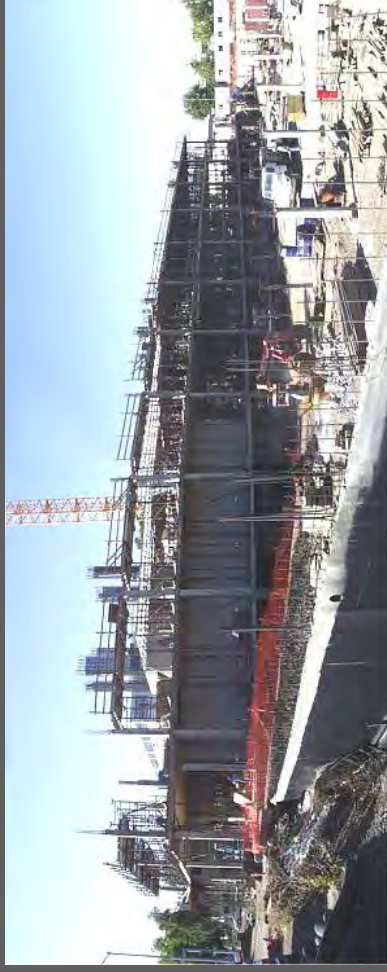
- Further investigation at the foundation revealed:
  - Installation of the foundation wall damp proofing system
  - Water issues exacerbating an already delicate structural condition
  - Construction defects during installation
  - Missing design detailing and then failed field solutions

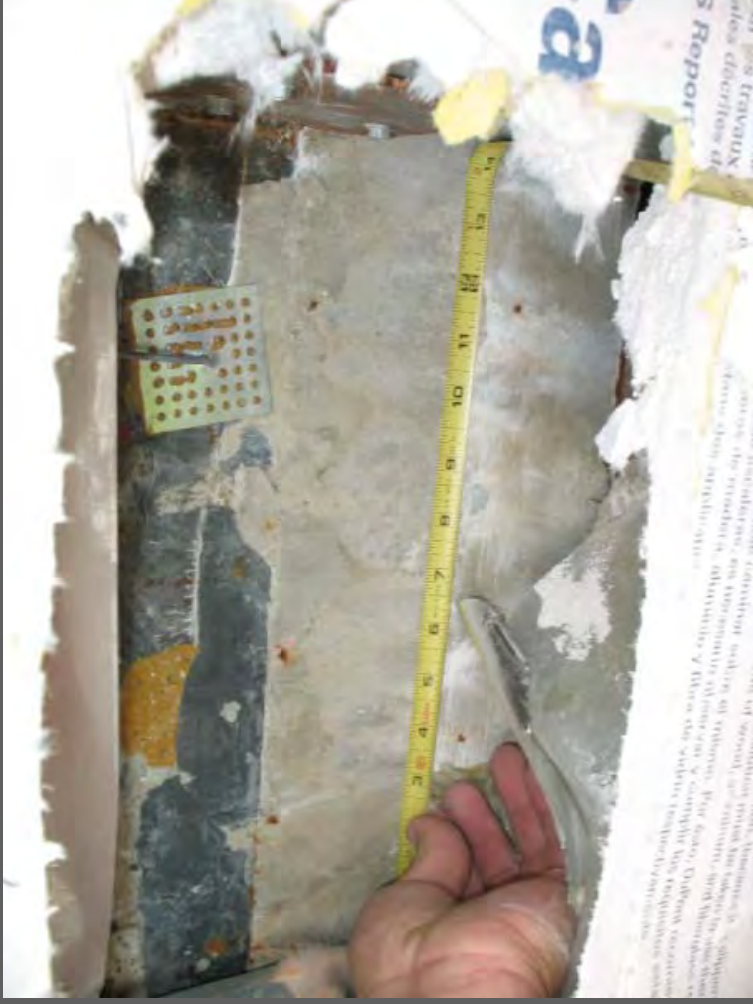
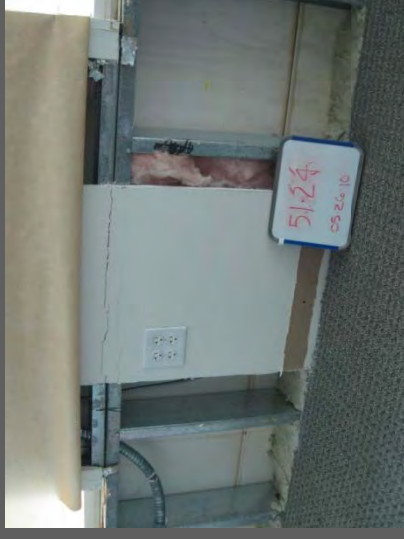
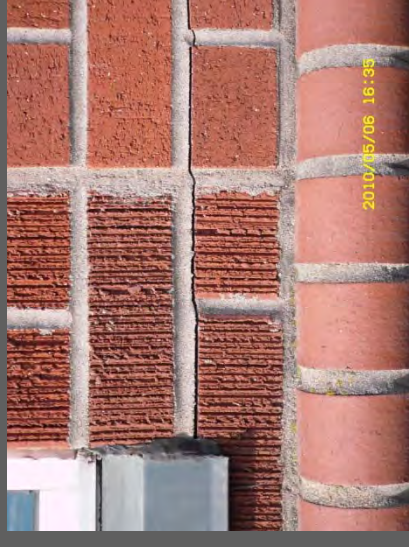
- Exterior brick and window survey and structural observations let to further discoveries:
  - Installed tendons different than design drawings
  - Construction methods have directly contributed to interior damage; slab deflections didn't help

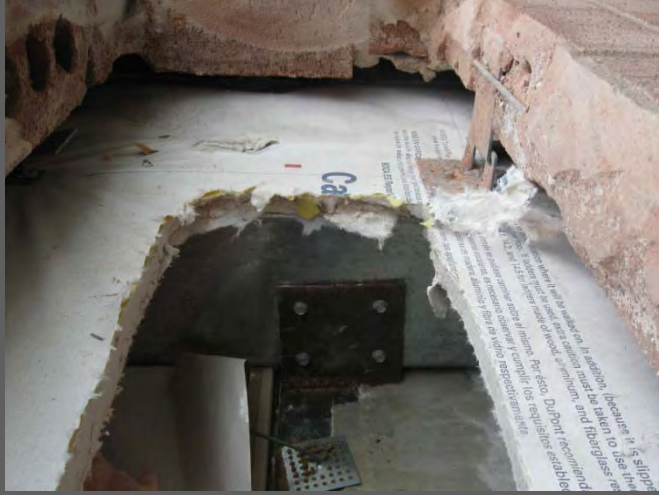
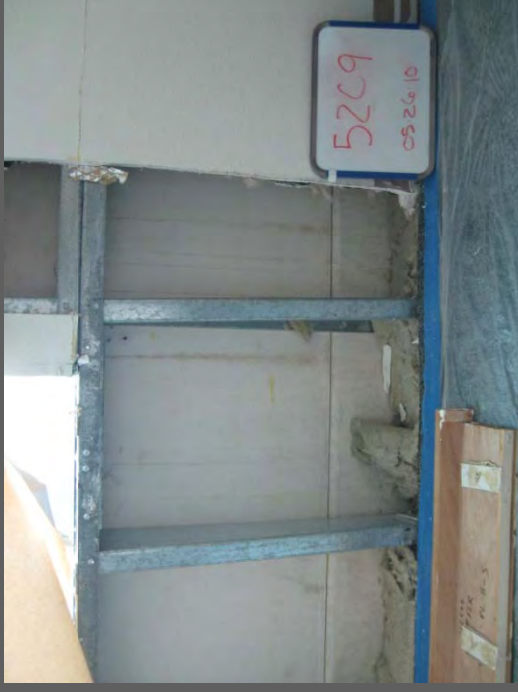
- Exterior brick and window survey and structural observations led to further discoveries:
  - Quality control issues at the time of construction
  - Observed brick movement revealed deformed structural stud walls

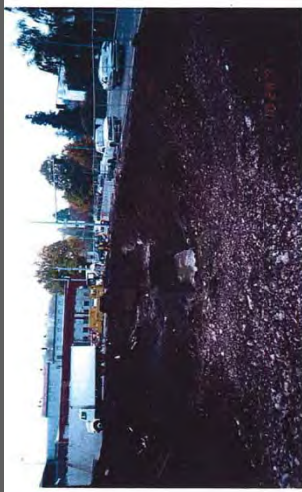
Photograph 1. Site 6 - Beginning of contaminated soil excavation after overburden removal, facing east.

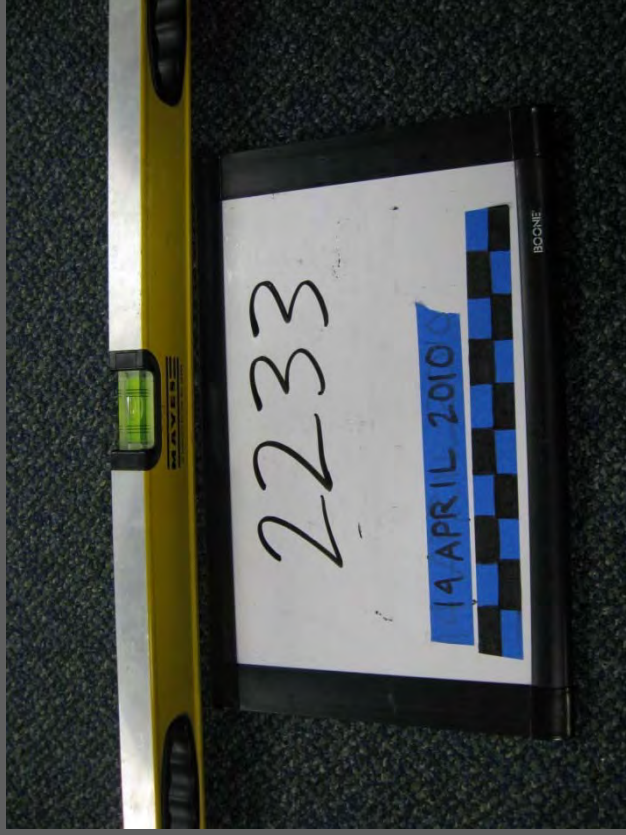
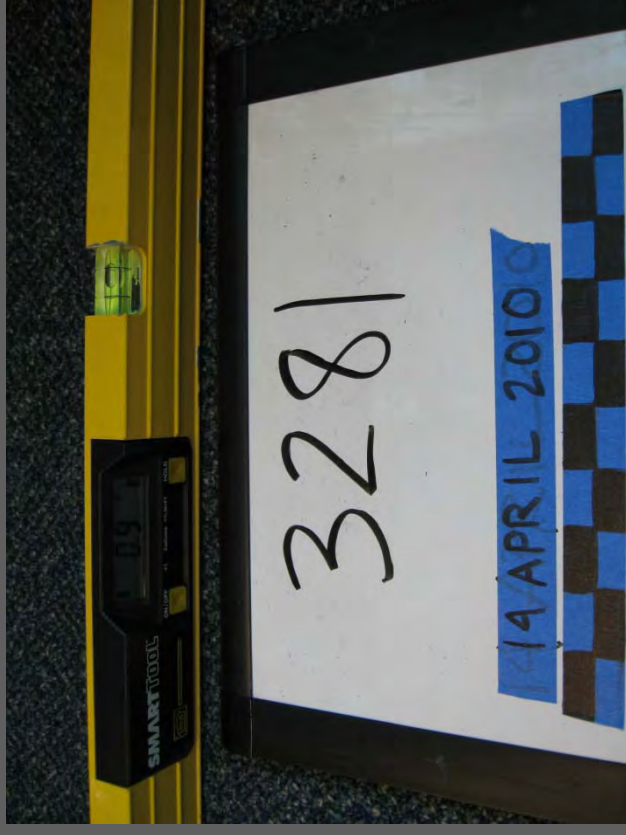
- Existing slabs exhibited significant perceptible deflections:
  - Previous survey showed the deflections grew progressively worse
  - Needed a defensible and repeatable methodology
  - Survey portions of the building not previously surveyed

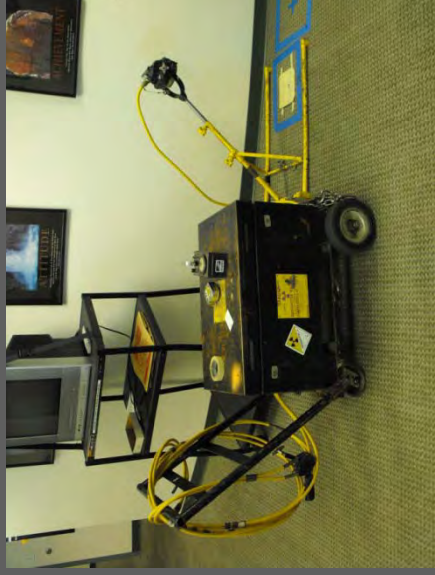
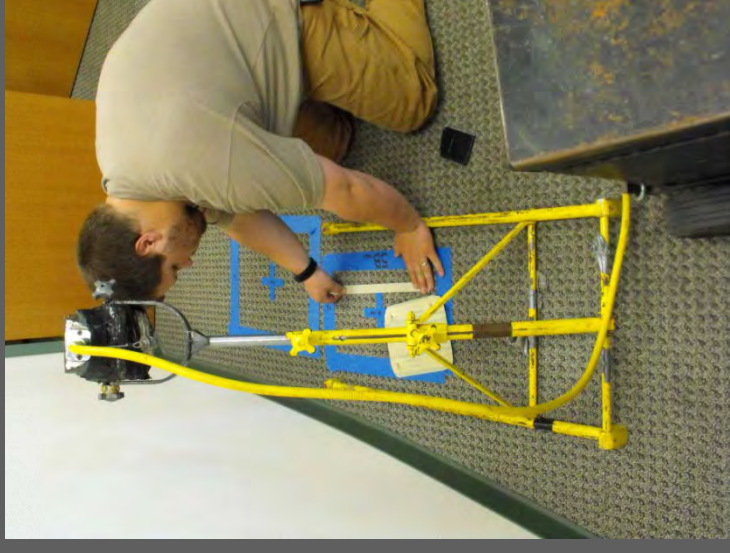
- Full building survey informed where material samples were to be taken:
  - Gather data from perceived 'good' and 'bad' locations at each floor
  - Each side of slab's pour strip
  - Used a combination of GPR and x-ray to locate cores

- Concrete core testing results showed less than designed strengths of 5000psi:
  - Ground Floor = 4360psi, 4600psi, 4424psi
  - Second Floor = 3460psi, 4210psi, 3710psi, 4080psi
  - Third Floor = 3960psi, 3490psi, 3800psi, 3500psi
  - Fourth Floor = 4310psi, 3730psi, 4860psi, 4520psi
  - Fifth Floor = 5150psi, 4240psi, 4520psi, 4510psi

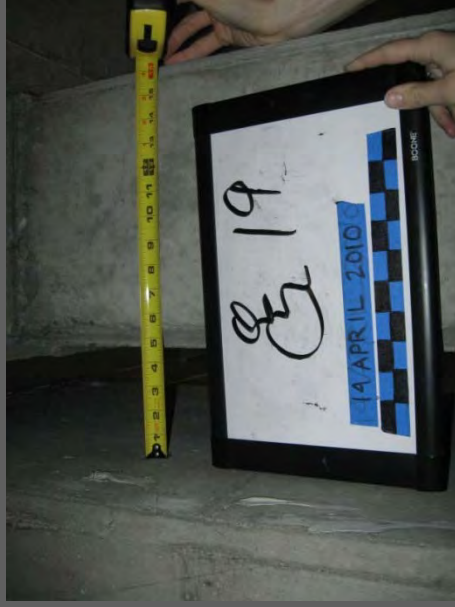
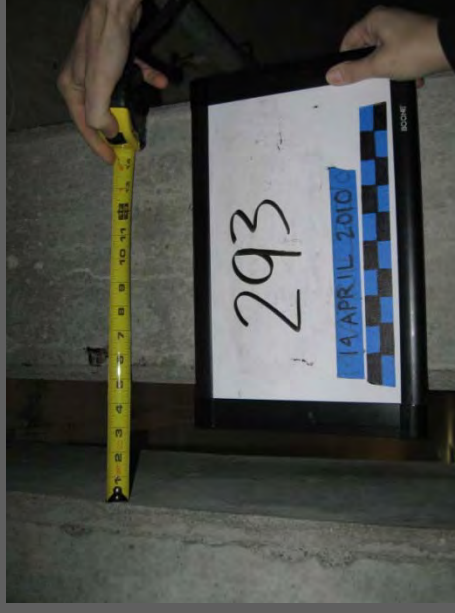
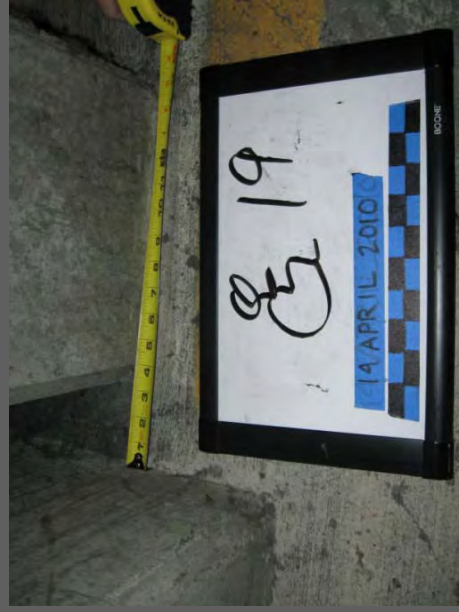
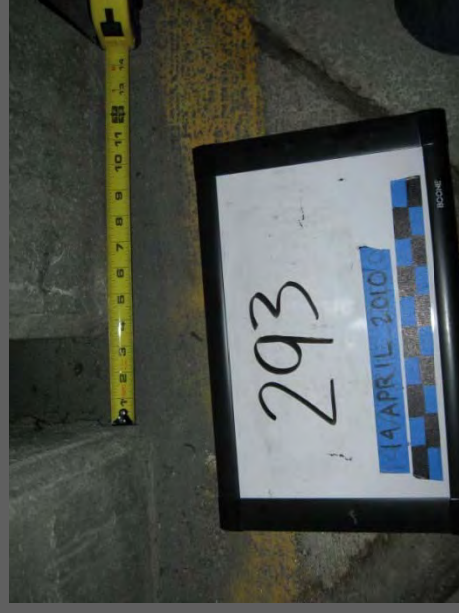
## Bus Mall Site Observation

- Observations include:
  - Cracking of the foundation wall
  - Cracking of non-structural members
  - Cracks at columns with significant damage due to water infiltration

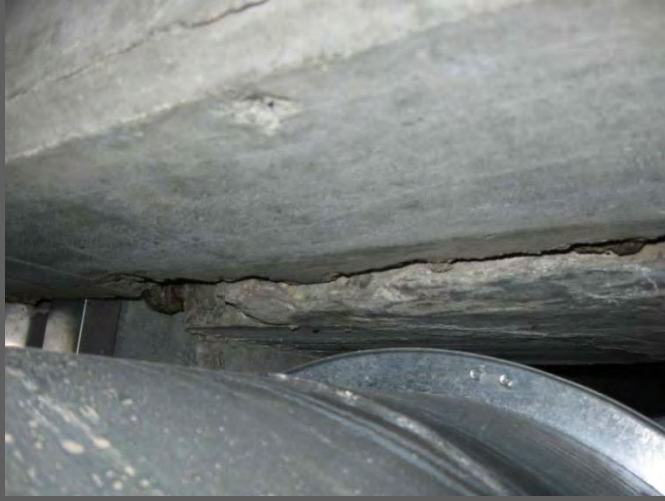
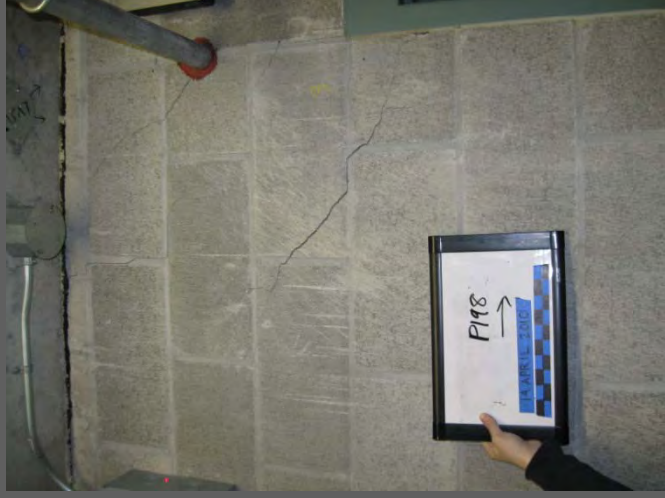
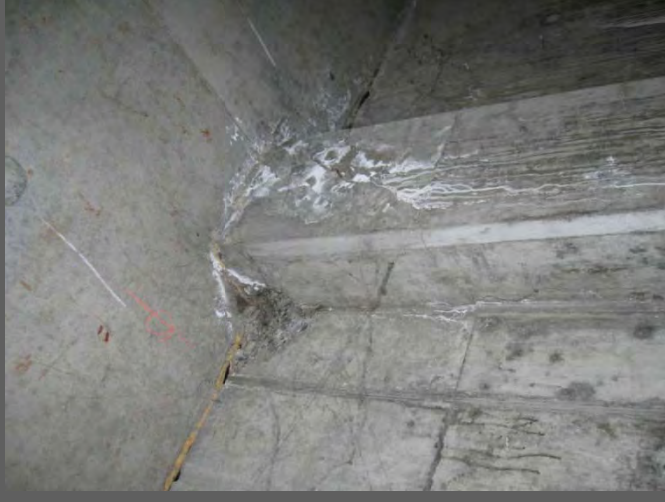
## TYPICAL MOVEMENT OF THE INTERIOR PARTITION

Typical movement of the interior partition walls in the east-west direction throughout the building indicating the settlement of the PT slab. Typically, the movement was measured to be around  $5/8"$ , but some measured greater than  $1"$ .

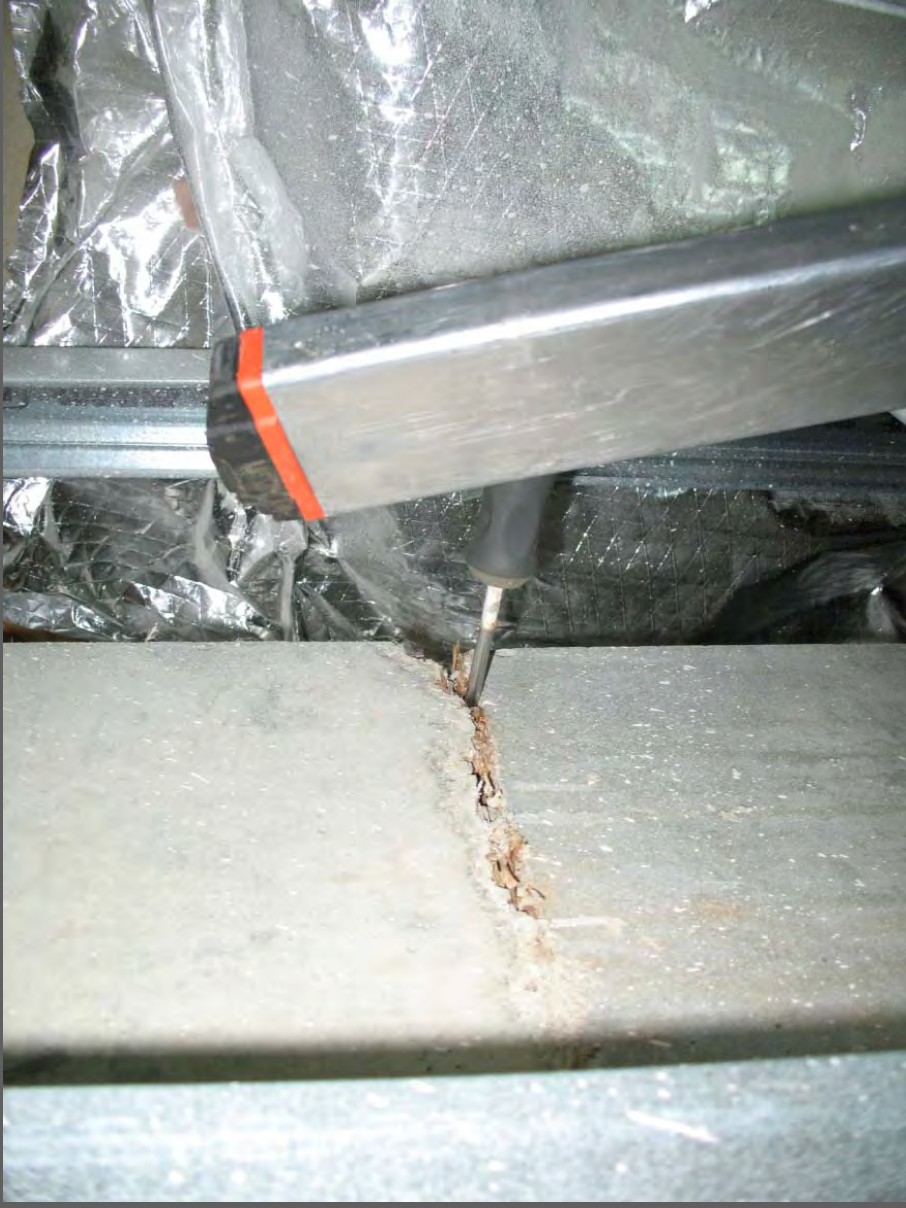
## WOOD CHIPS CAST INTO CONCRETE COLUMN

Poor construction methods were used during the construction of the slab; as a full layer of debris was allowed to be cast into the concrete column at Grid D-13 effectively placing a bond breaker approximately 2' below the fifth floor slab. The screw driver was easily driven approximately 2" into the concrete column.

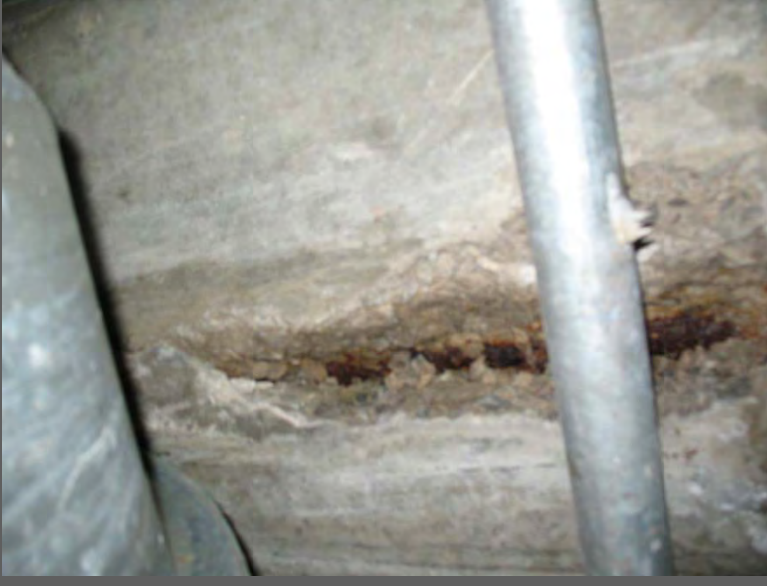
## SIGNIFICANT CRACKING IN CONCRETE COLUMN AT GRID A-10

Cracking that has occurred at each of the concrete columns at the joint between the building and the bus mall (Grids A-10 and O-10). The spall at Grid O-10 was easily removed exposing the reinforcing steel and corrosion on the reinforcing steel due to water penetration.

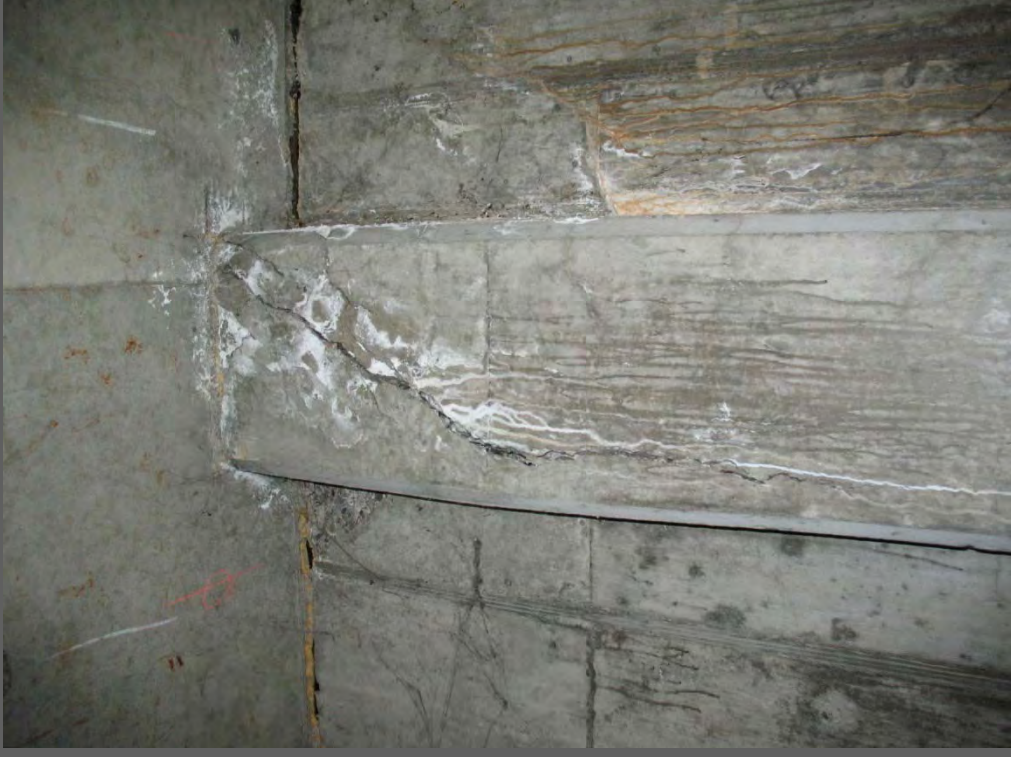
## SIGNIFICANT CRACKING IN CONCRETE COLUMN AT GRID M-1

Cracking has occurred at the concrete column at Grid M-1, as well as moisture penetrating through the basement concrete walls and causing damage to the concrete structure.

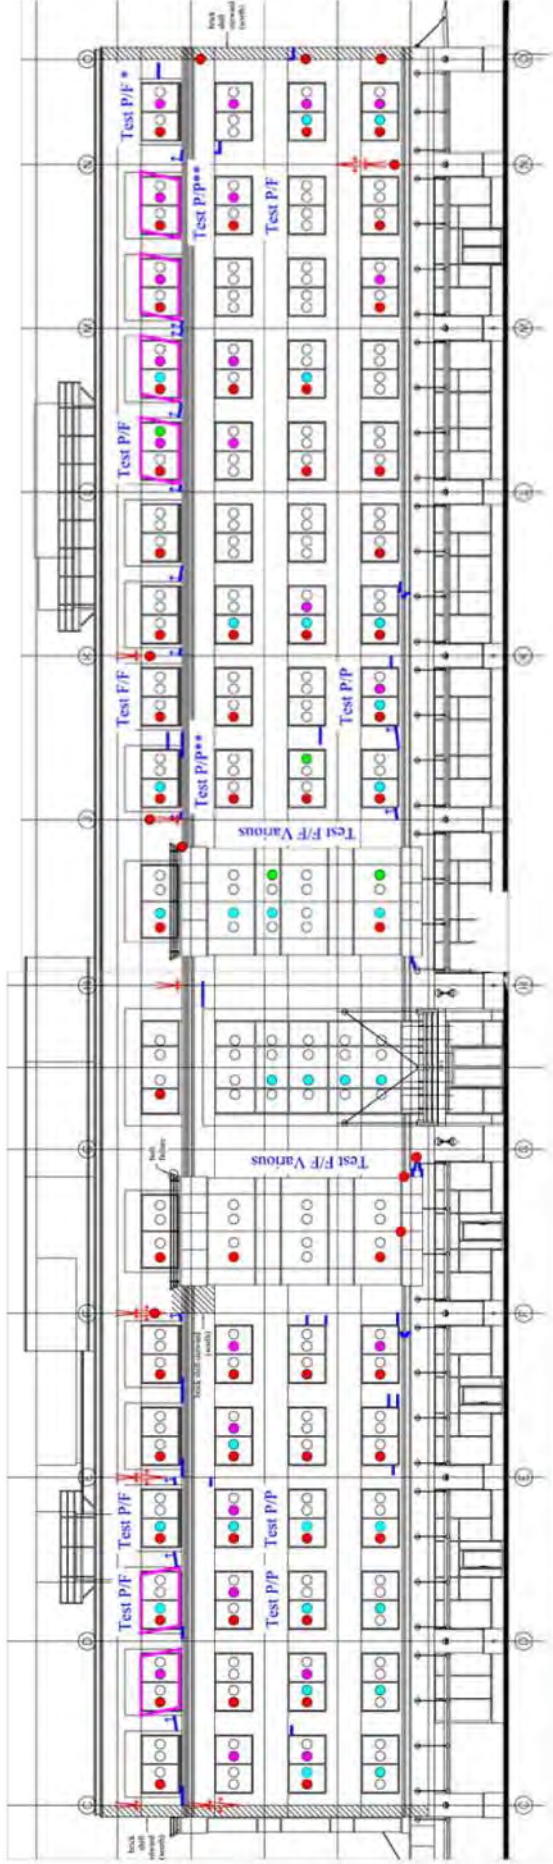
- no with  
press. press. diff. diff.
- sealant failed, compressed, or split
- failed IGU
- crack
- short gasket
- open frame joint or frame issue
- control joint issue
- Test P / F
- P = pass
- F = fail

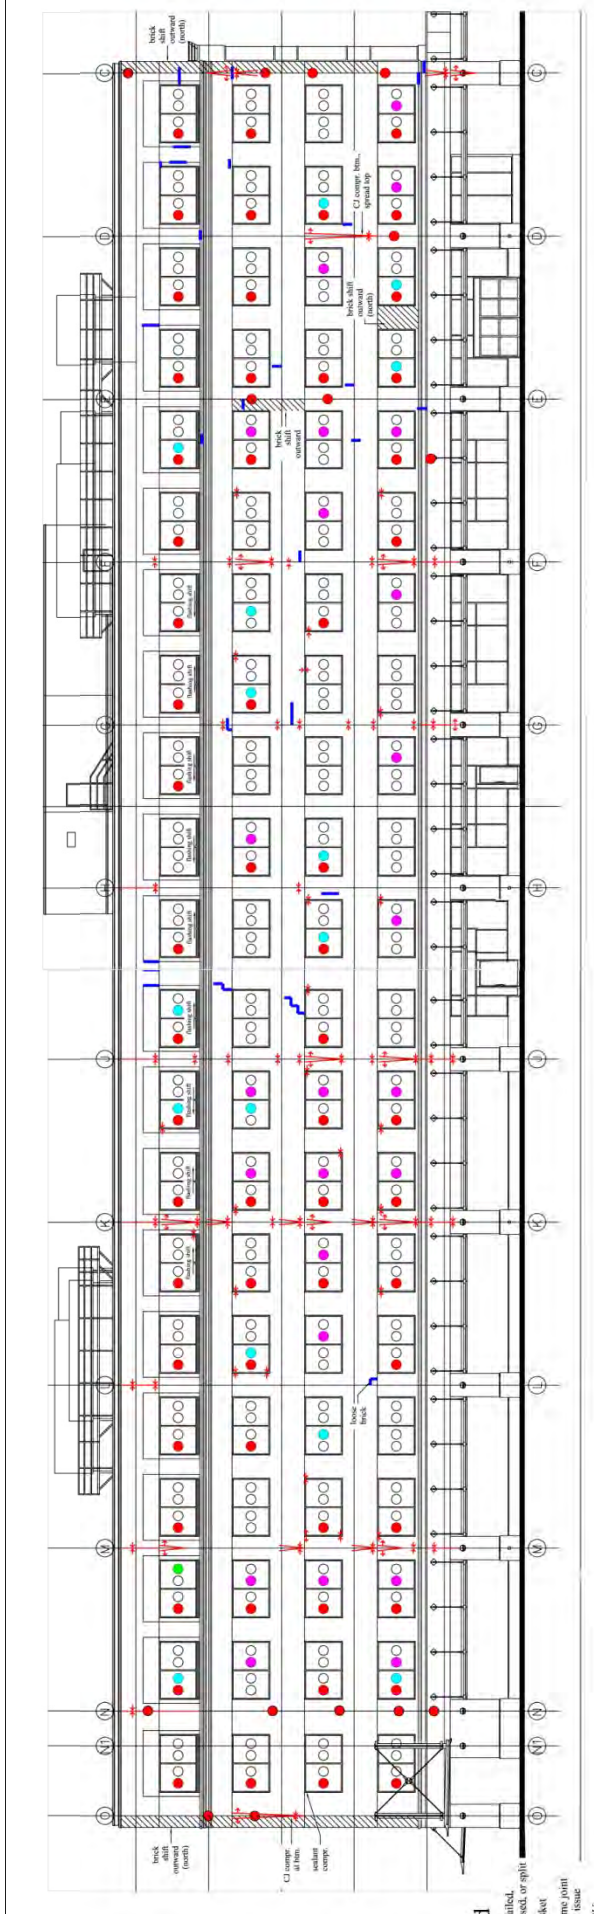
- sealant failed, compressed, or split
- short gasket
- open frame joint or frame issue
- failed IGU
- crack
- control joint issue

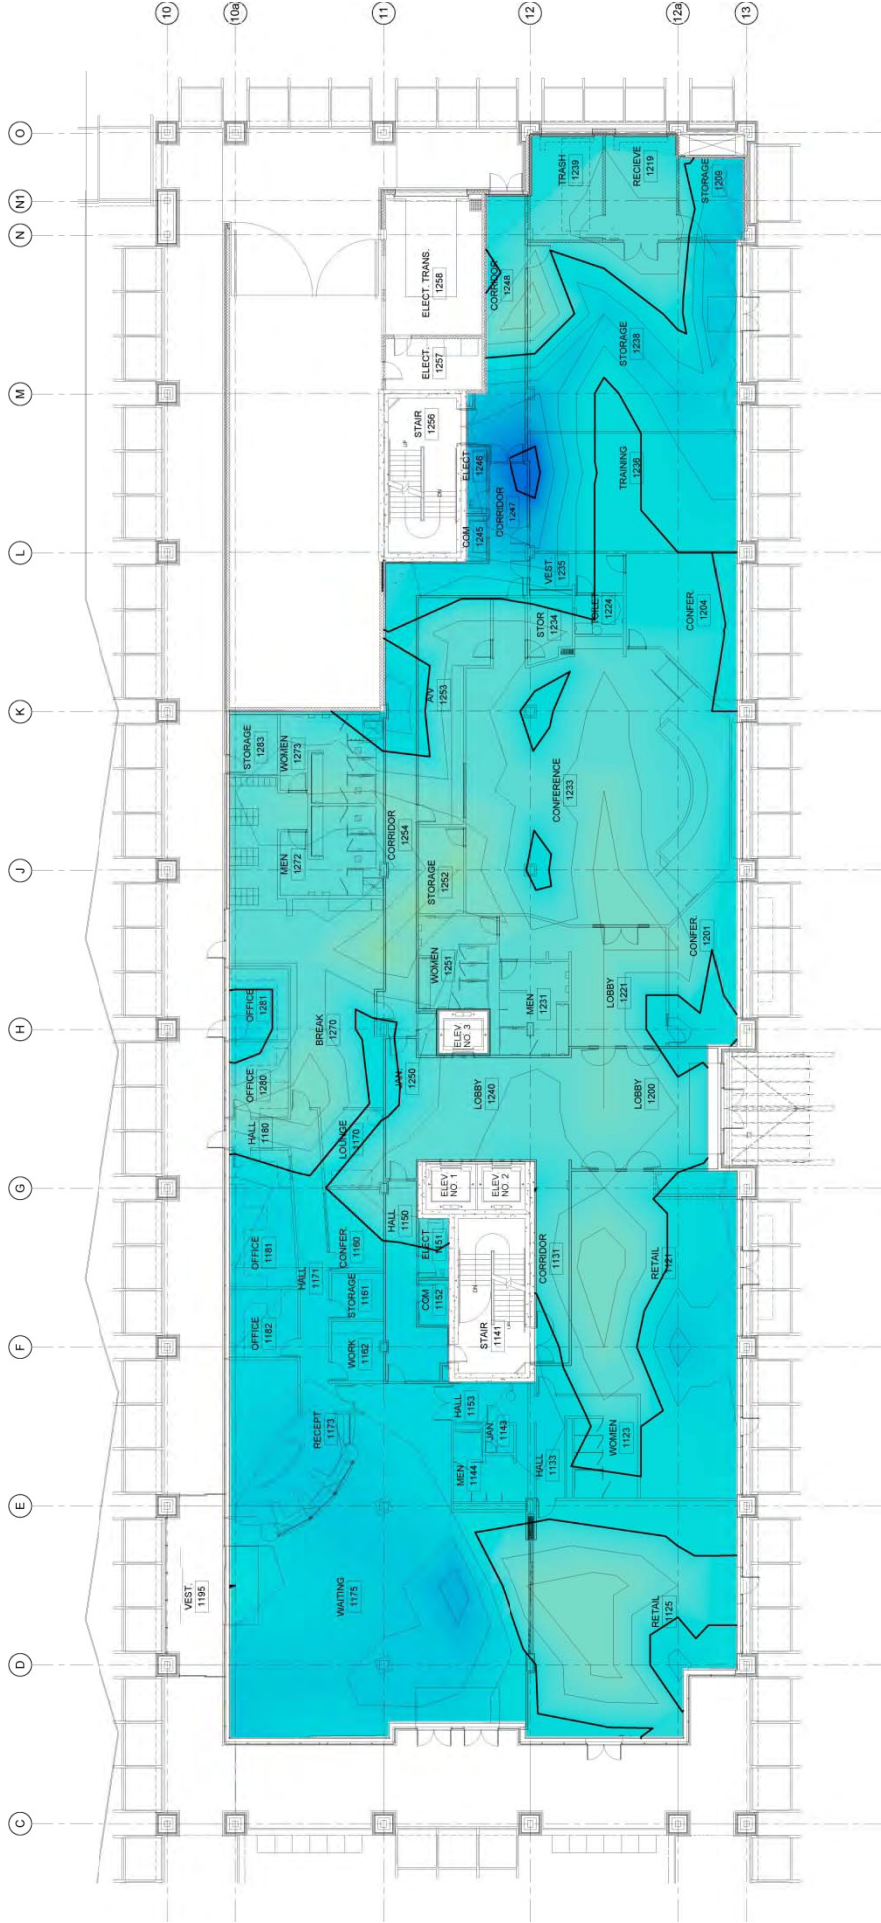
Ground Floor

# OBSERVED SLAB DEFLECTION
