**Marion County Courthouse Square  
555 Court Street NE, Salem Oregon  
Remediation Study Final Report  
February 07, 2011**

**Volume Four of Six**

Marion County  
Courthouse Square Structural Remediation  
Project Summary  
June 09, 2010

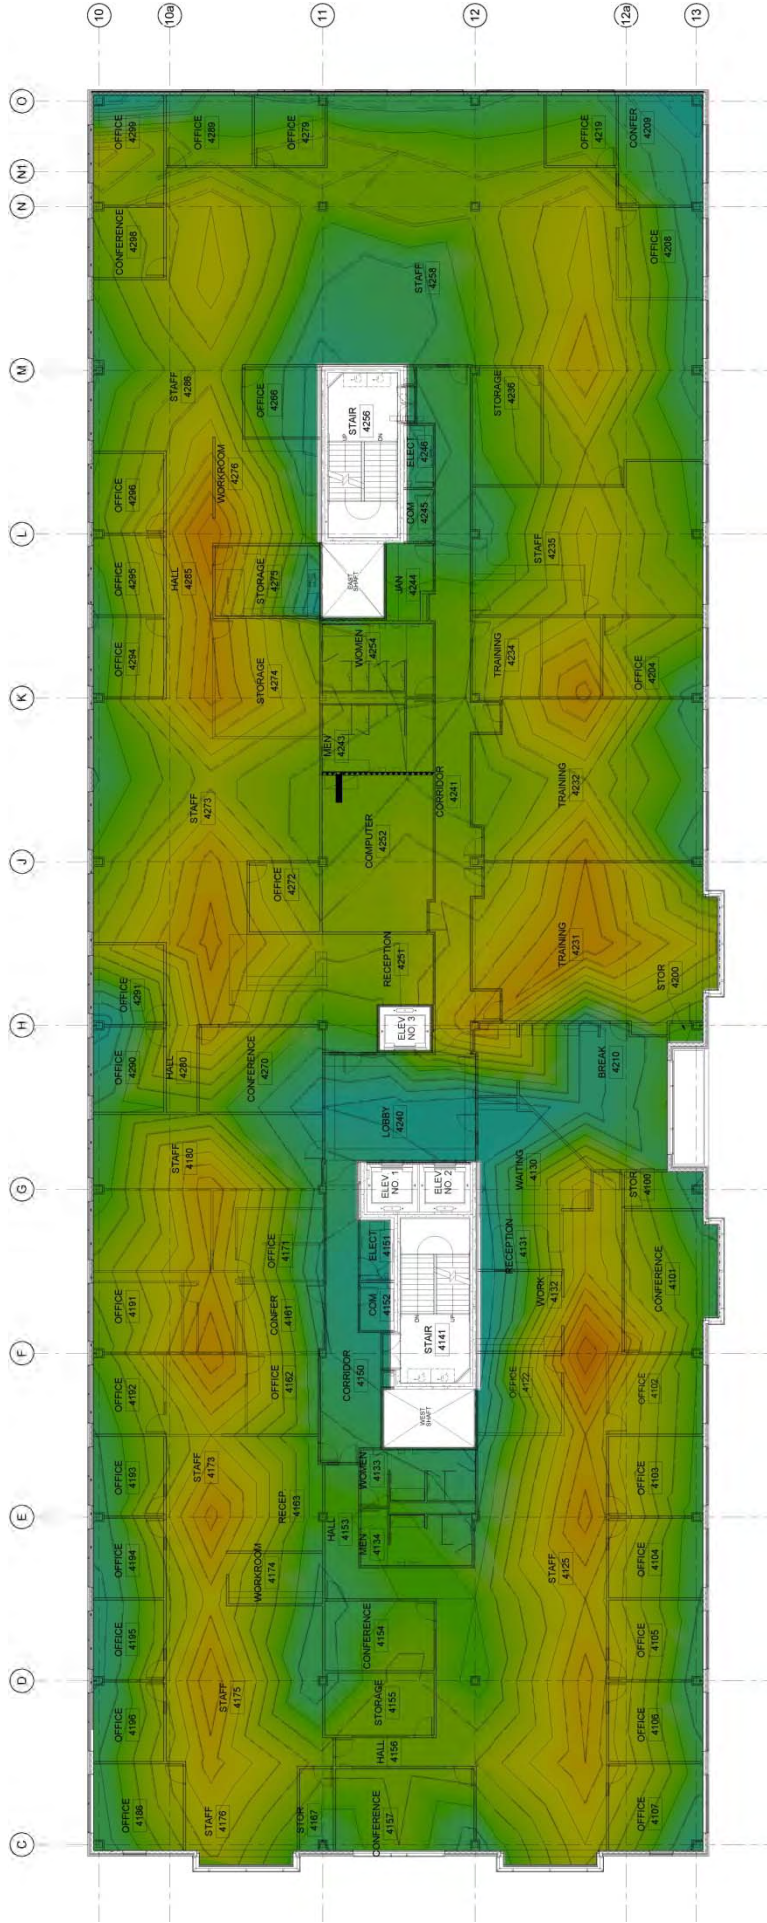
Fourth Floor

# OBSERVED SLAB DEFLECTION

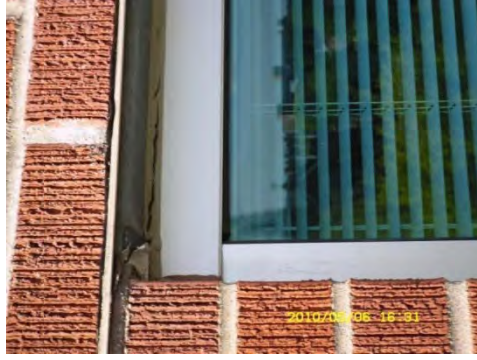
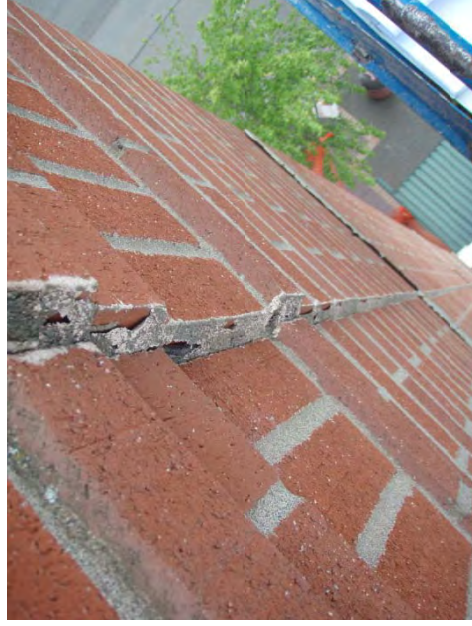
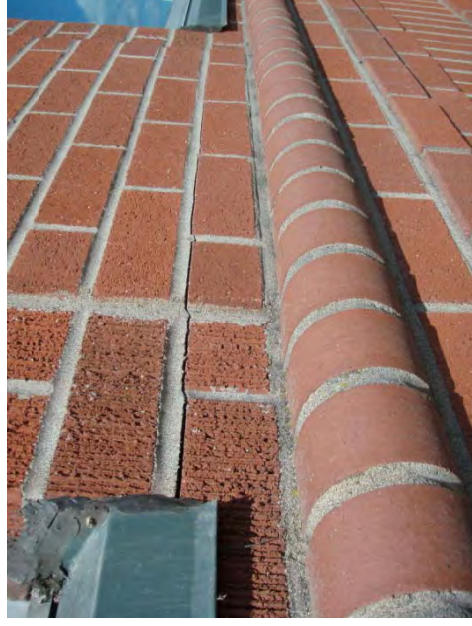
Exterior Observation found:

- Water infiltration issues at the curtain walls including failed window units
- Window frames out of alignment
- Brick control and expansion joints not uniform
- Window sealant at the end of it's useful life

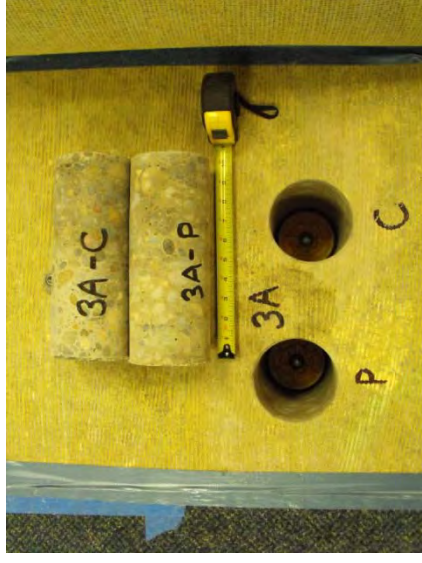
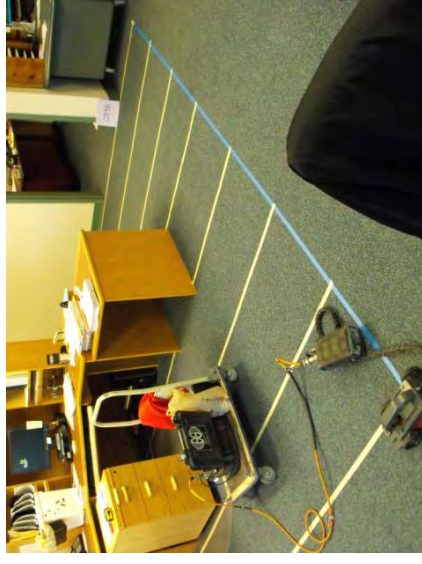
# MATERIAL TESTING: Compressive Tests 54

Concrete testing results showed less than designed strengths of 5000psi:  
Actual strengths are:

- Ground Floor = 4360psi, 4600psi, 4424psi
- Second Floor = 3460psi, 4210psi, 3710psi, 4080psi
- Third Floor = 3960psi, 3490psi, 3800psi, 3500psi
- Fourth Floor = 4310psi, 3730psi, 4860psi, 4520psi
- Fifth Floor = 5150psi, 4240psi, 4520psi, 4510psi

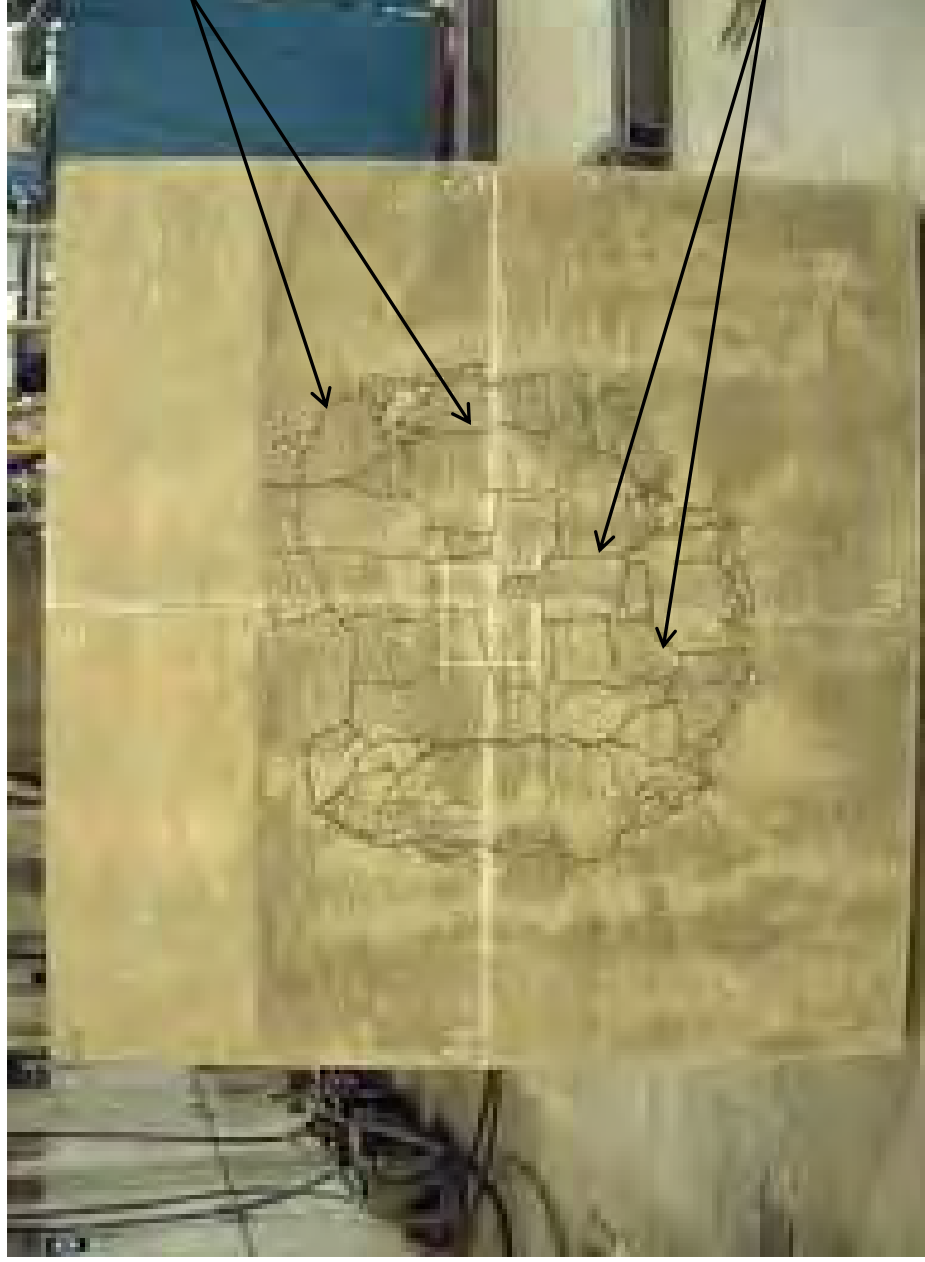
# PUNCHING SHEAR

Radial cracks

Radiating cracks

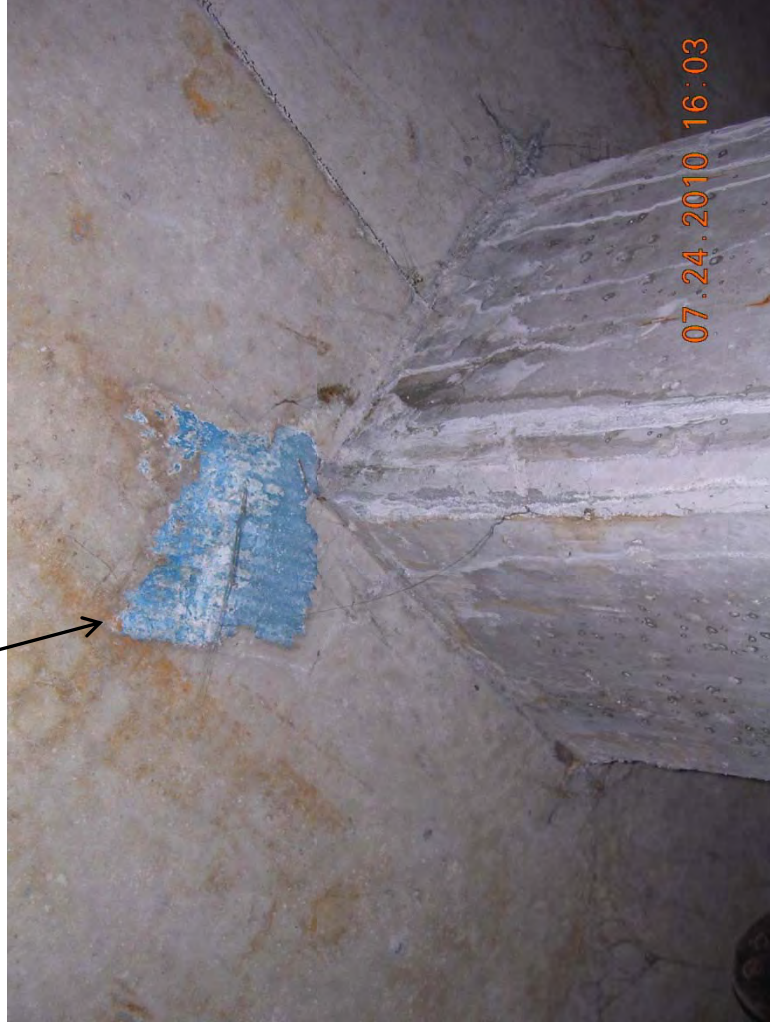
Debris on the form work cast into the Bus Mall slab.

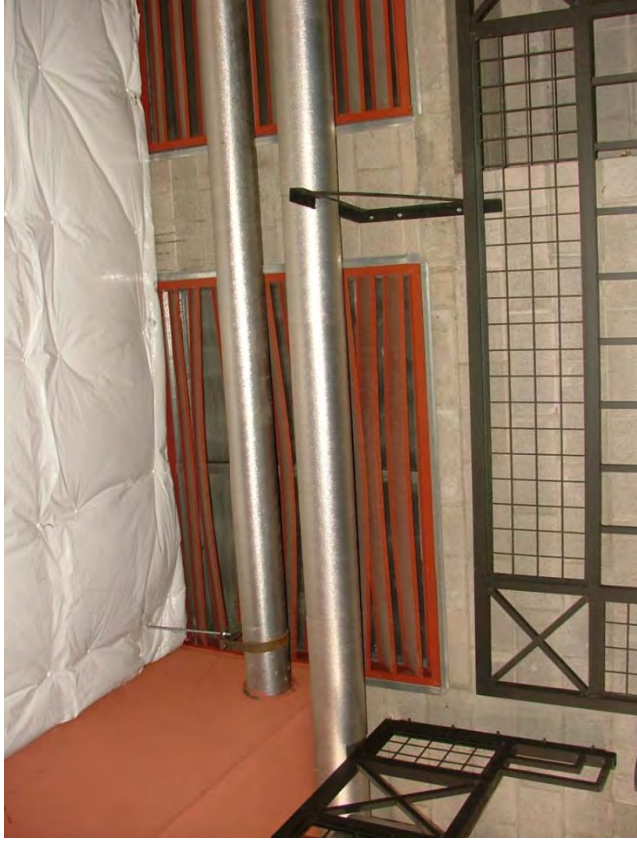
Equipment damaged related to building movement include:

- Intake louver at parking garage ramp
- Fan room wall cracks in the Basement
- Fan housekeeping pad cracked

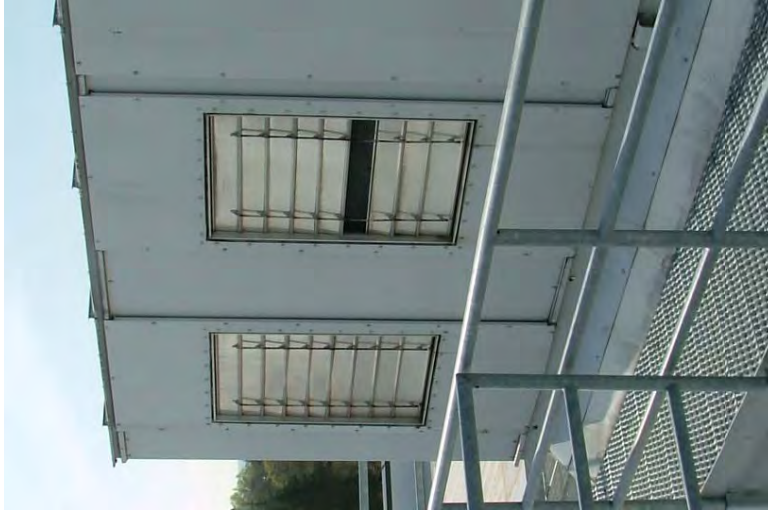
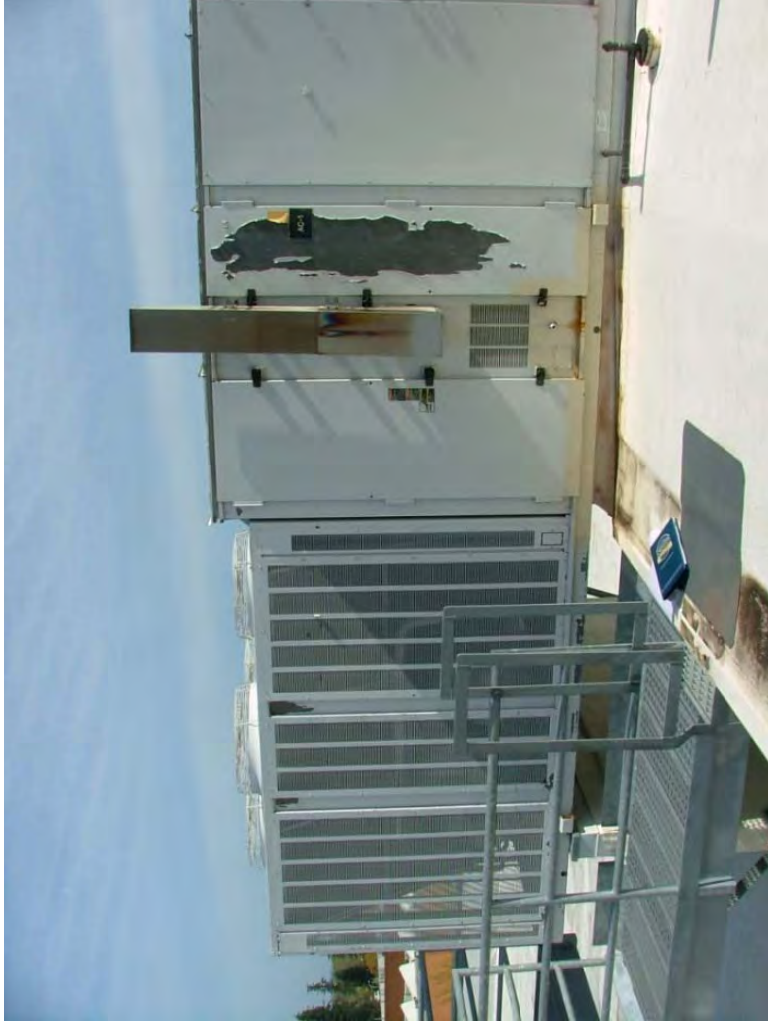
A note of special concern

- Fire/ smoke damper access panels should be installed at west shaft
- Equipment wear and tear

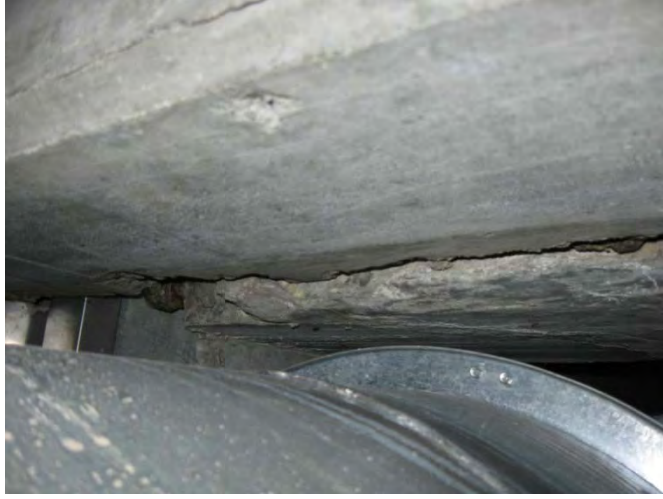
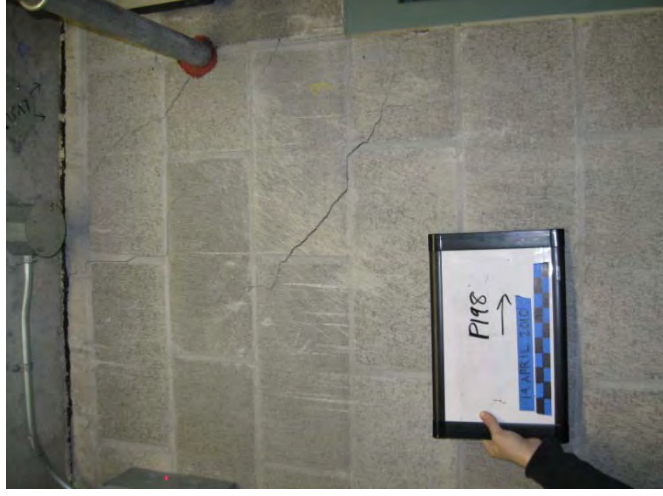
Observations include:

- Cracking of the foundation wall
- Cracking of non-structural members
- Cracks at columns with significant damage due to water infiltration

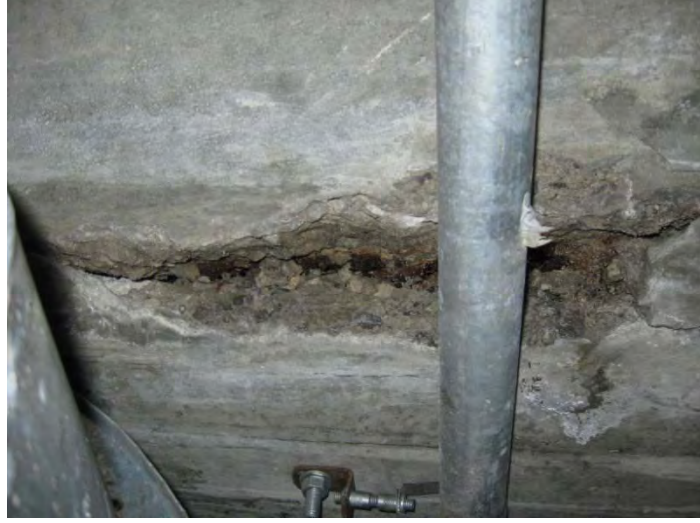
## Significant Cracking in Concrete Column at Grid M-10a

Cracking has occurred at the concrete column at Grid M-10a, as well as moisture penetrating through the basement concrete walls and causing damage to the concrete structure.

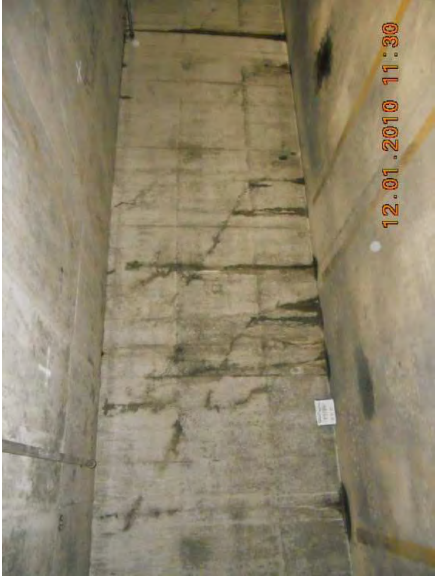
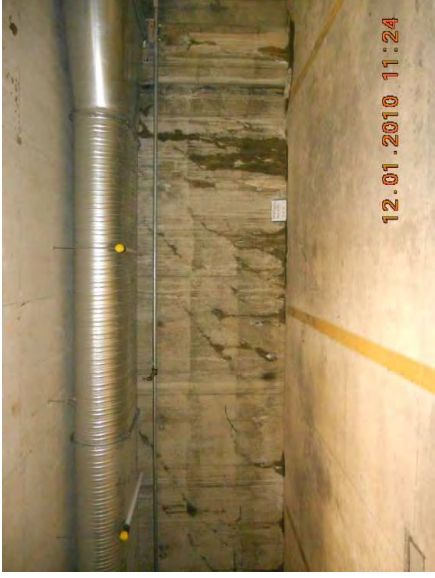
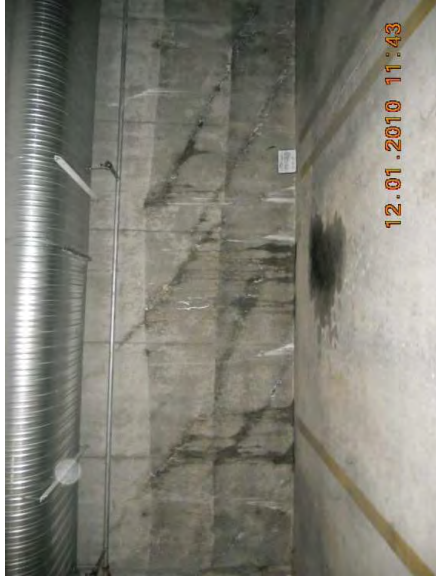
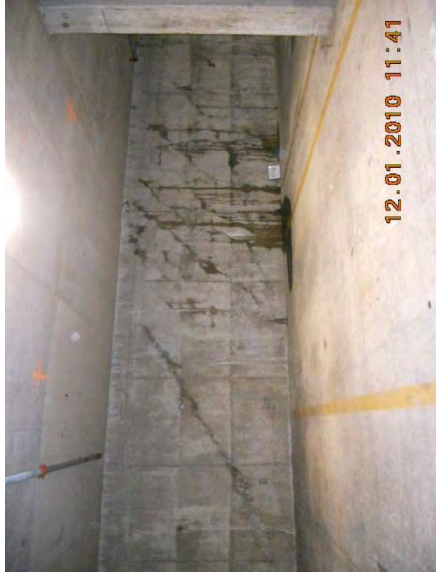
# FLOOR DESIGN ACTUAL CONDITIONS:

## BUS MALL SHRINKAGE AND SHORTENING

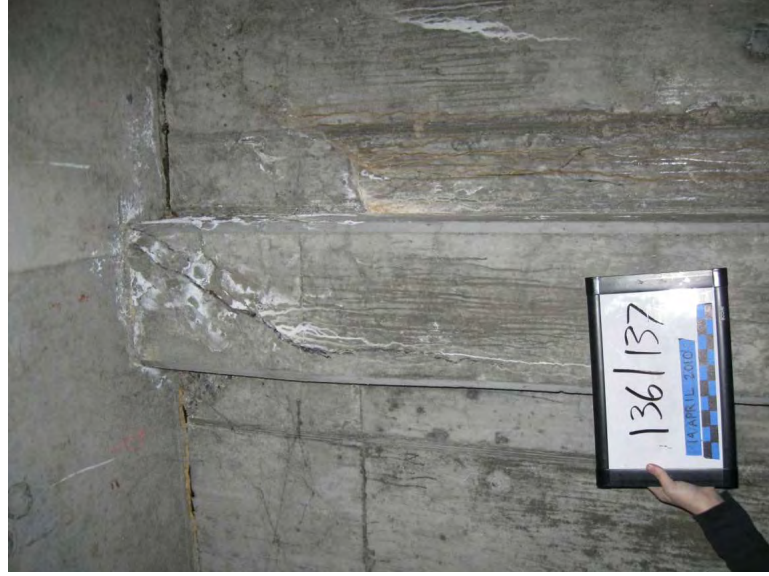
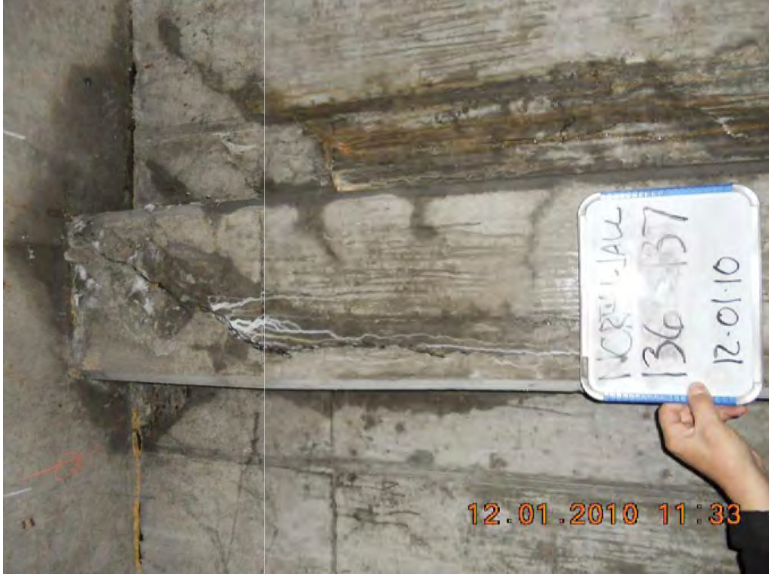
# FLOOR DESIGN ACTUAL CONDITIONS: NORTH BLOCK SHRINKAGE AND SHORTENING

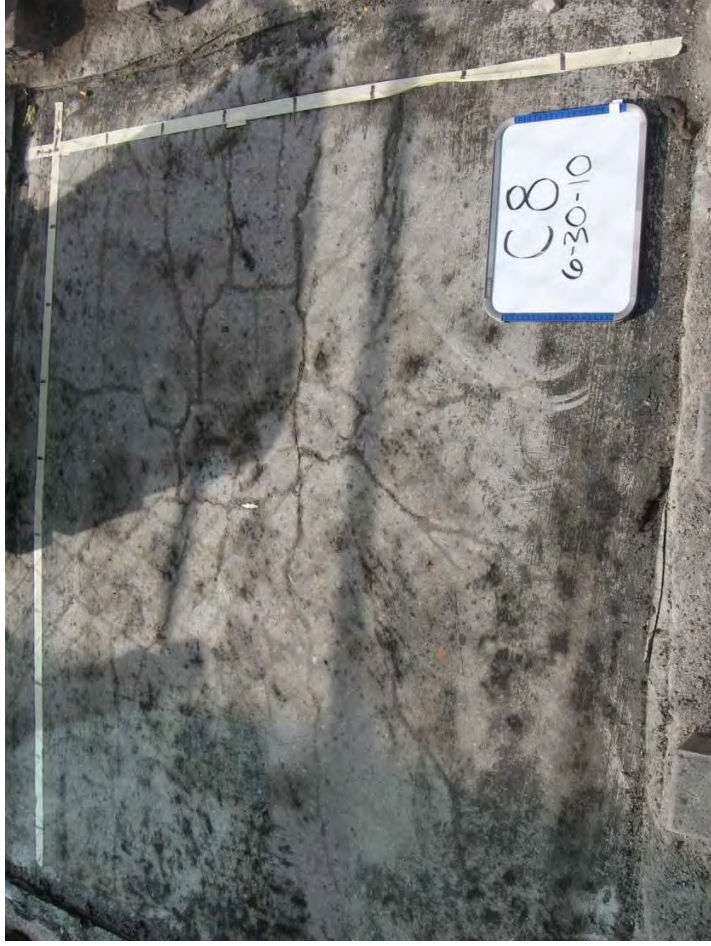
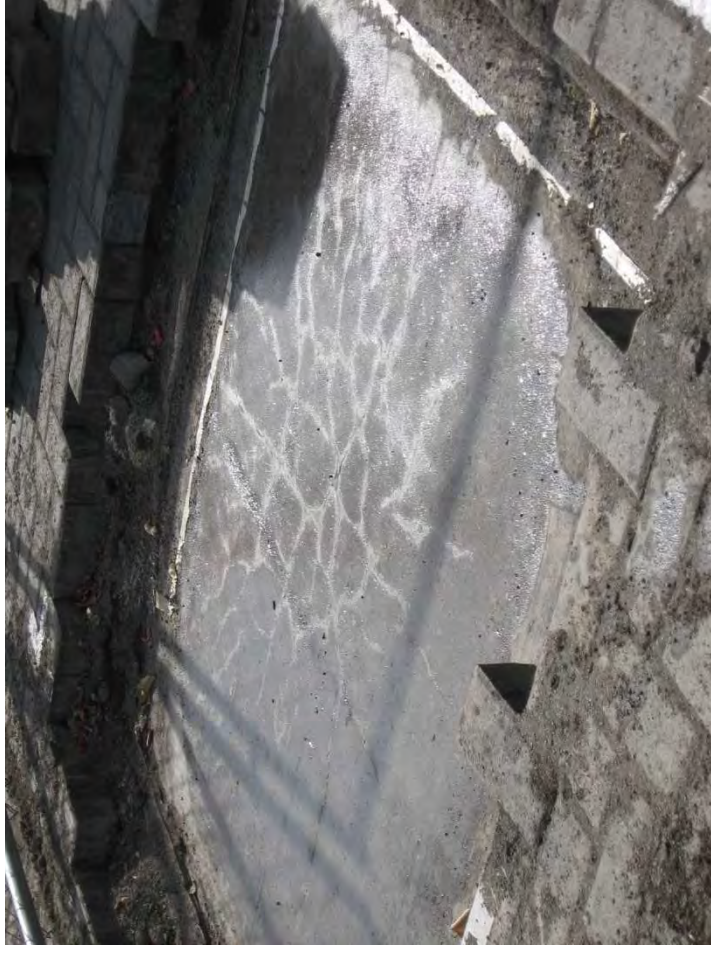
# COLUMN DESIGN ACTUAL CONDITIONS: BUS MALL PUNCHING SHEAR

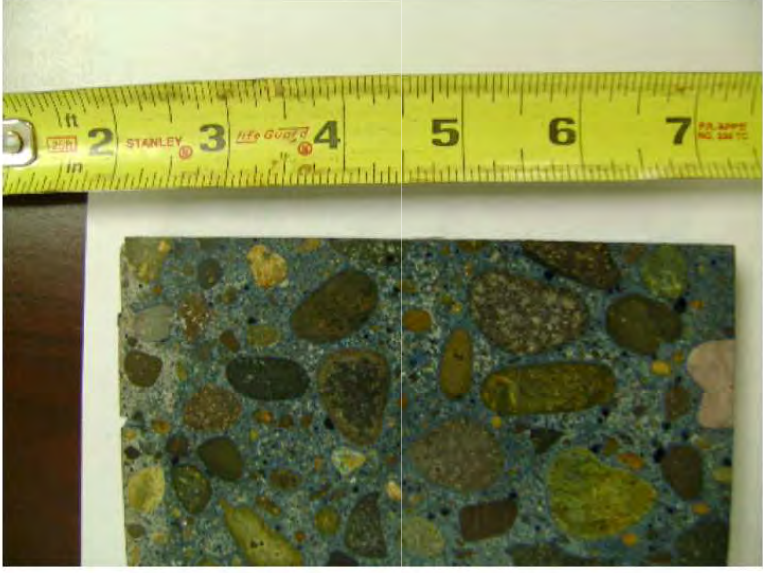
Photograph #2 - Sample 06033-2. Color change can be seen in paste at top surface as well as the bulk paste.

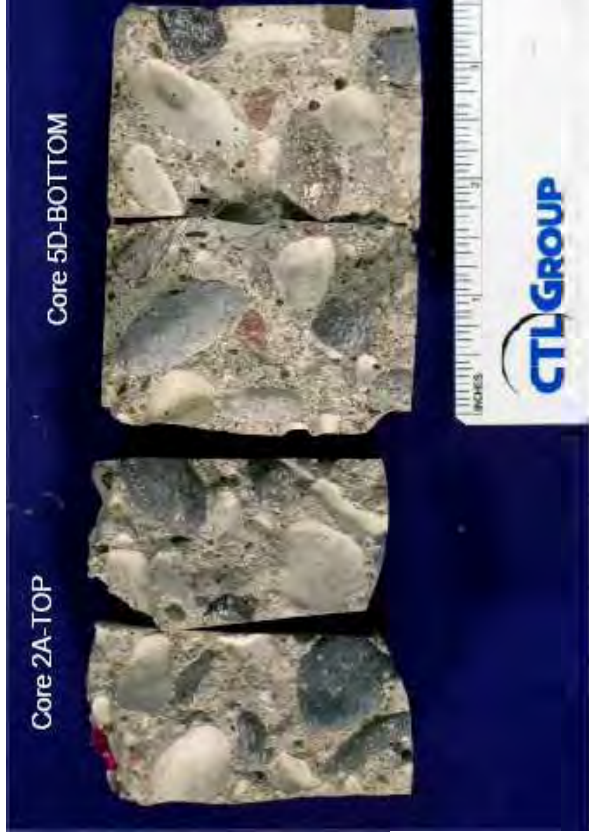
Fig. 7 Image showing freshly fractured surfaces of Cores 2A-TCP and 5D-BOTTOM. The fracture surfaces pass around almost all coarse aggregate particles indicating a weak paste-aggregate bond. Scale is marked in inches.

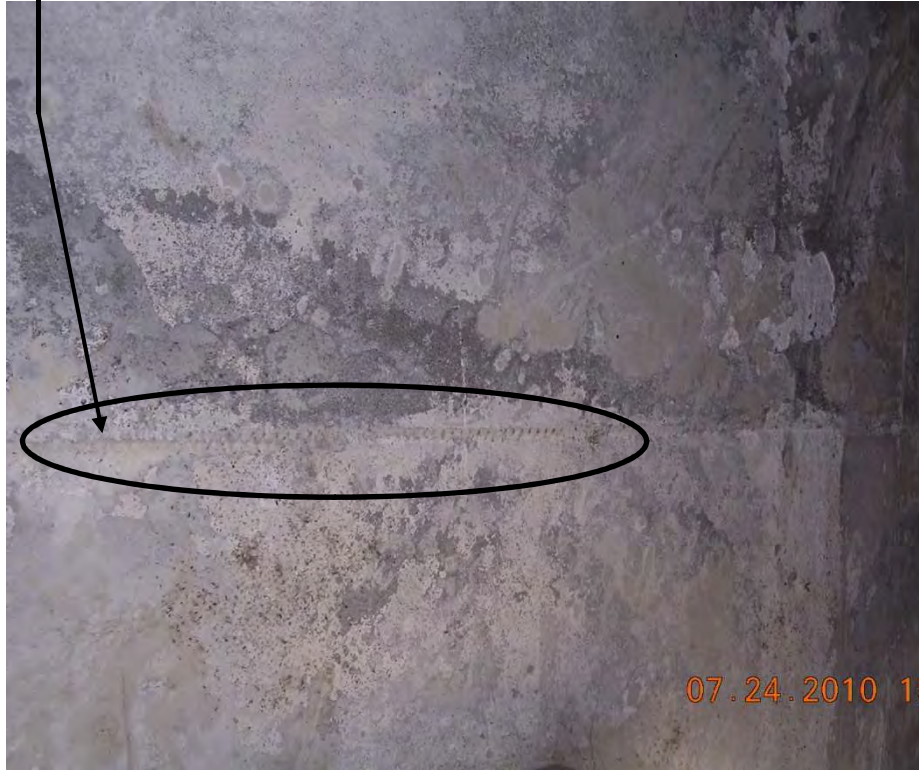
REINFORCING BAR EXPOSED AT THE BOTTOM OF THE BUS MALL SLAB

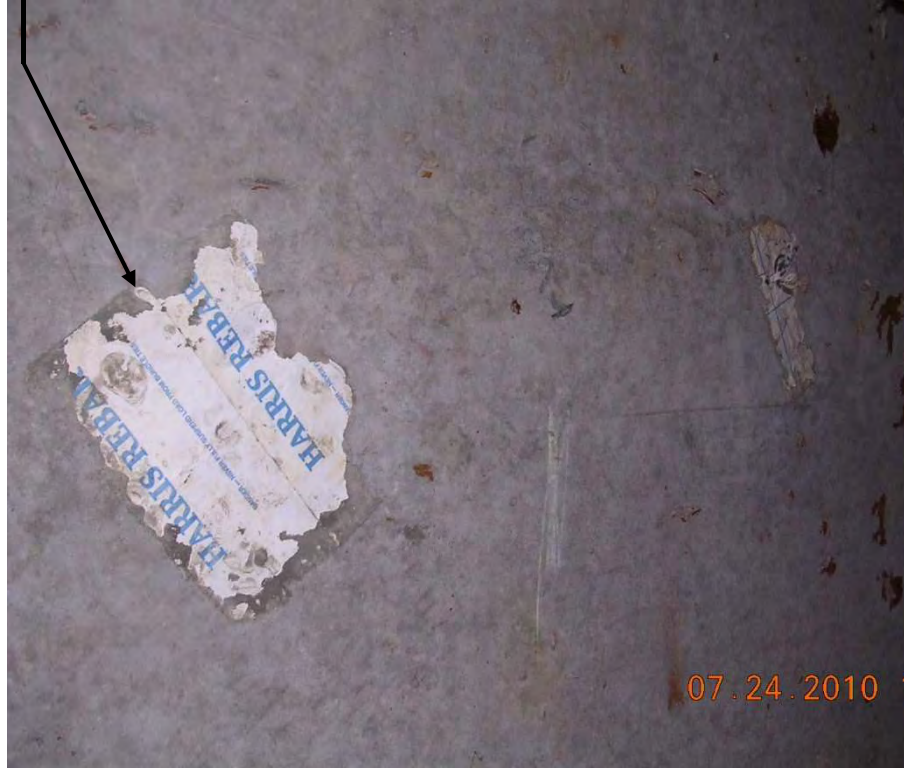
DEBRIS ON THE FORM WORK CAST INTO THE  
BUS MALL SLAB

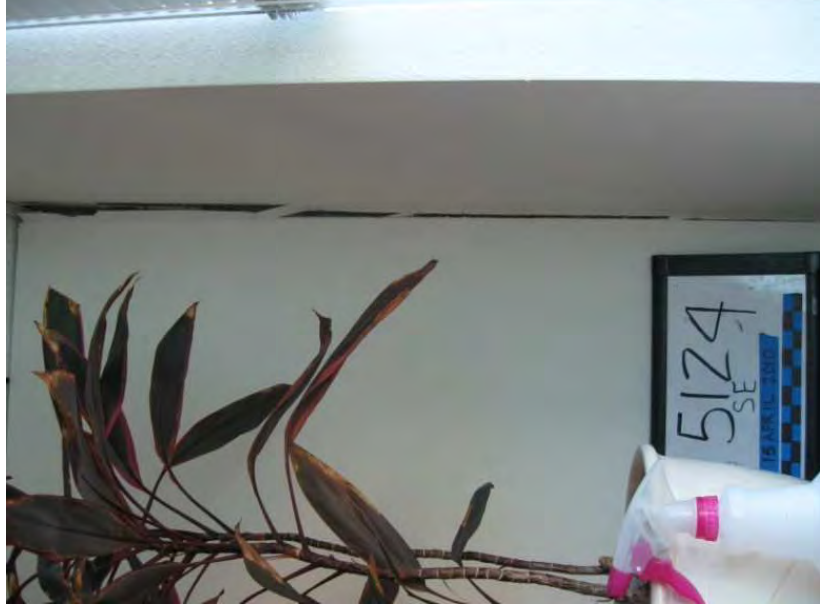
# RESULTS OF DESIGN, MATERIALS, AND CONSTRUCTION ISSUES: WALLS

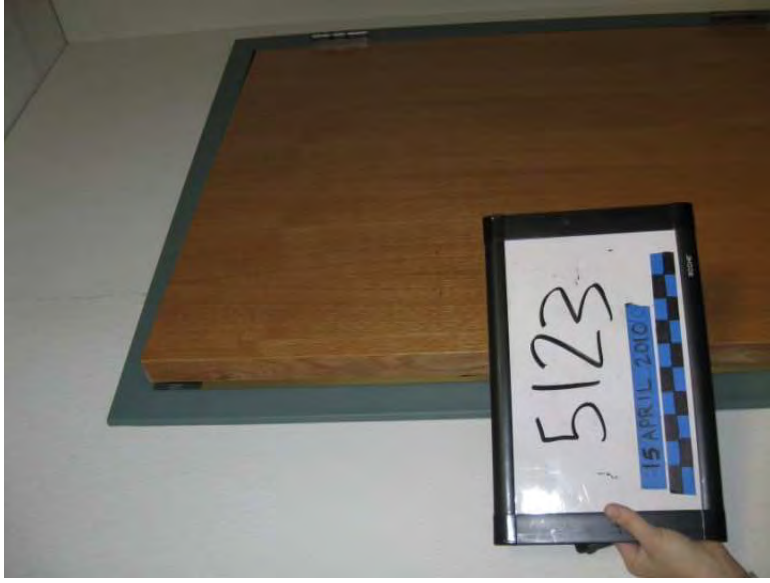
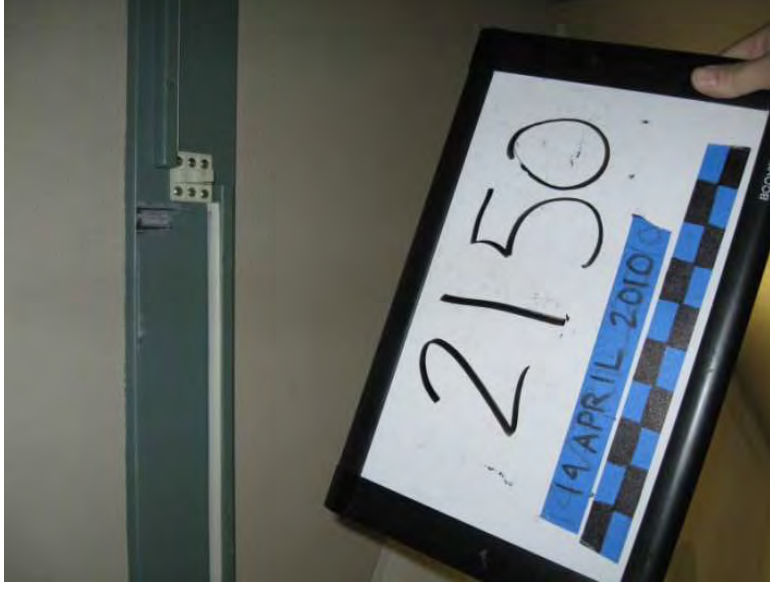
# RESULTS OF DESIGN, MATERIALS, AND CONSTRUCTION ISSUES: DOORS

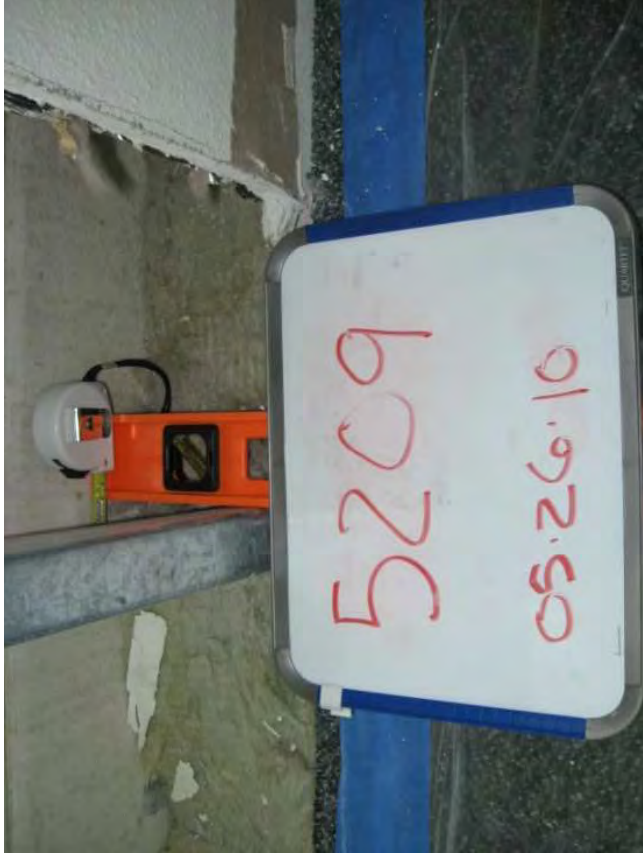
SE Corner

← BRICK RESISTANCE      BRICK RESISTANCE →

SLAB MOVEMENT →

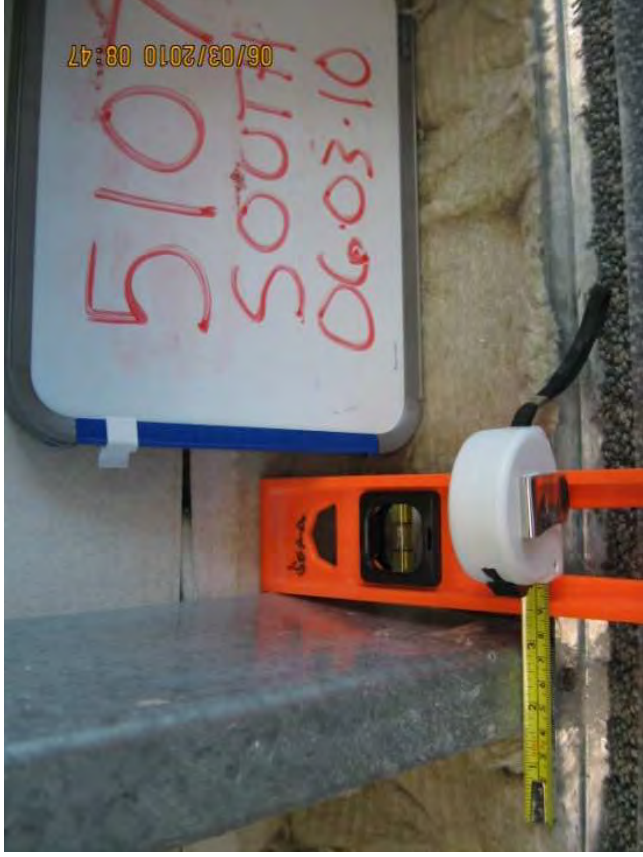
SW Corner

SLAB MOVEMENT →

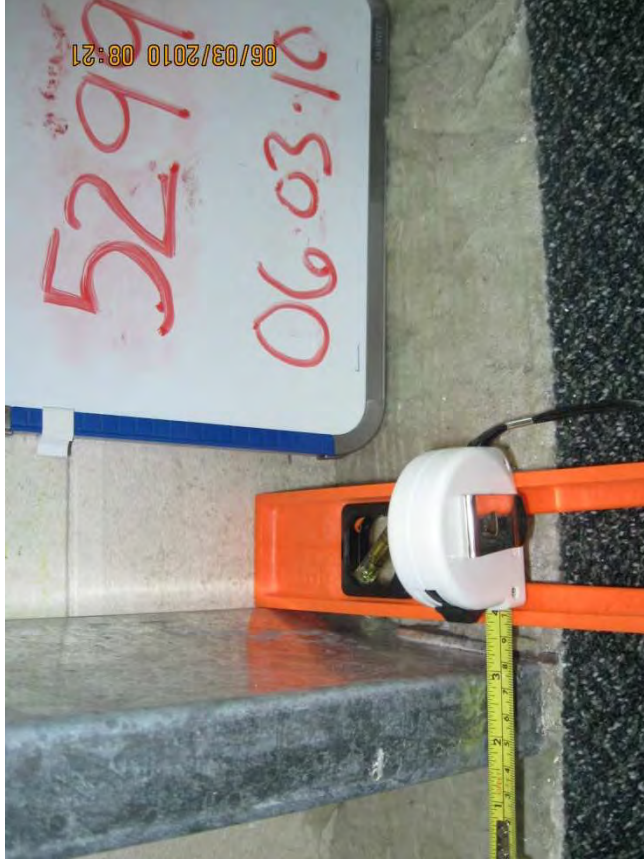
NE Corner ← SLAB MOVEMENT

BRICK RESISTANCE →

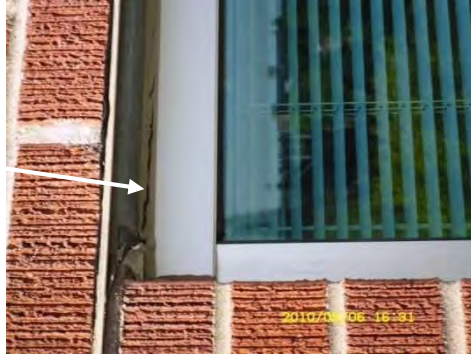
SHEARED SEALANT

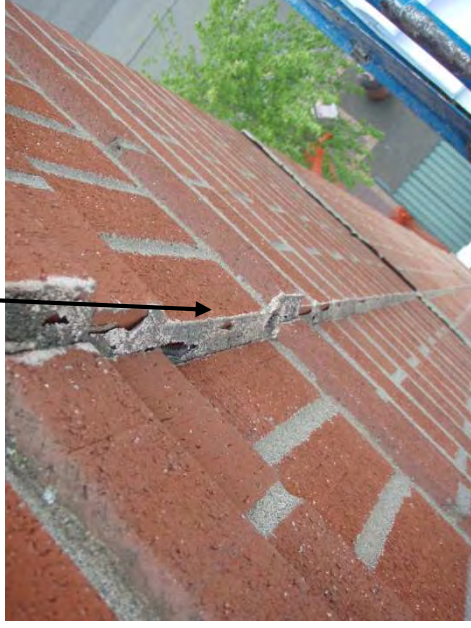
OUT OF PLANE  
MOVEMENT

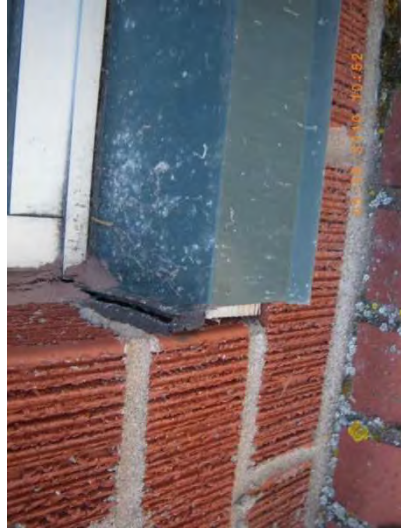
COMPRESSED SEALANT

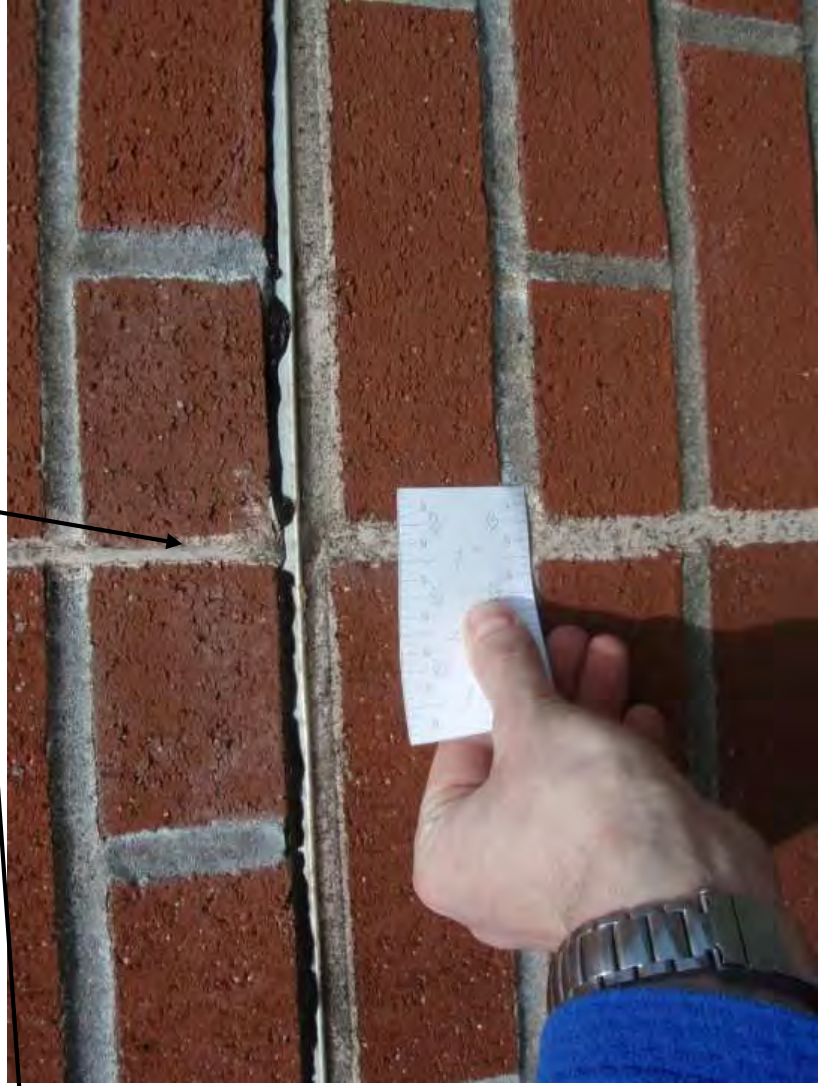
SEPARATED FLASHING

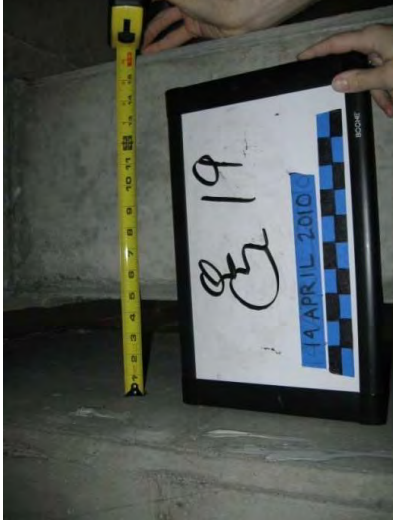
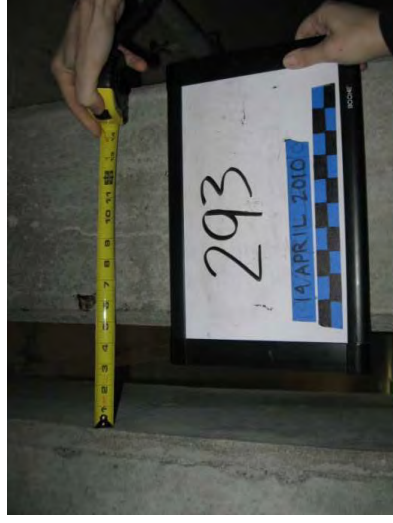
# RESULTS OF DESIGN, MATERIALS, AND CONSTRUCTION: COLUMN GAP AT THE BUS MALL SLAB

4 1/2 INCHES  
AT TOP

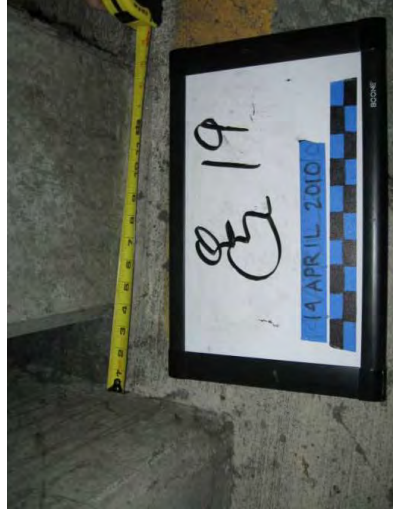
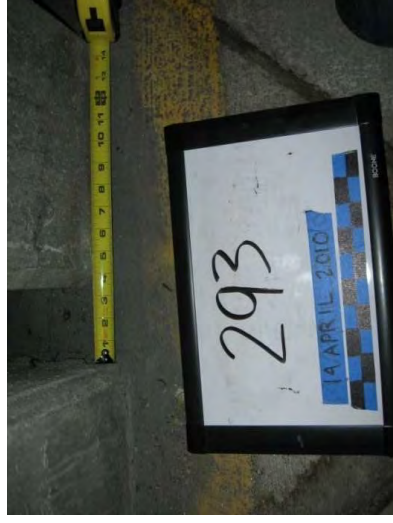
3" INCHES  
AT BOTTOM
